2016 International Petroleum Environmental Conference

MINE TAILINGS DRAINAGE – A BOTTOMS UP APPROACH USING HDD DRILLING AND INSTALLATION METHODS

Callahan Mine - Maine

OU 3 Tailing Impoundment

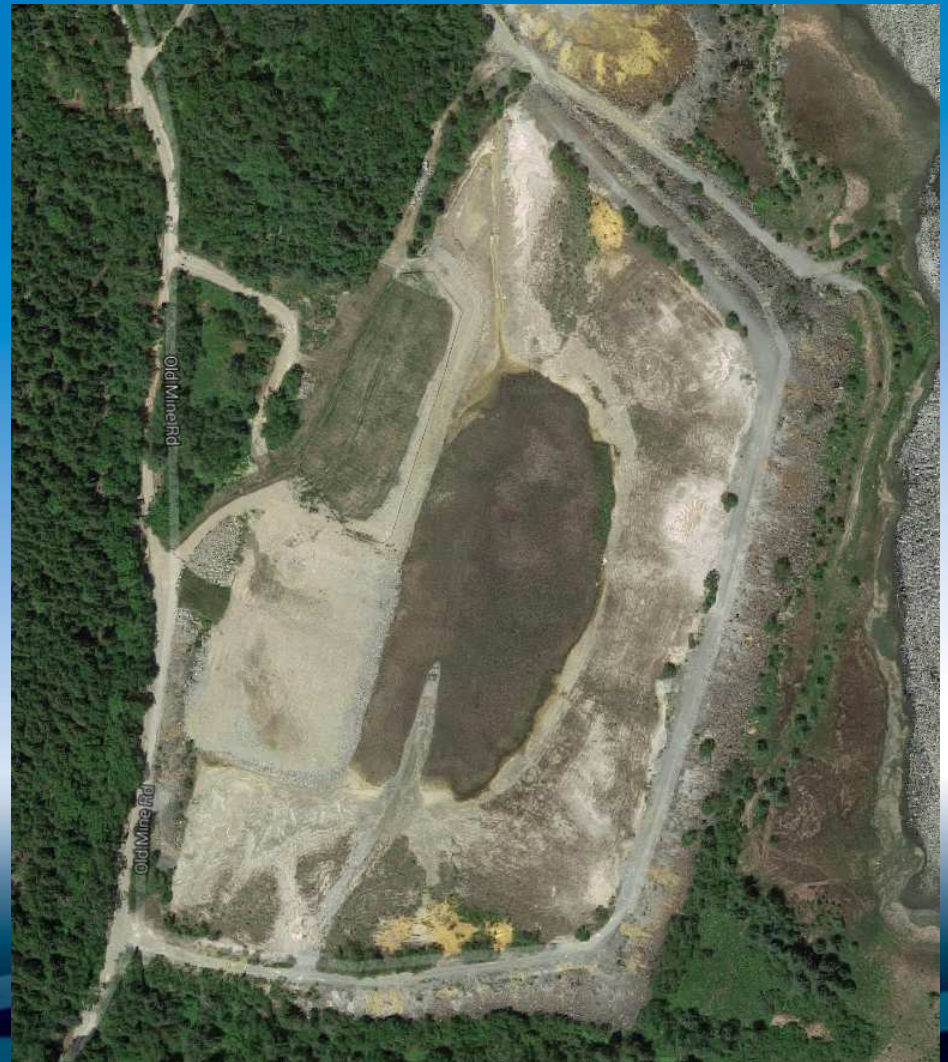
- 17 acres
- Over 700,000 cubic yards of material
 - Fine sand, silt and clay
 - Saturated material
- Three sided dam
 - 60' height
 - 1.3H to 1V
 - Constructed of cobble and boulder sized waste rock material

- Impoundment “marginally unstable” under long term static conditions
- May fail under long term design magnitude earthquake
- Tailing material and seepage result in sediment and surface water contamination
 - Pb, Zn, Cd, As, Mg

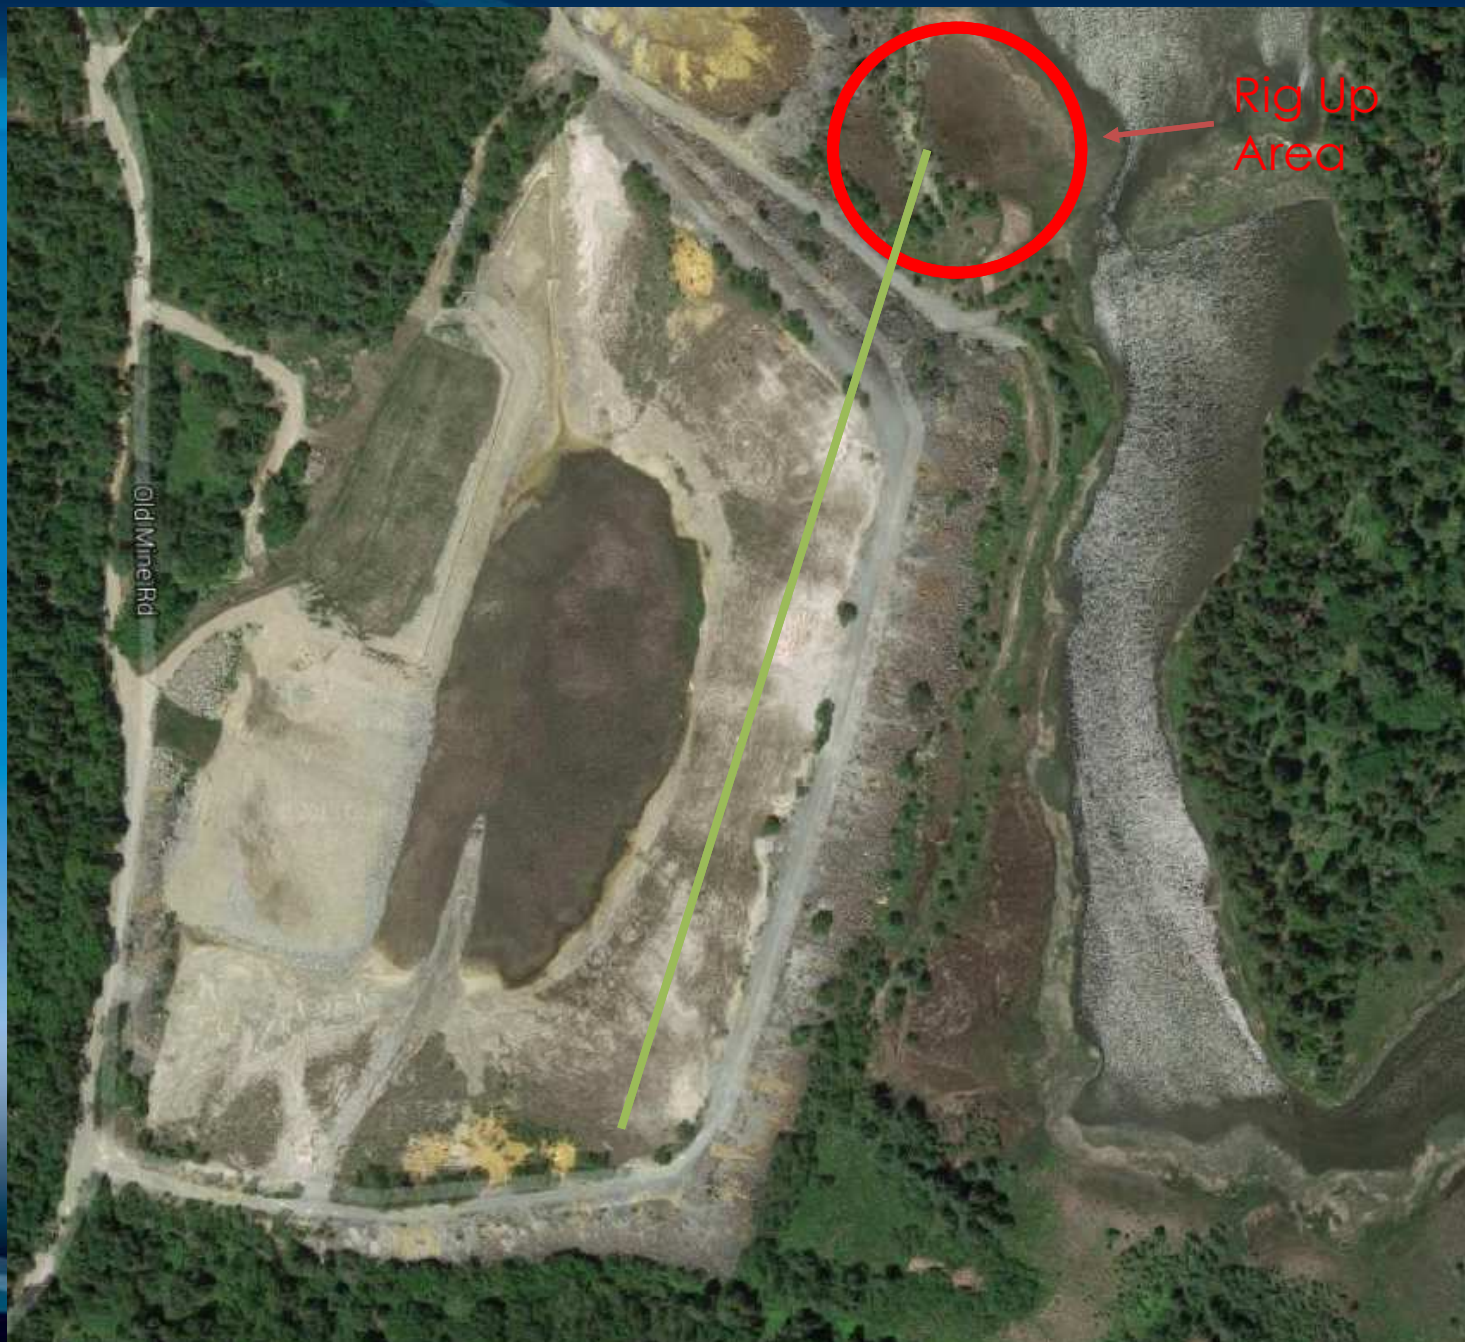
- Well screen needed to be at the base of the tailings
- No rig up area to drill from East to West
- Limited rig up area to the North
- No room to work or lay out well materials on the South side of the pond

Old Mine Rd

Rig Up
Area

Blind Well Open Hole
