IMPACT OF PETROLEUM VAPOR INTRUSION ON OBTAINING SITE CLOSURE

Justin L. Fabriziani & Michael T. Jordan
Terracon Consultants, Inc., Raleigh, NC

International Petroleum Environmental Conference
October 8, 2016

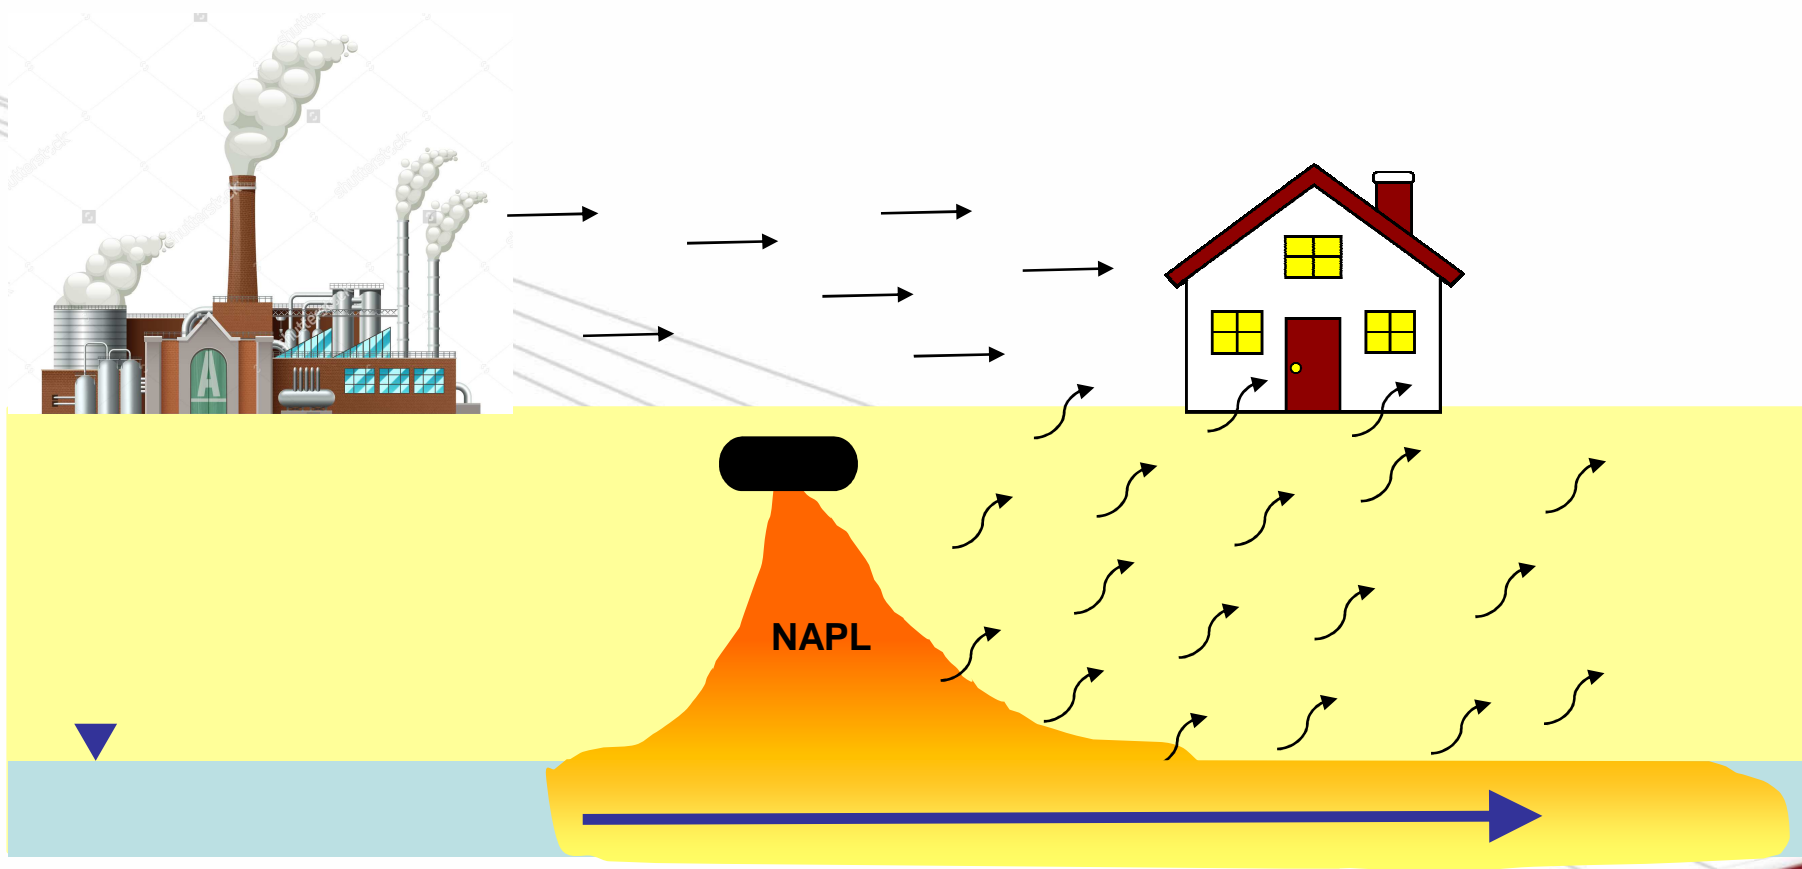
What is Petroleum Vapor Intrusion (PVI)?

process by which volatile petroleum hydrocarbons released as vapors from NAPL, petroleum-contaminated soils, or petroleum-contaminated groundwater migrate through the vadose zone and into overlying buildings (ITRC, 2014)

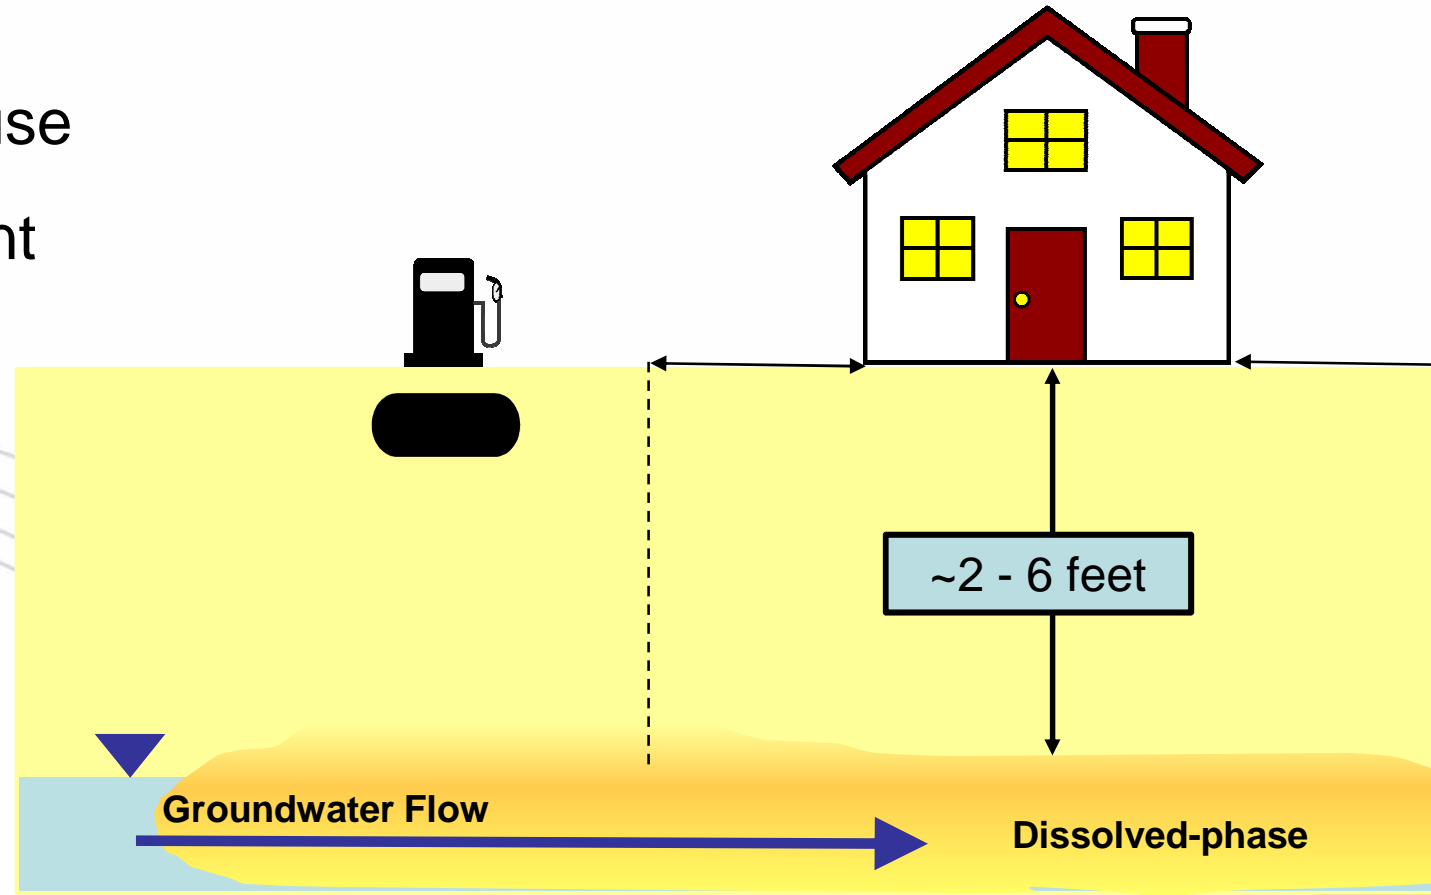
Study #2 – Residence

zene plume beneath house

cluding factors not present

L not present

/ = ~2 to ~6 feet
