# Reclamation of Remote Oil Sand Exploration (OSE) Programs

Matthew Hartley: AECOM Canada Ltd

IPEC: November 8 – 10, 2016

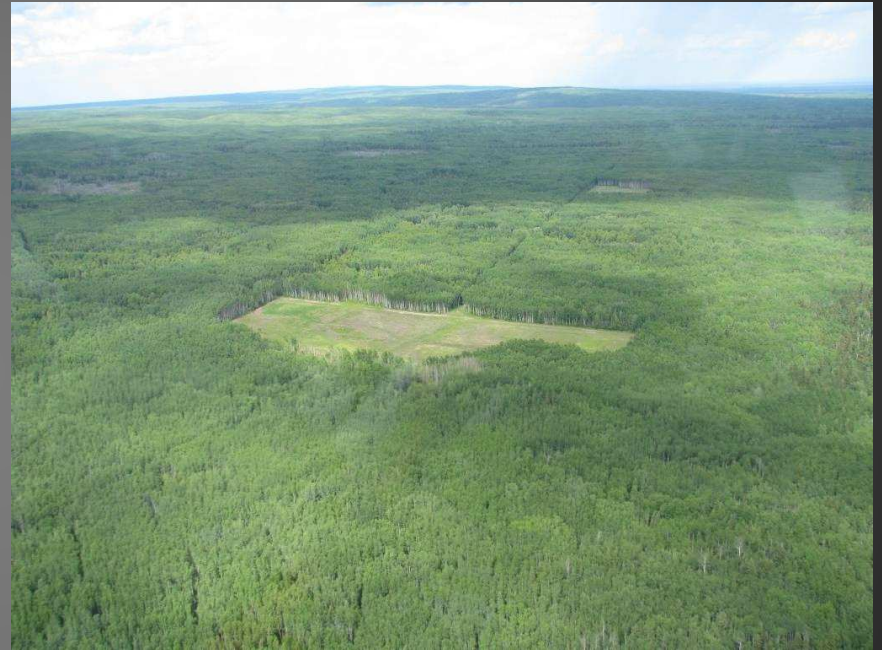
- Coal & Oil Sands (OSE) Reclamation Requirements
- Overview of landscape, vegetation and soil conditions
- Approx. 50% of sites have been subject to an aerial monitoring inspection
- Digital imagery obtained from approx. 90% of sites following deployment of an aerial reconnaissance program
- Identification of ground assessment and/or mitigation requirements

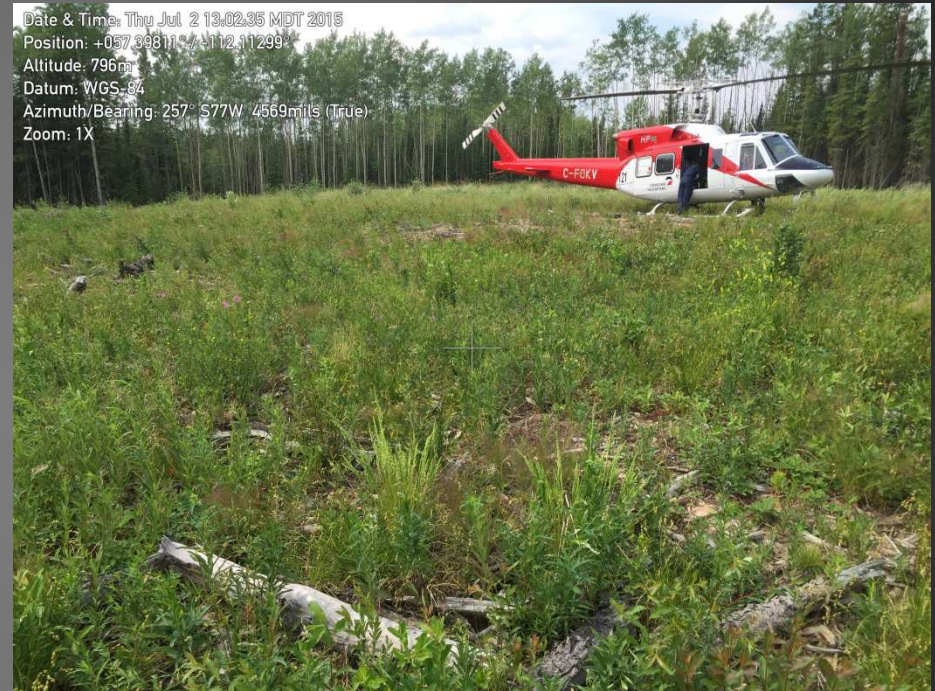
- 10% of sites within an OSE program require ground truthing
- Verify aerial observations
- Assessed as per either forested or peatland reclamation criteria
- Reclamation success determined through comparison to off-site undisturbed areas

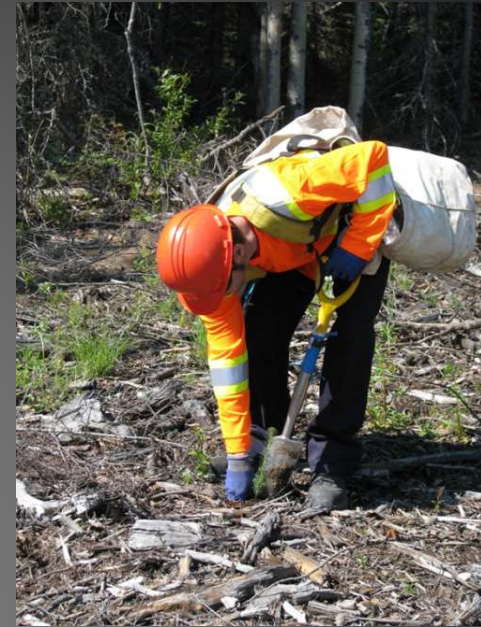
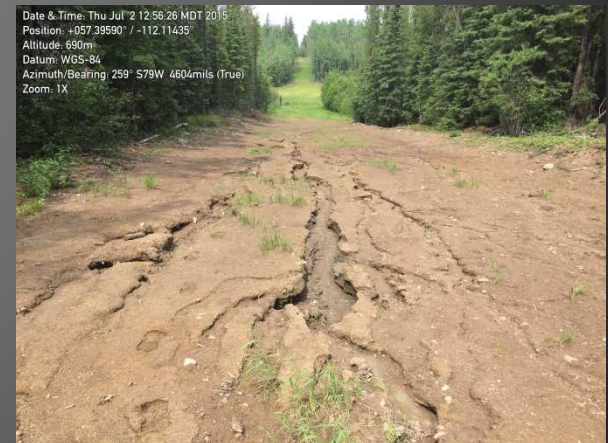
- Approx. 25,000 trees planted in past two years at approx. 30 sites
- Black & White Spruce, Jackpine and Lodgepole
- Planted between July 1 and August 31 with intention of achieving greatest survival success rate
- Densities followed applicable reclamation criteria of 2,000 stems per hectare
- Presence of grass was a key consideration
- Also utilized for erosion control purposes

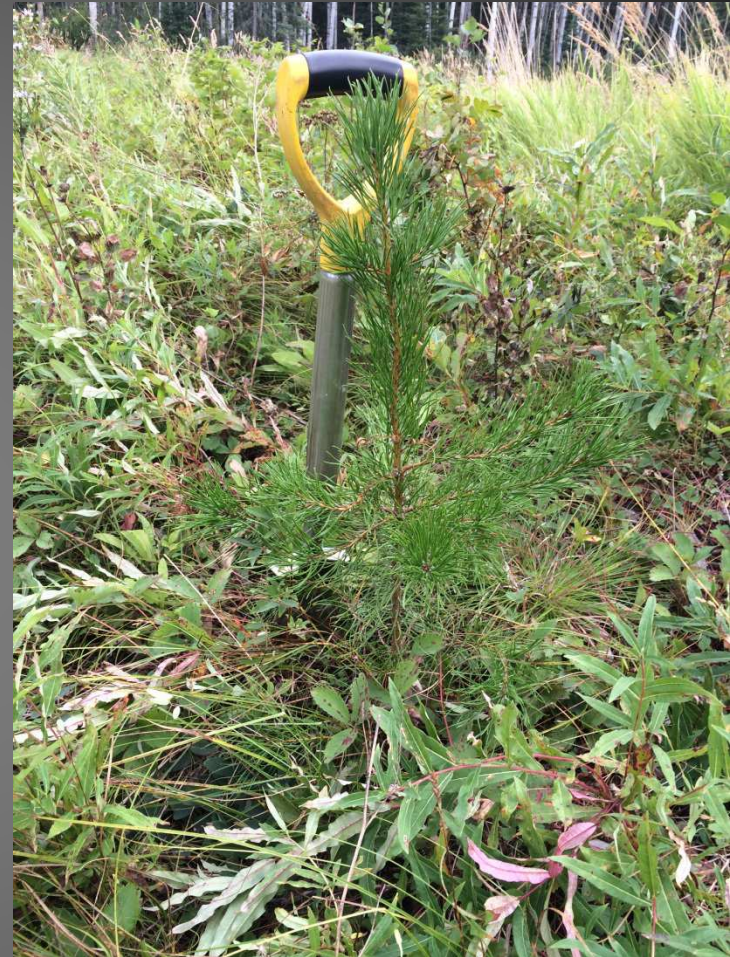
- Post planting inspections required to assess trajectory success
- Approx. 25% of sites that had been planted in in past two years were inspected
- Key considerations are survival rates, plant health and growth
- Minimum of two growing seasons and acceptable trajectory required for the purposes of reclamation certificate applications

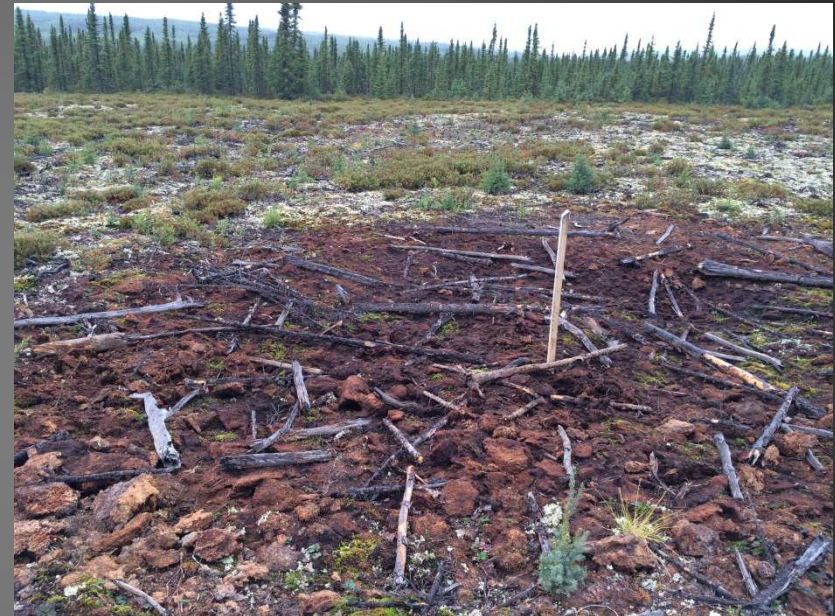
- Subsidence at well centers is common
- Subsidence may not affect the forest ecosystem and may actually be beneficial
- Wide or deep subsidence does pose an issue and may negatively impact reclamation trajectory
- Four sites have required re-contouring in past two years
- Utilization of coarse woody debris and topsoil from surrounding area

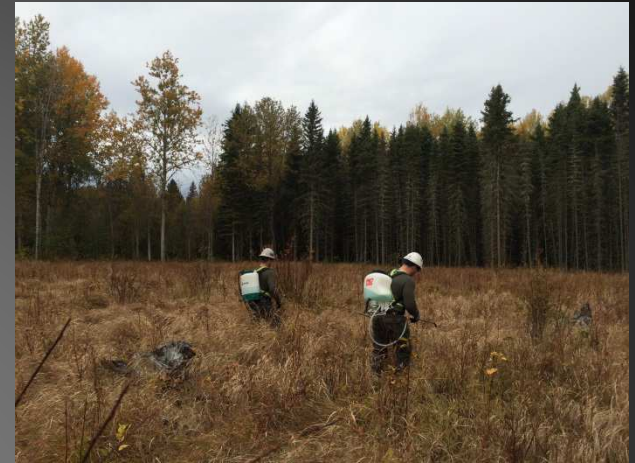
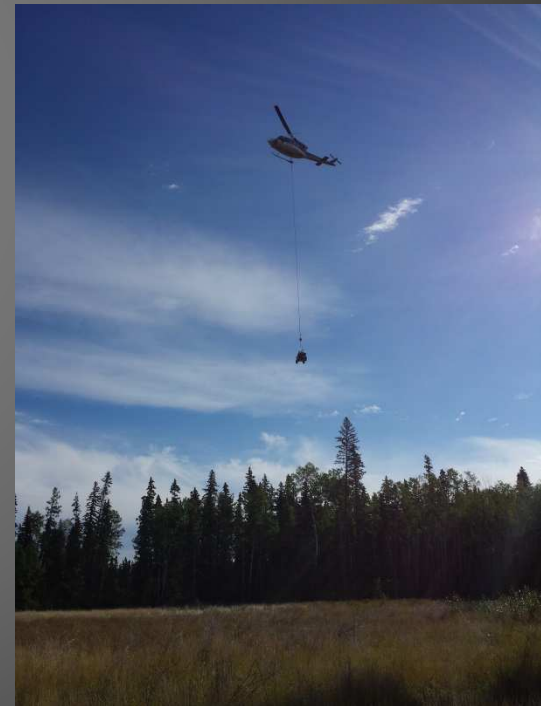
- Four predominant noxious weed species
- Scentless Chamomile, Perennial Sow Thistle, Common Tansy and Canada Thistle
- Approx. 60 sites have been subject to weed management in past two years
- Spot spraying and hand picking largely utilized
- Three specific sites required an all-terrain vehicle and boom sprayer to be utilized

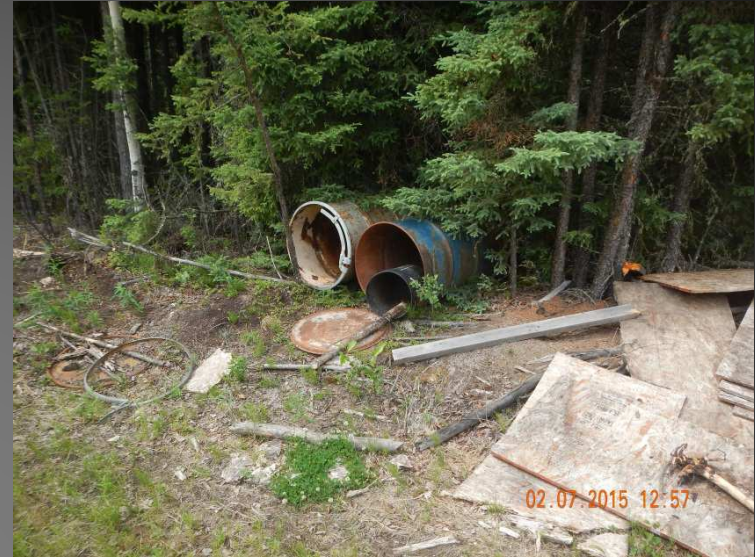
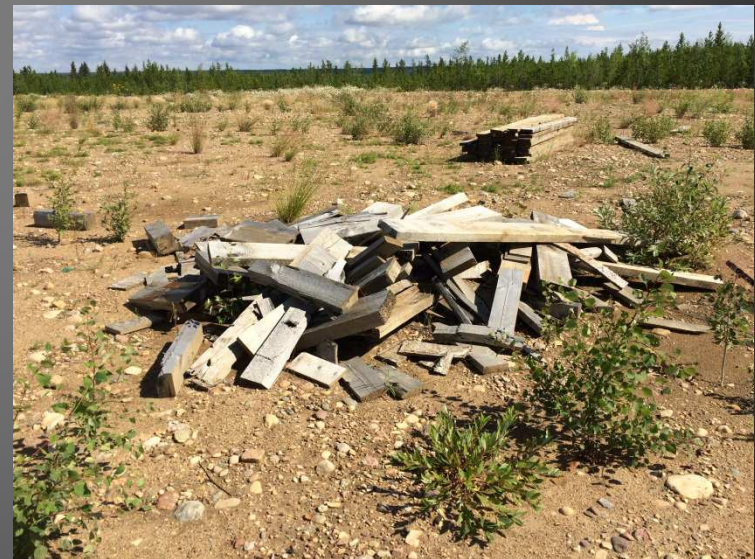
- Debris and garbage present to various areas at the project site particularly former camp areas and laydown areas
- A limited amount of debris (wooden planks, piping etc.) have been removed using ground access methods
- Significant amount remains

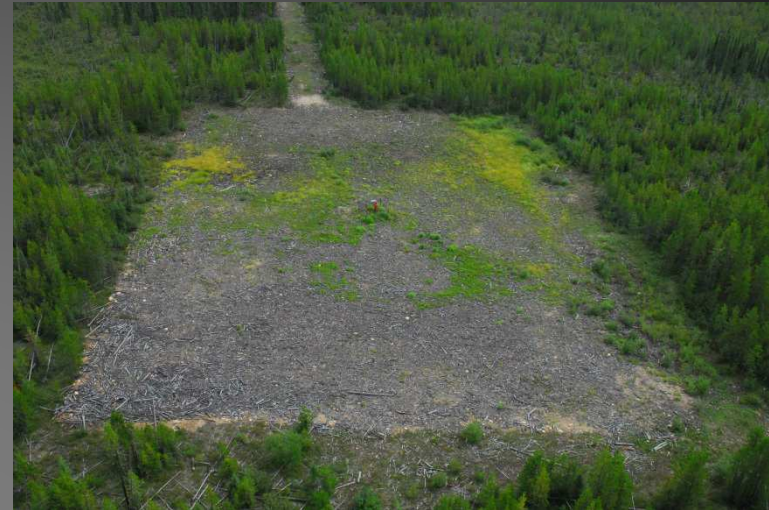
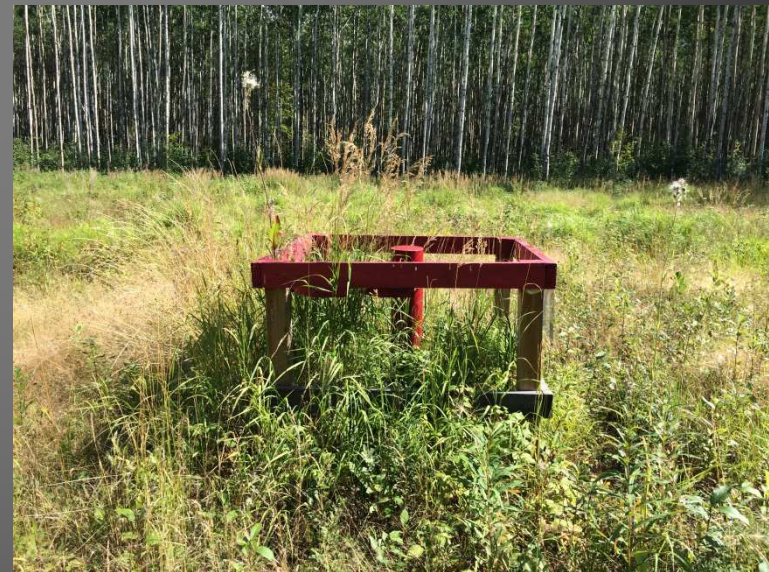
- Twenty wells subject to Directive 13 requirements
- Seven well locations subject to Directive 20 requirements
