## Enhanced In-situ Chemical Reduction followed by Enhanced Bioremediation to treat Cis-1, 2-DCE And VC

Lead author: Amit Haryani, PE, LSRP, AECOM

Presented by: Josephine Molin, FMC Corporation

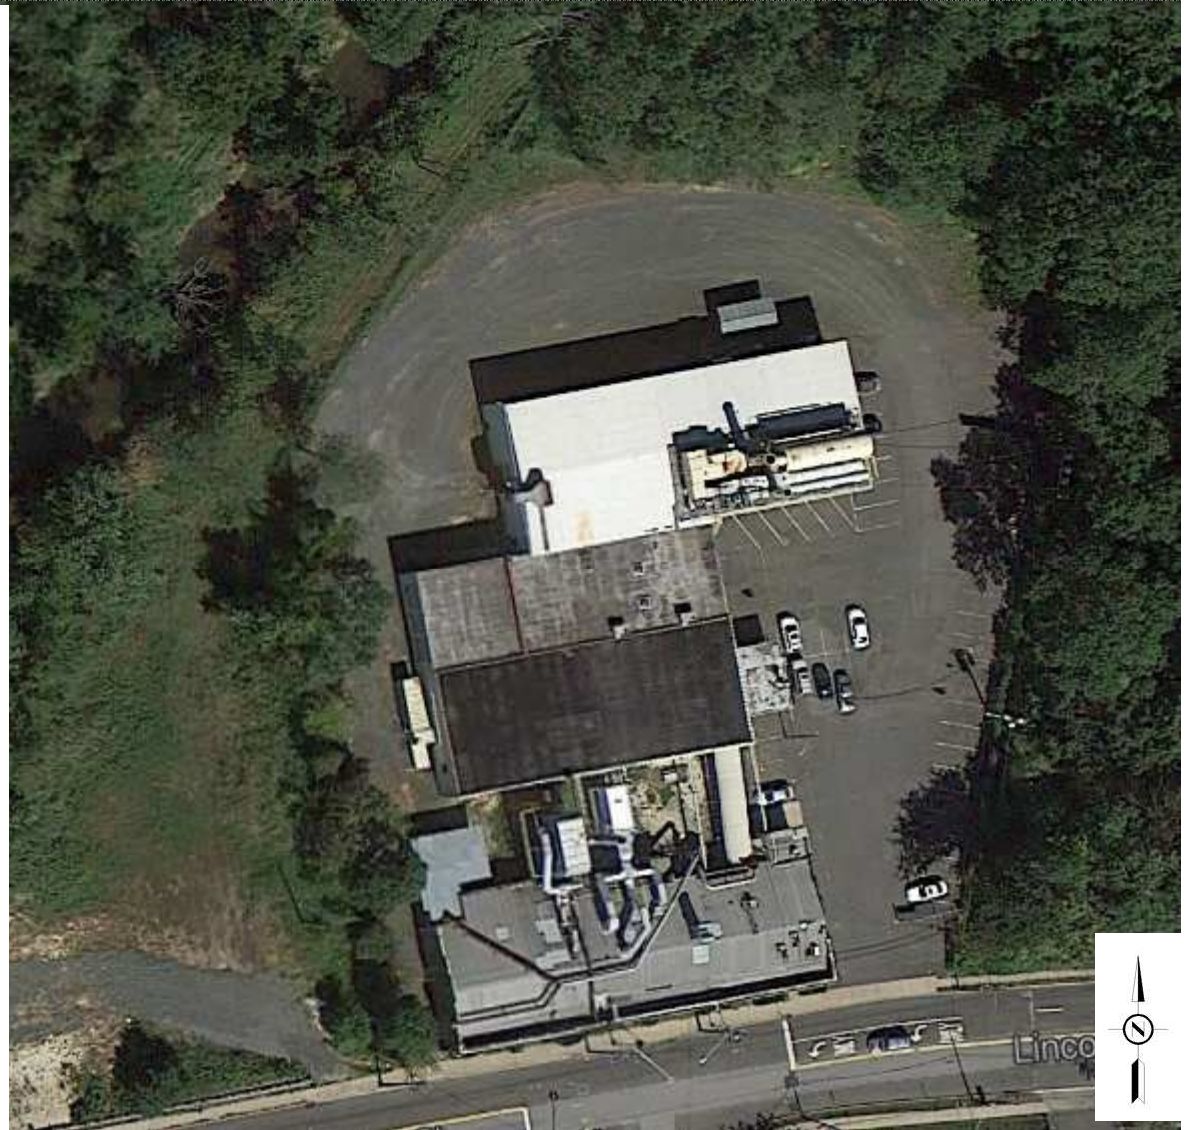
- Confidential Site in NJ
- Site History
  - Former Auto repair Garage
  - Currently a manufacturing facility for over 30 years

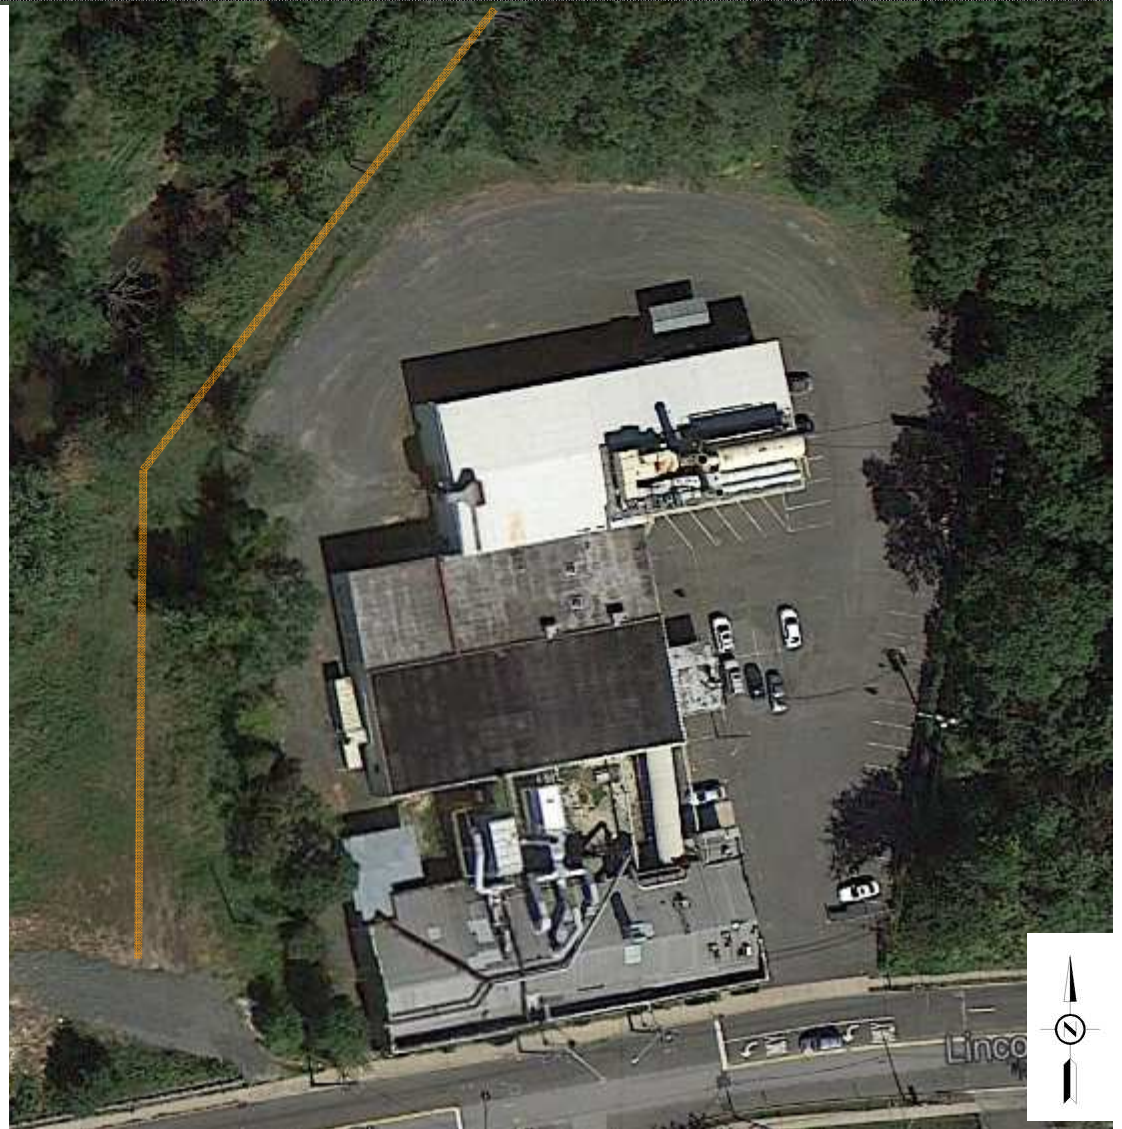
- Site Constraints
  - Water body within 100-ft of the site
  - Water main pipe (preferential pathway) within 50 ft
  - Unknown extent of the buried drum field
- Remedies Evaluated
  - ISCO: Potential impacts to water body
  - P&T: Not aggressive enough
  - AS&SVE: Potential sink hole concerns
  - ISCR + Drum Removal: Retained
- Substrate:
  - EHC in situ chemical reduction compound

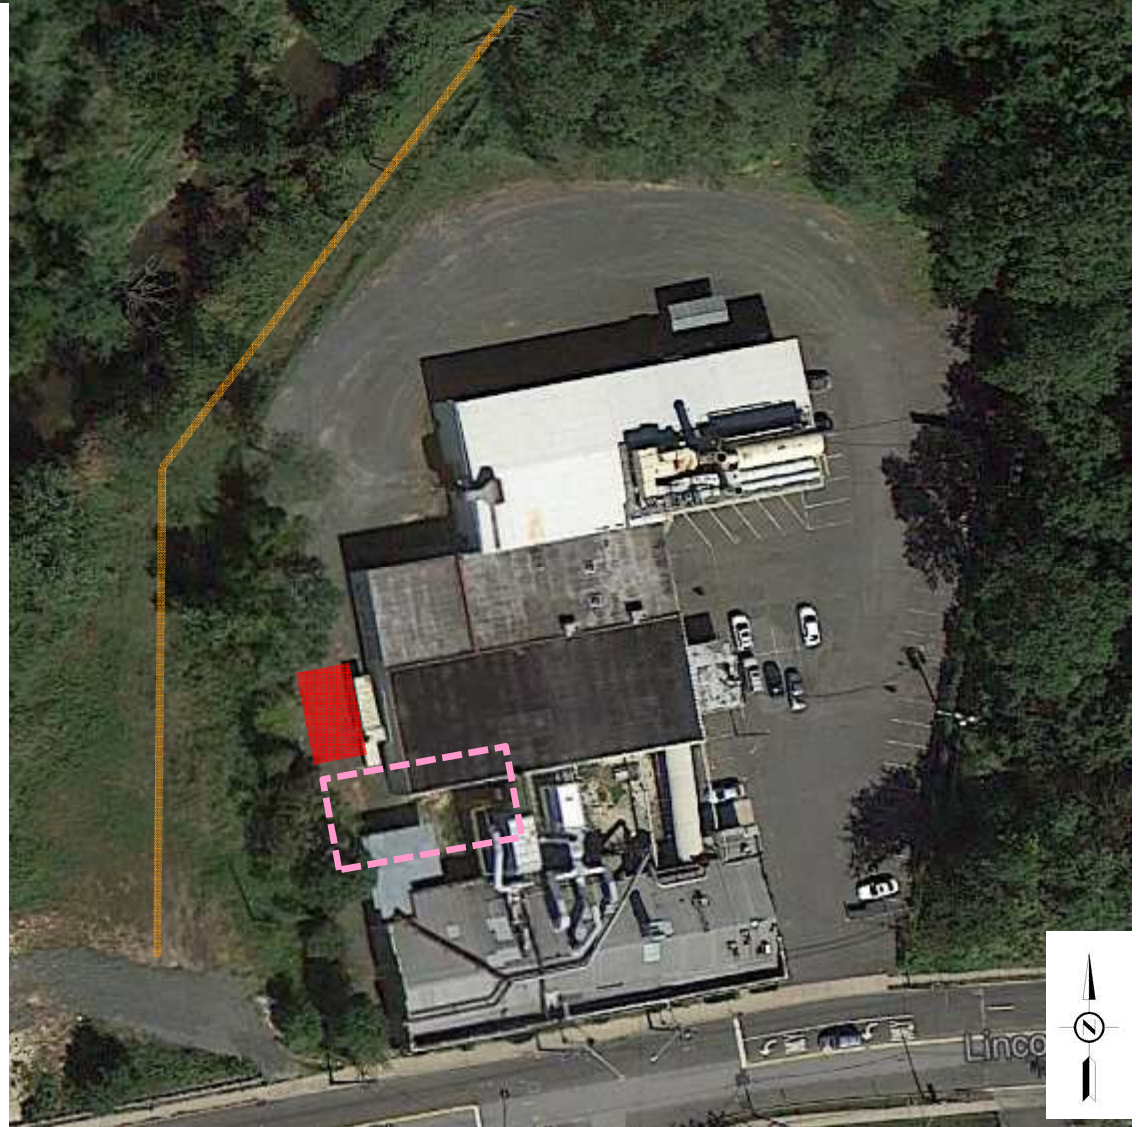
- Excavate and Remove Buried Drums
  - Drums and impacted soil above water table
- ISCR to treat GW impacts
  - Direct placement of EHC into soil at base of excavation
  - Supplemental EHC injections in sidegradient plume area via direct push

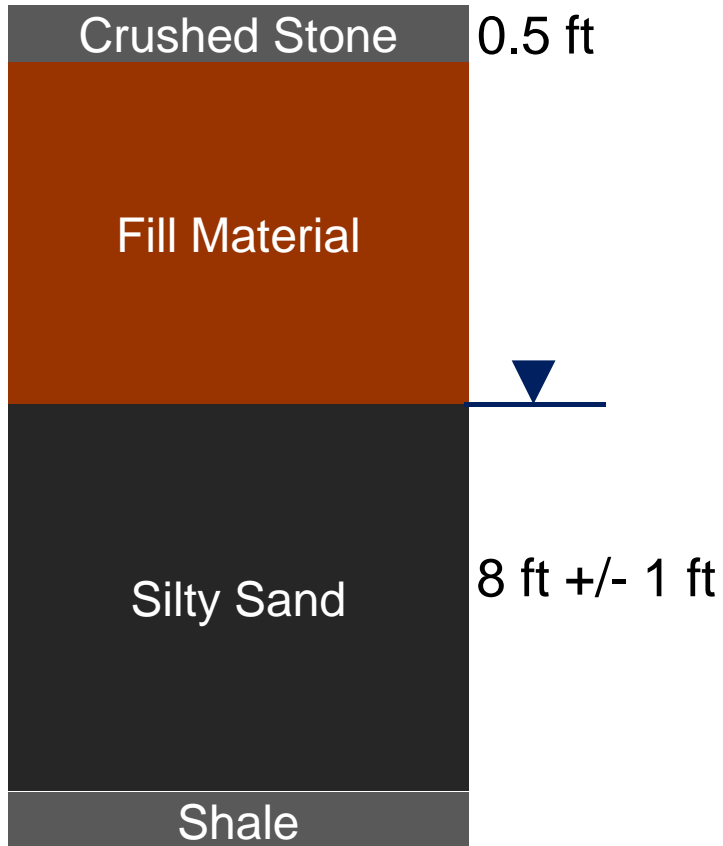
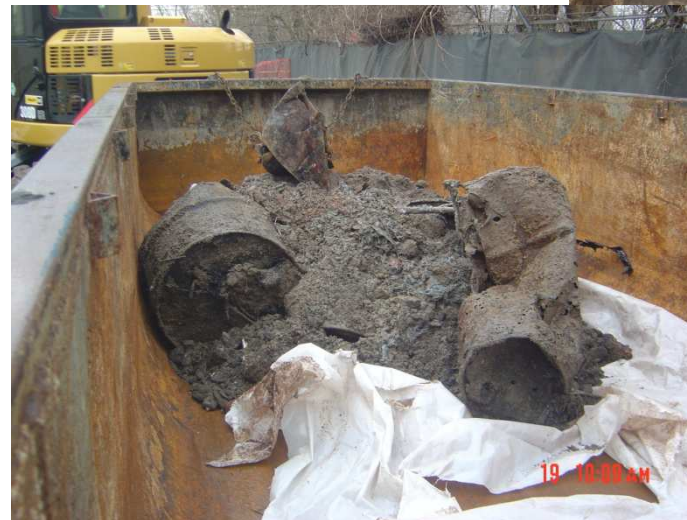
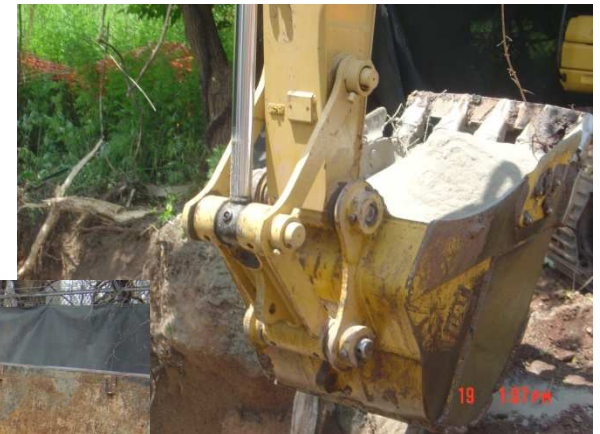
# Source Area and Drum Removal

- Soil and drums removed from an area measuring 25' x 35' x 8' deep
- Six roll-offs of impacted soil removed
- 42 drum carcasses removed

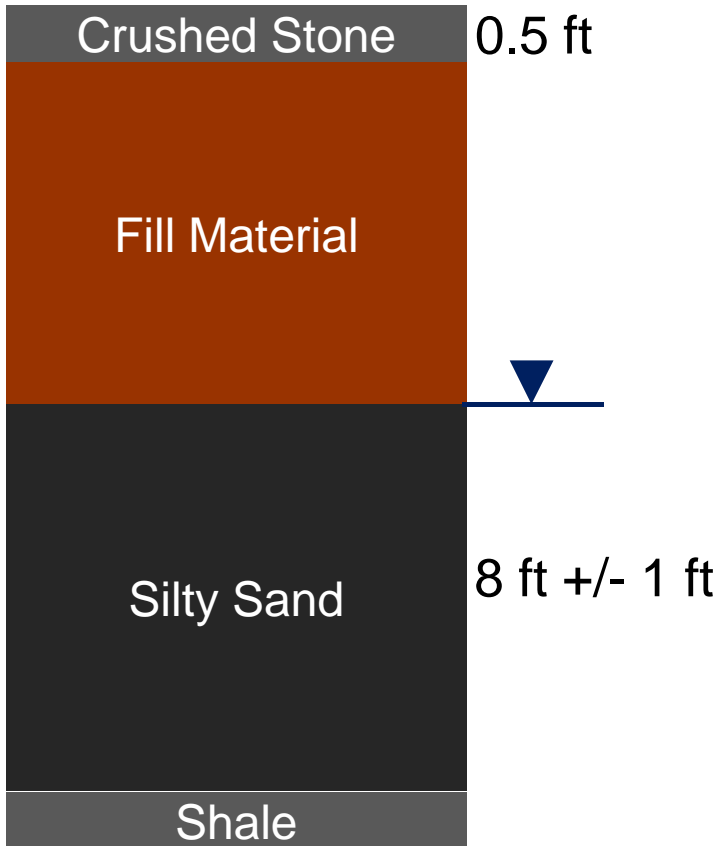
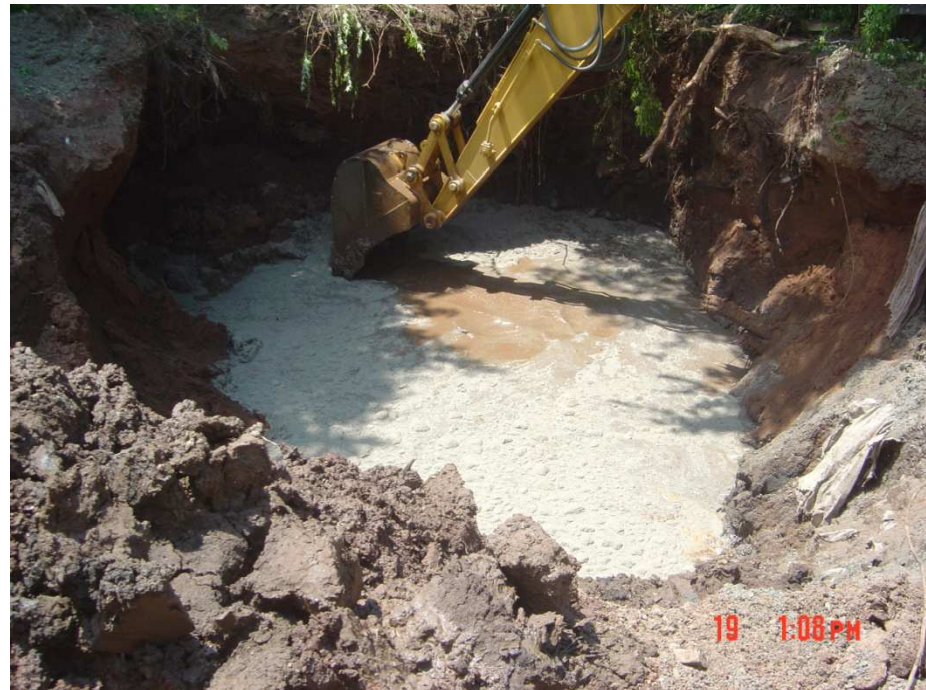
# EHC<sup>®</sup> Blending

- EHC mixed into soil at base of excavation from 8-16 ft bgs
- Dosage: 1 wt% EHC (to native soil mass)
- 1,300-lb of EHC added
- Mixed in-place using buckets

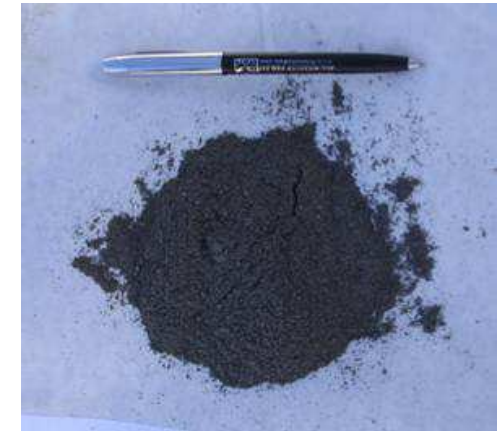
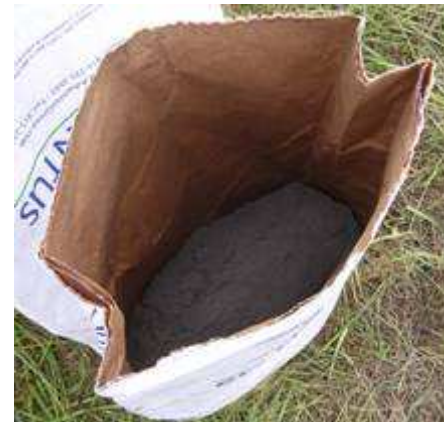
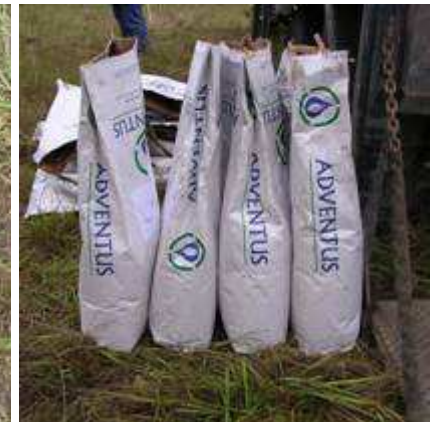
# EHC<sup>®</sup> Composition

- EHC is delivered as a dry powder and includes the following:
  - Micro-scale zero valent iron (standard ~40%)
  - Controlled-release, food grade, complex carbon (plant fibers) (standard ~60%)
  - Major, minor, and micronutrients
  - Food grade organic binding agent
- Sustainable Solution:
  - scrap metal
  - food production by-products
