Simple Forensic Evaluations that revealed the Old Contamination in New Discoveries and thus Justified Closure or Resumption of State Cleanup Funding

Paco Amram, P.E., LEED AP

Environmental Consulting & Technology, Inc. (ECT)

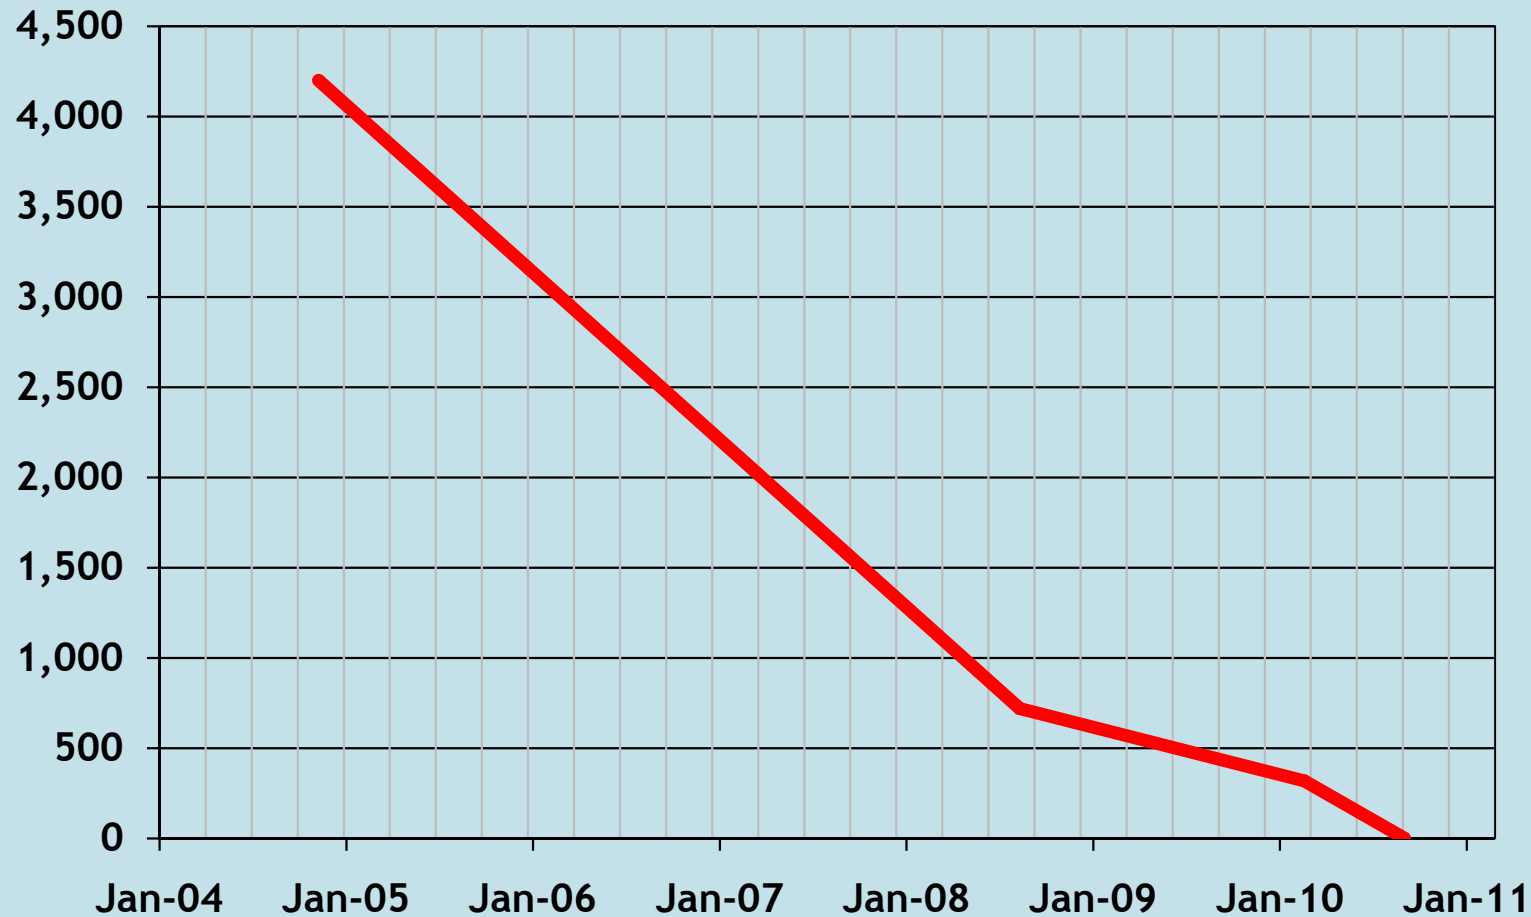
Typical Trend: VOC

- evaluated well by well, in report.

MW-16 Benzene (DTW = 6 - 7')

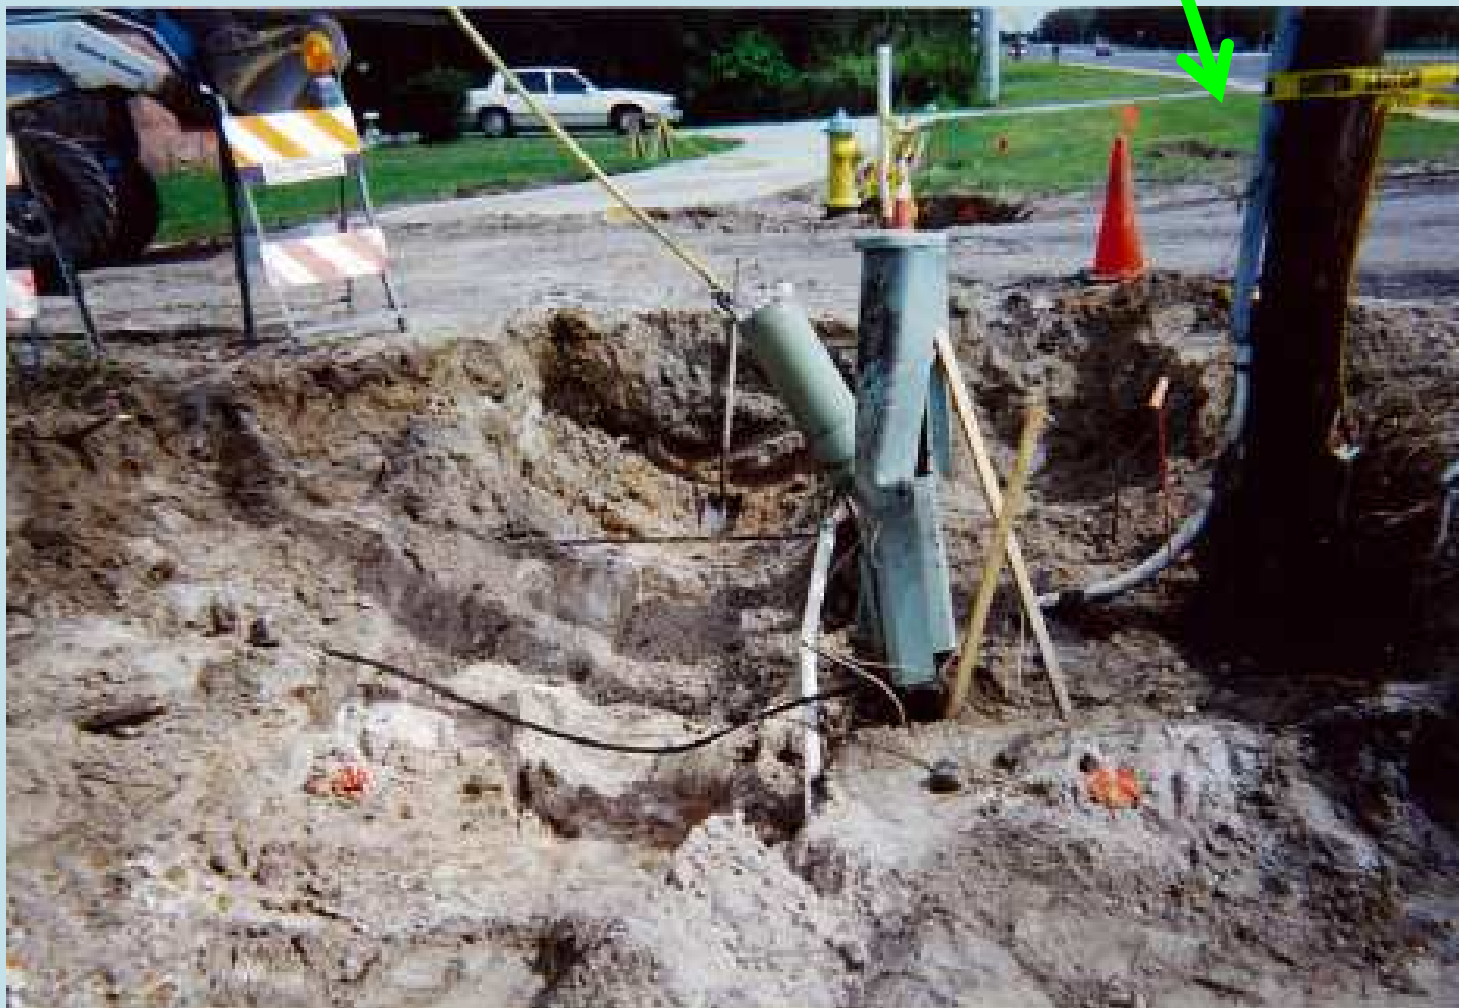
Background Samples, up slope

**Background Samples
UP-slope of spill impacts**

- On site, few non-compliant samples:
 - B : M = 3 : 1 to 2 : 1
 - = 4,000 x Diesel Fuel B(a)P content
 - B(a)P = 24 x criteria
 - TPH Max = 345 and 458 mg/L (vs. SCTL 340)
- Background Samples
 - B(a)P and TPH at and above spill cleanup samples

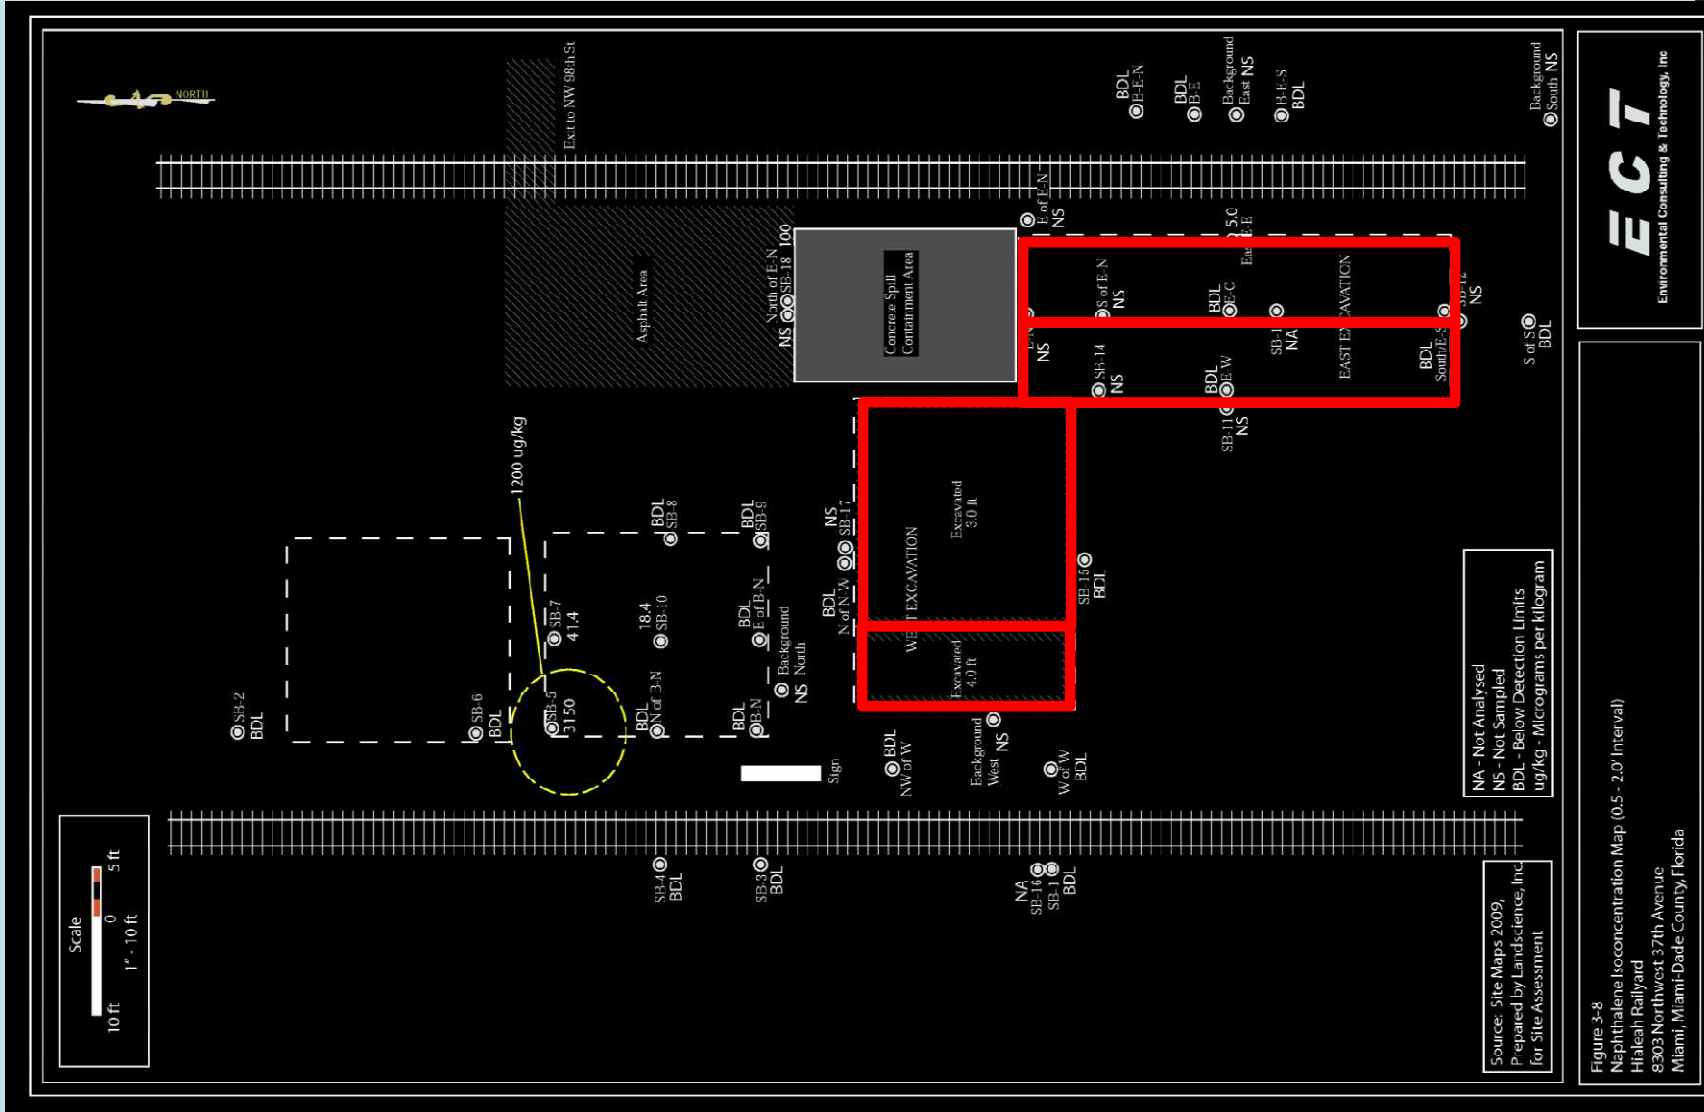
Naphthalene 0.5 - 2 ft - isolated

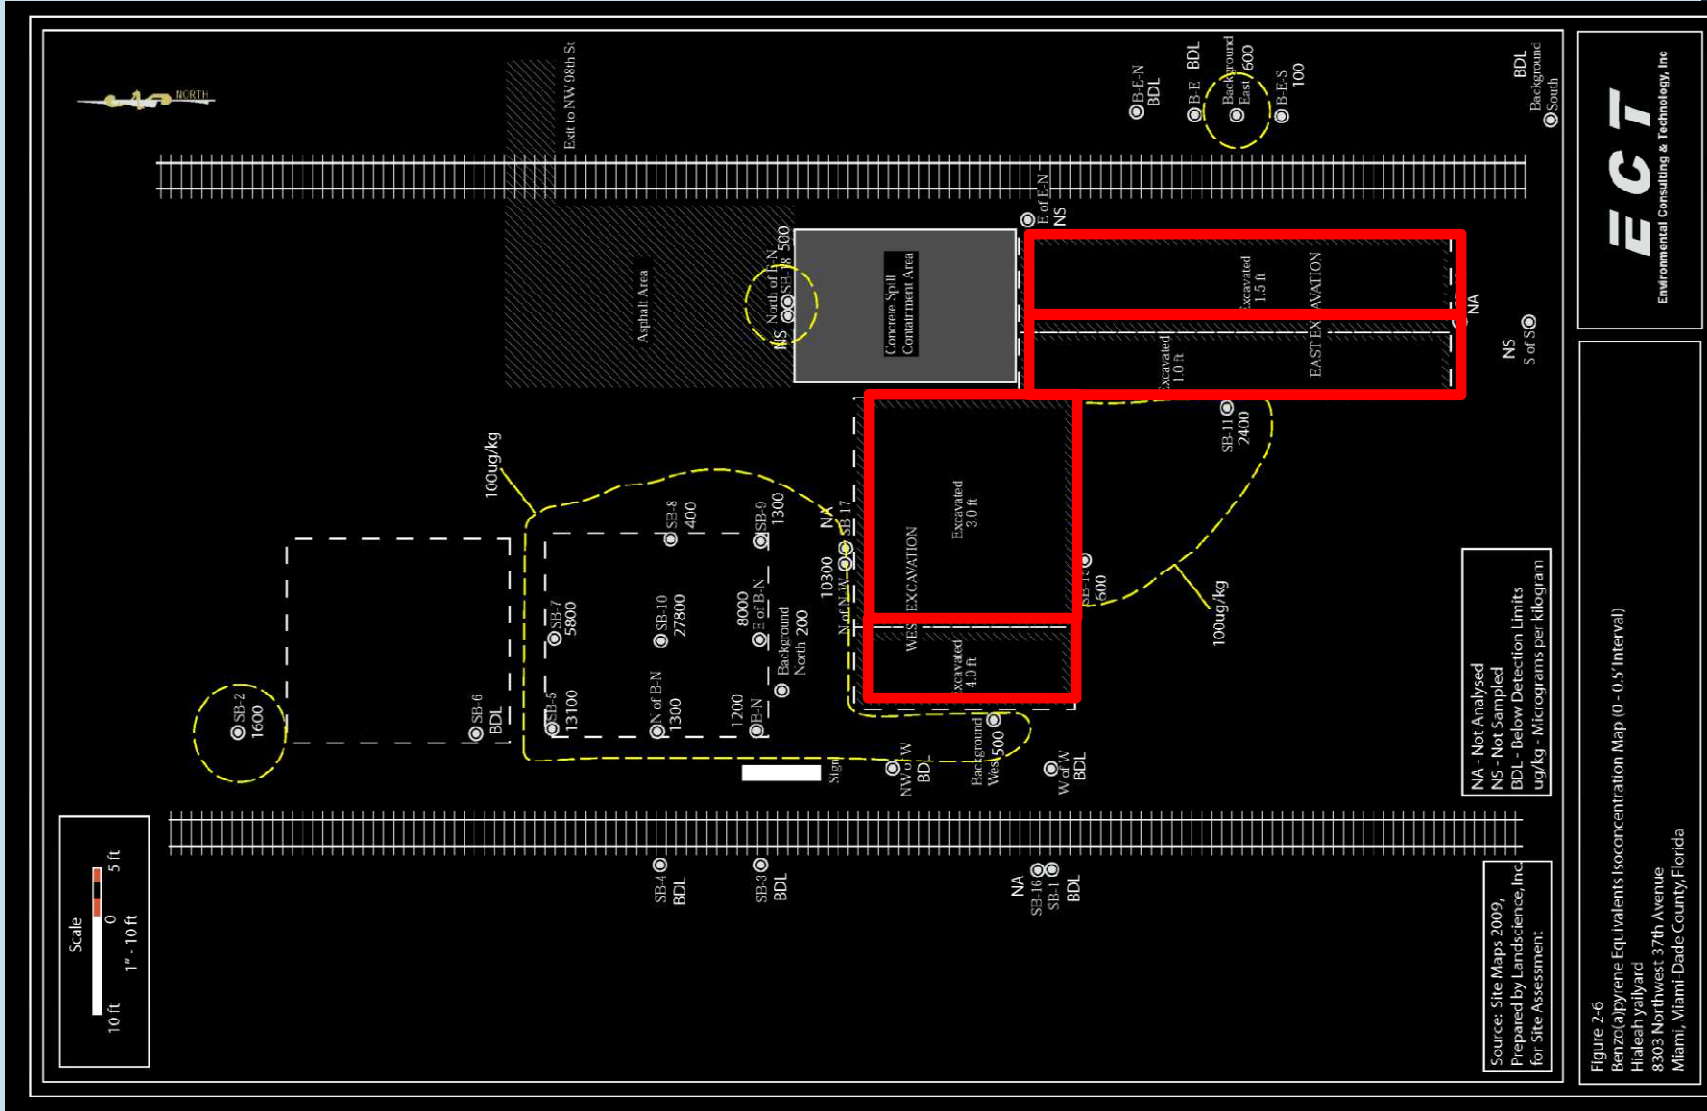
B(a)P Eq. 0 - 0.5 ft - no Naphthalene

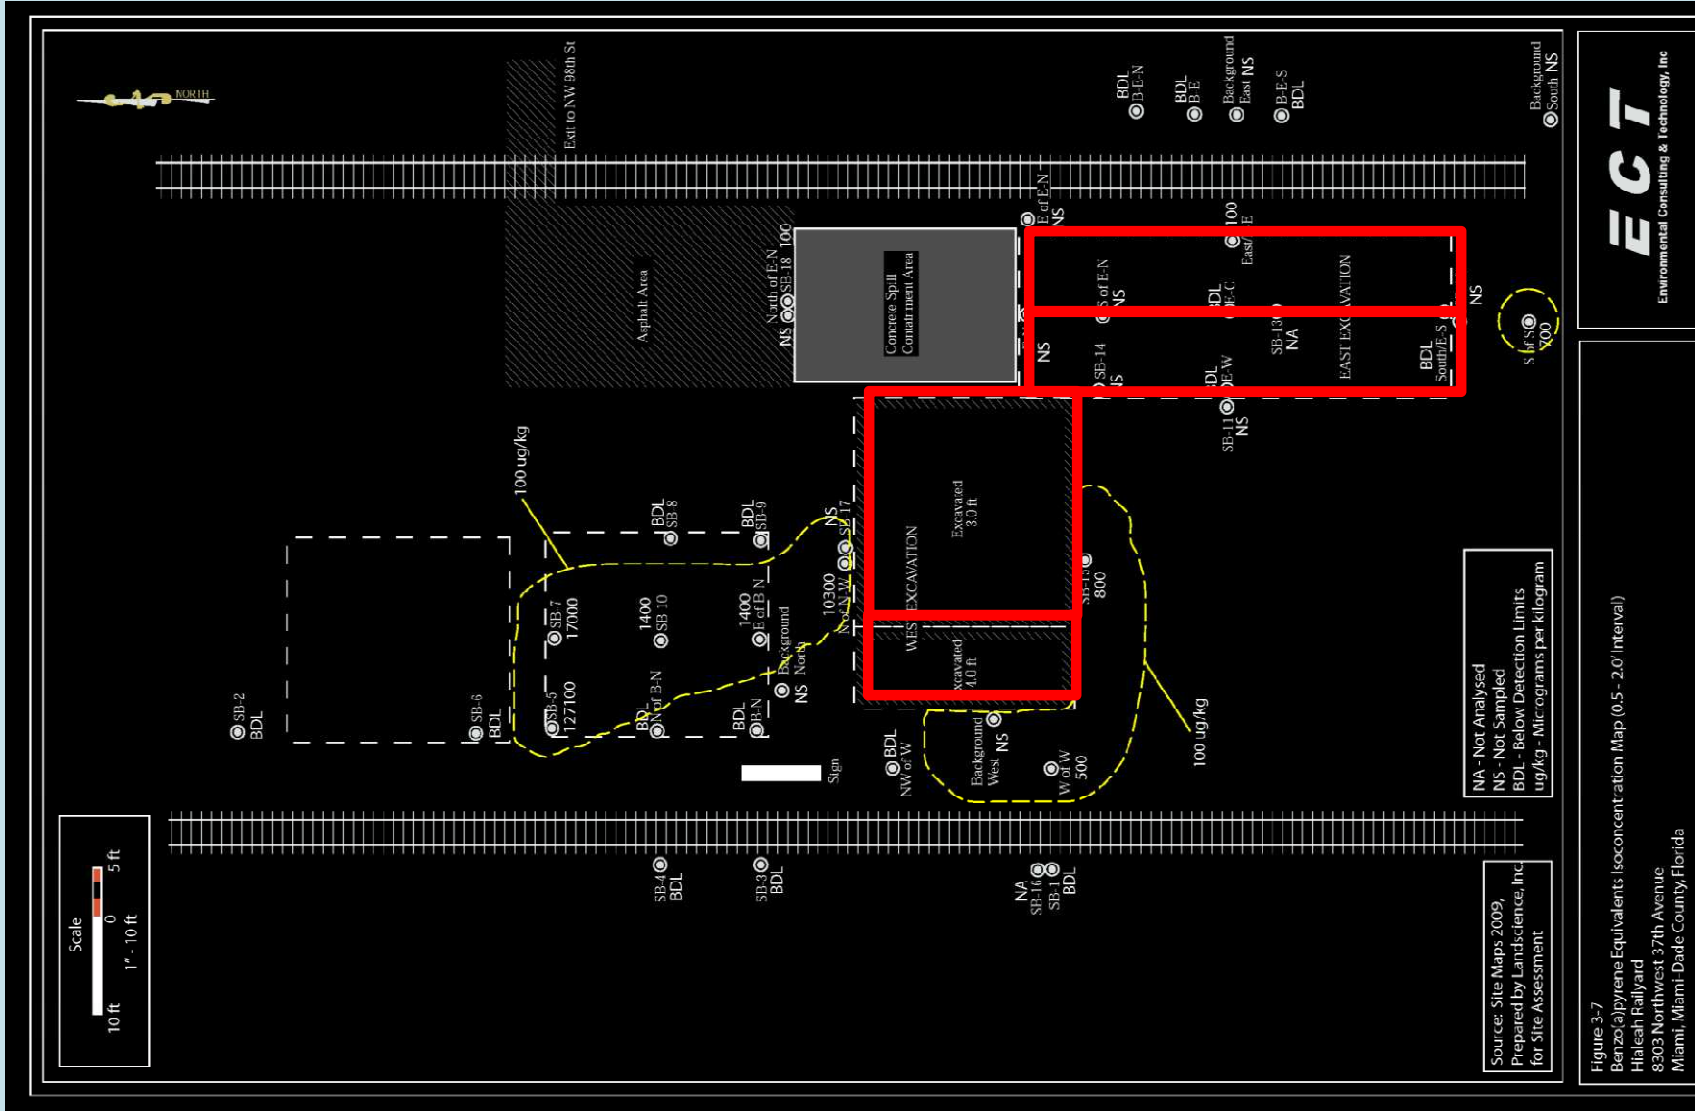
B(a)P Eq. 0.5 - 2 ft (vs. Naphthalene spot)

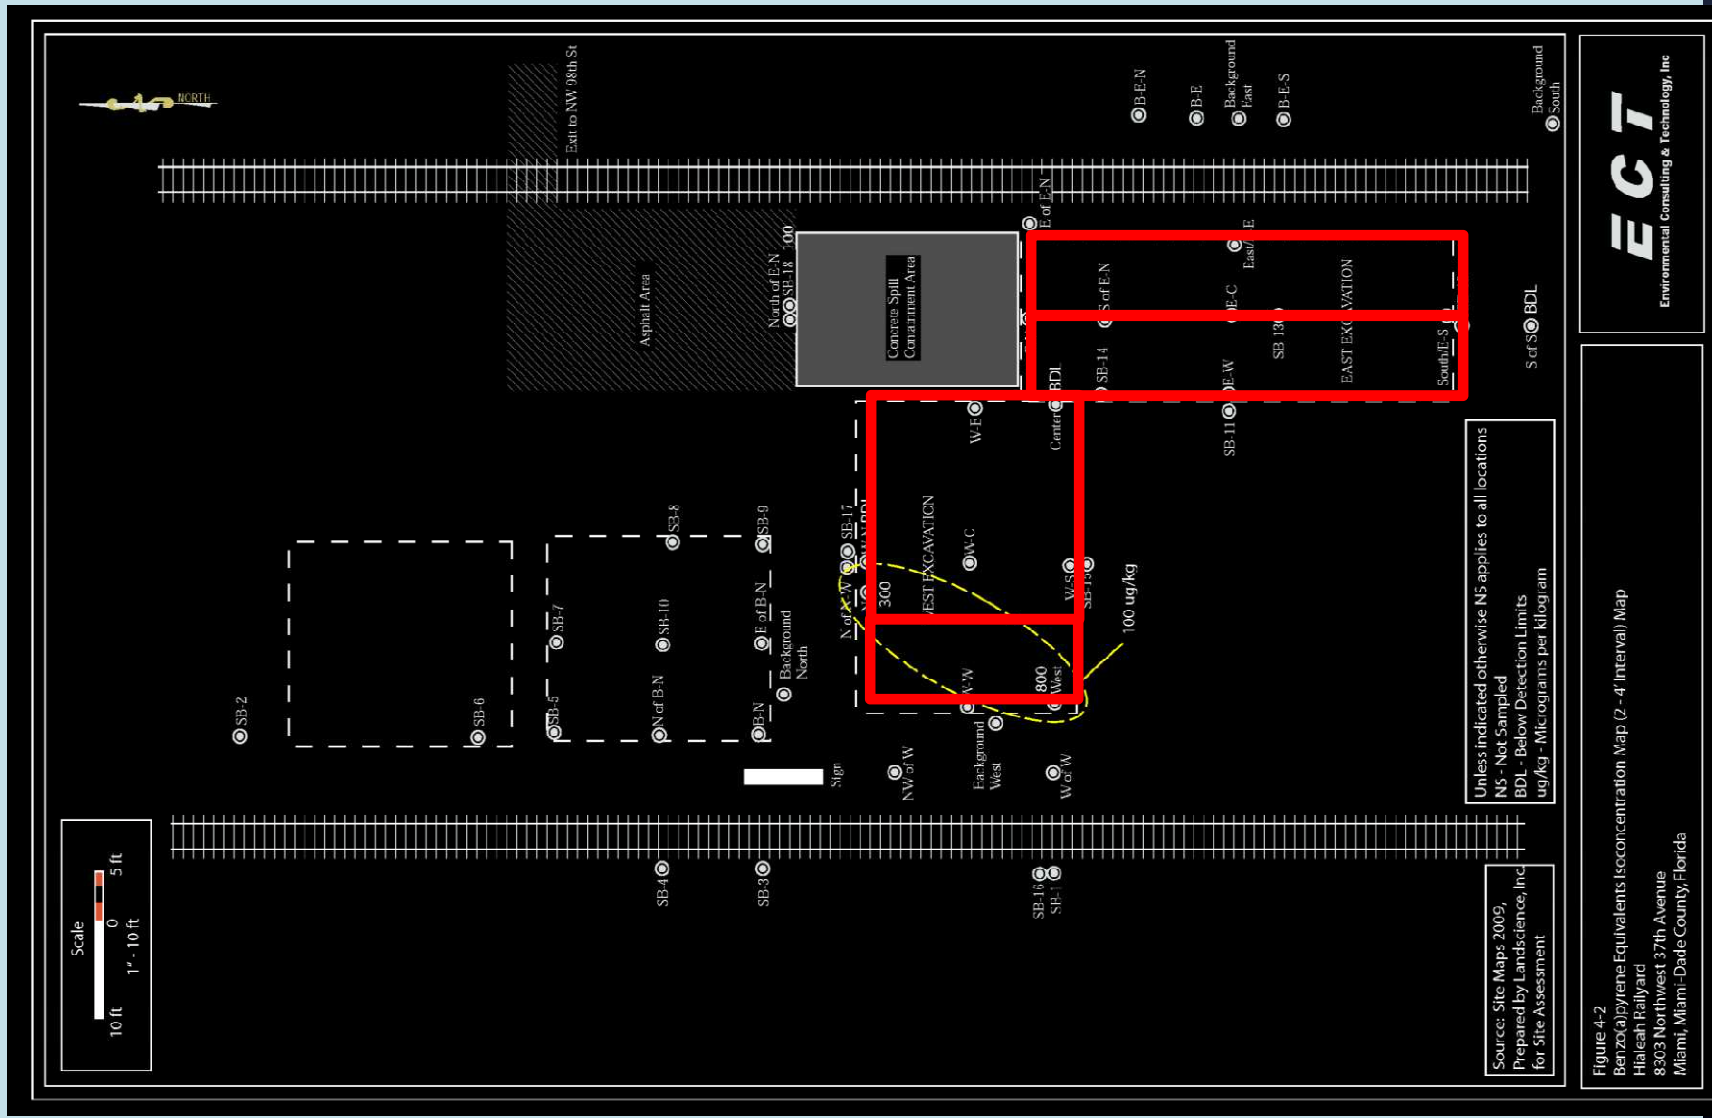
Figure 4-2
Benzopyrene Equivalents Isoconcentration Map (2-4' Interval) Map
Hialeah Railway Yard
8303 Northwest 37th Avenue
Miami, Miami-Dade County, Florida

B(a)P Eq. 2 - 4 ft - no Naphthalene

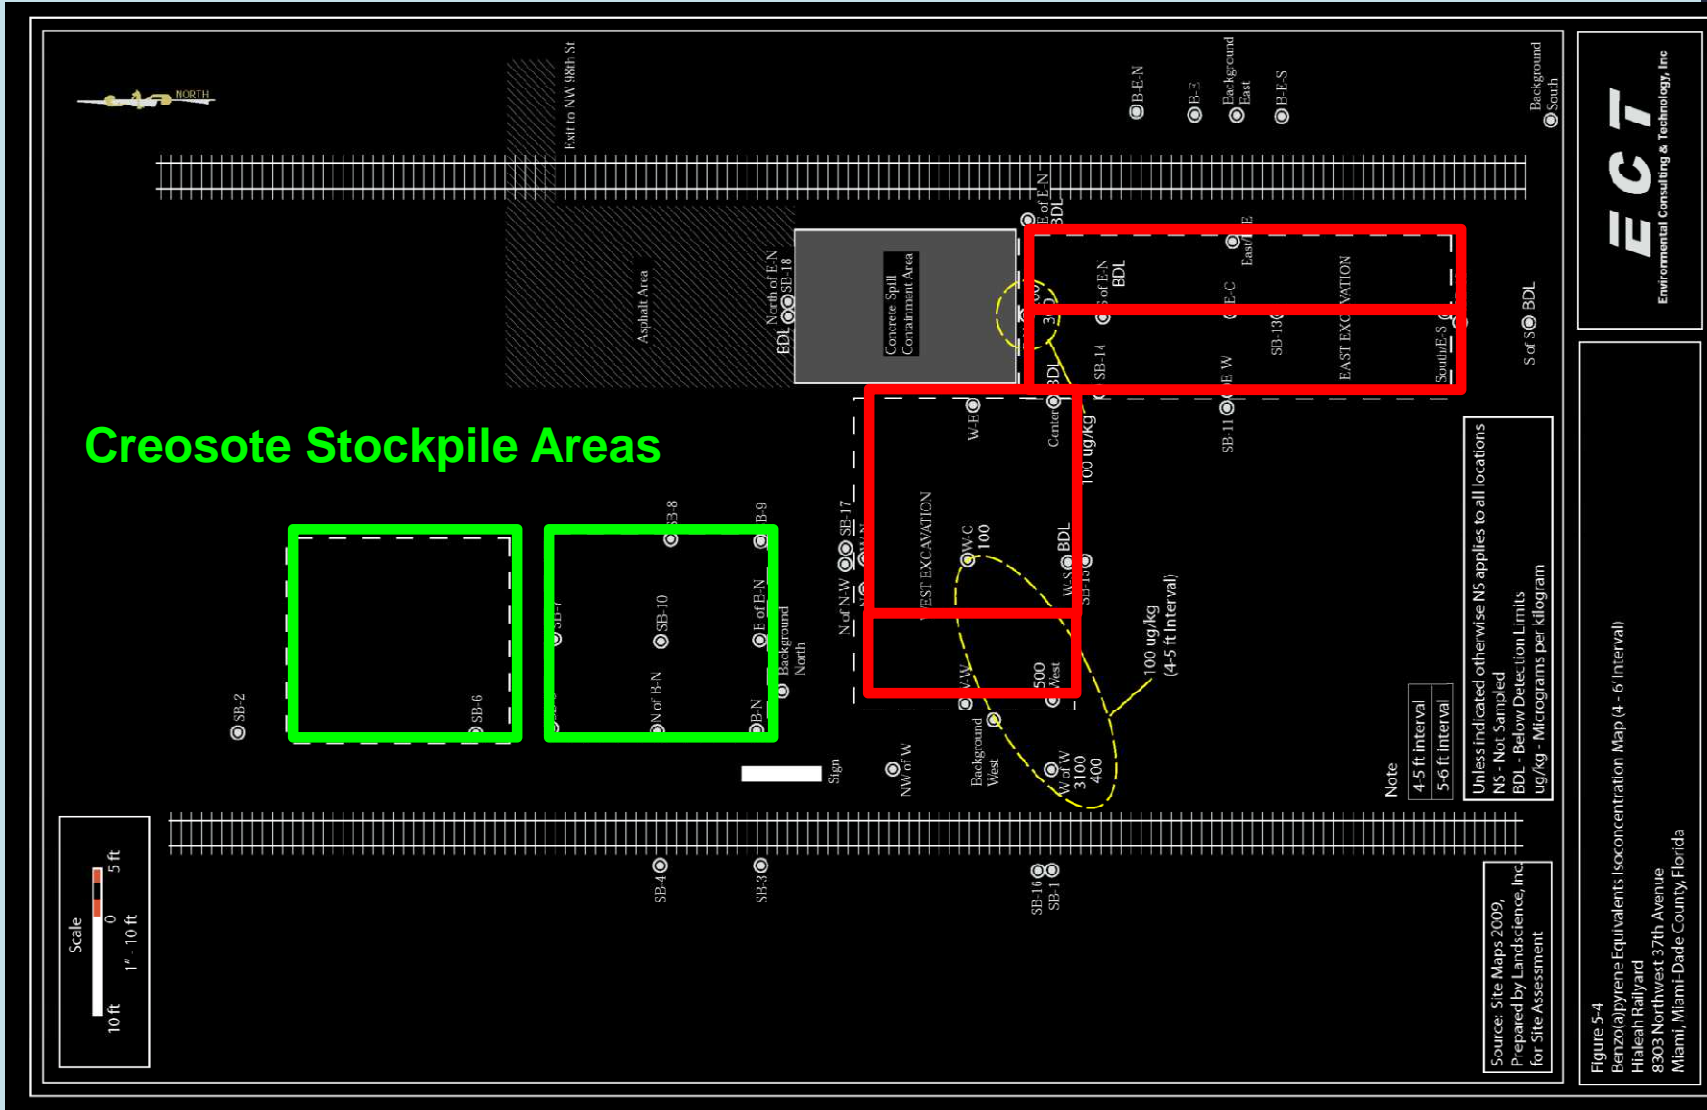
B(a)P Eq. 4 - 6 ft -

no Naphthalene

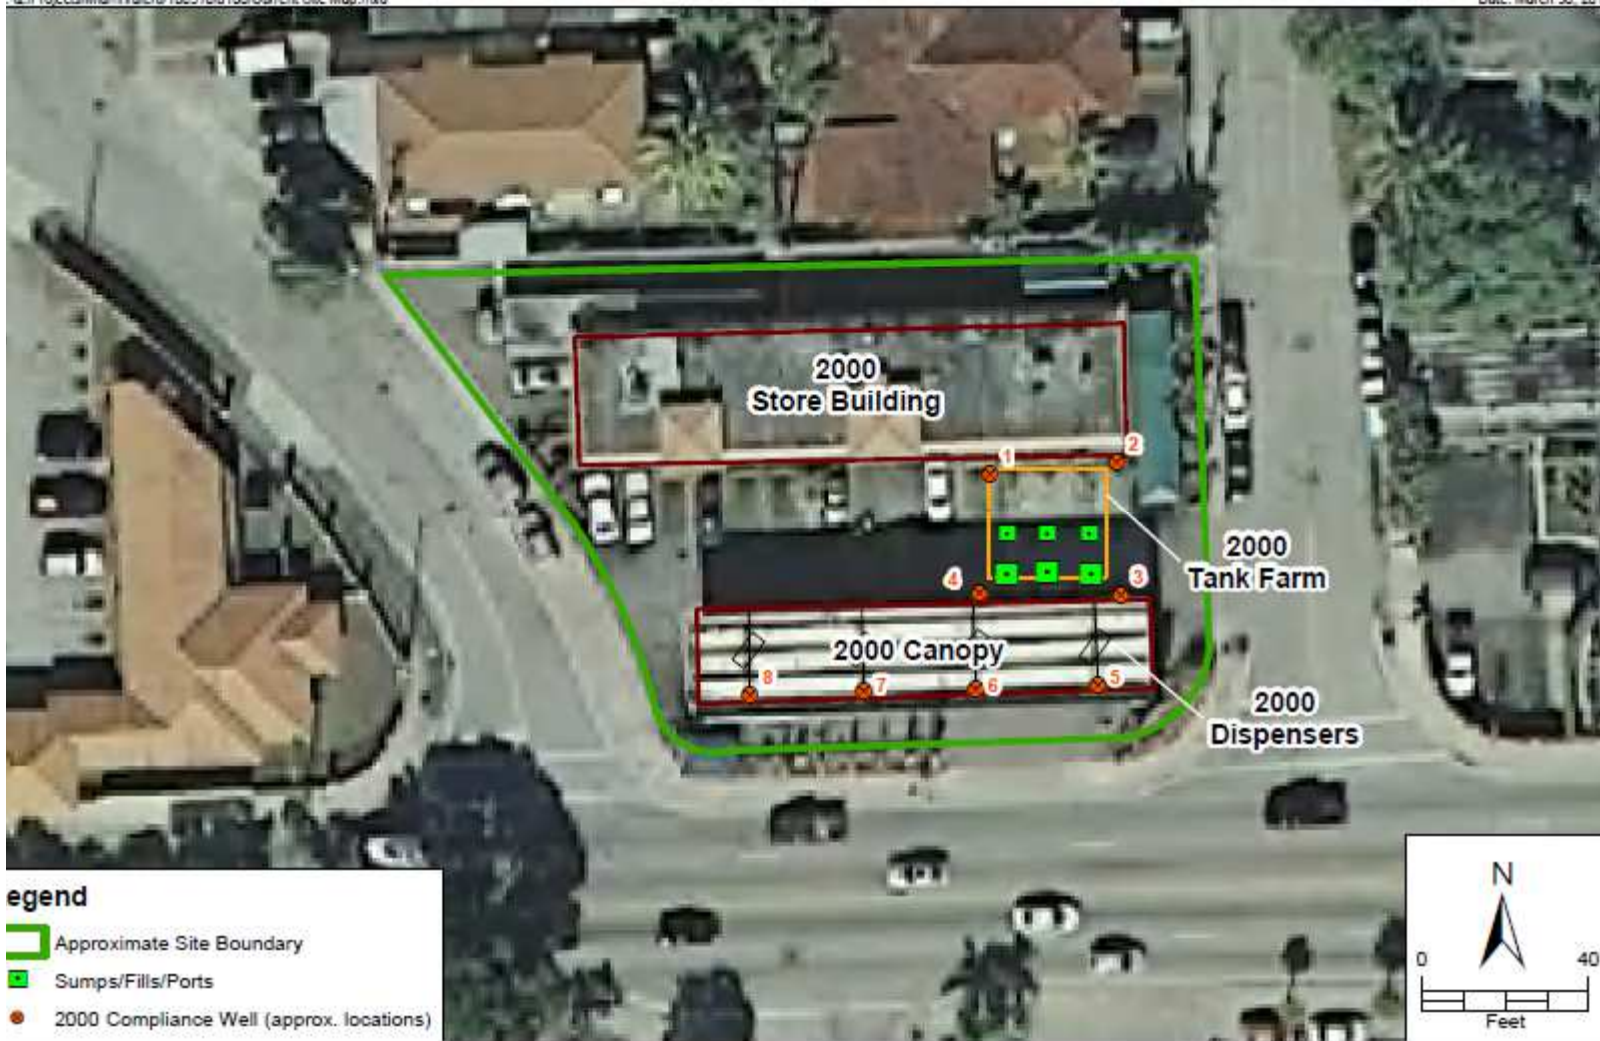
FIGURE 2.
CURRENT SITE LAYOUT ON 2009 AERIAL PHOTOGRAPH MAP

2000 Redevelopment

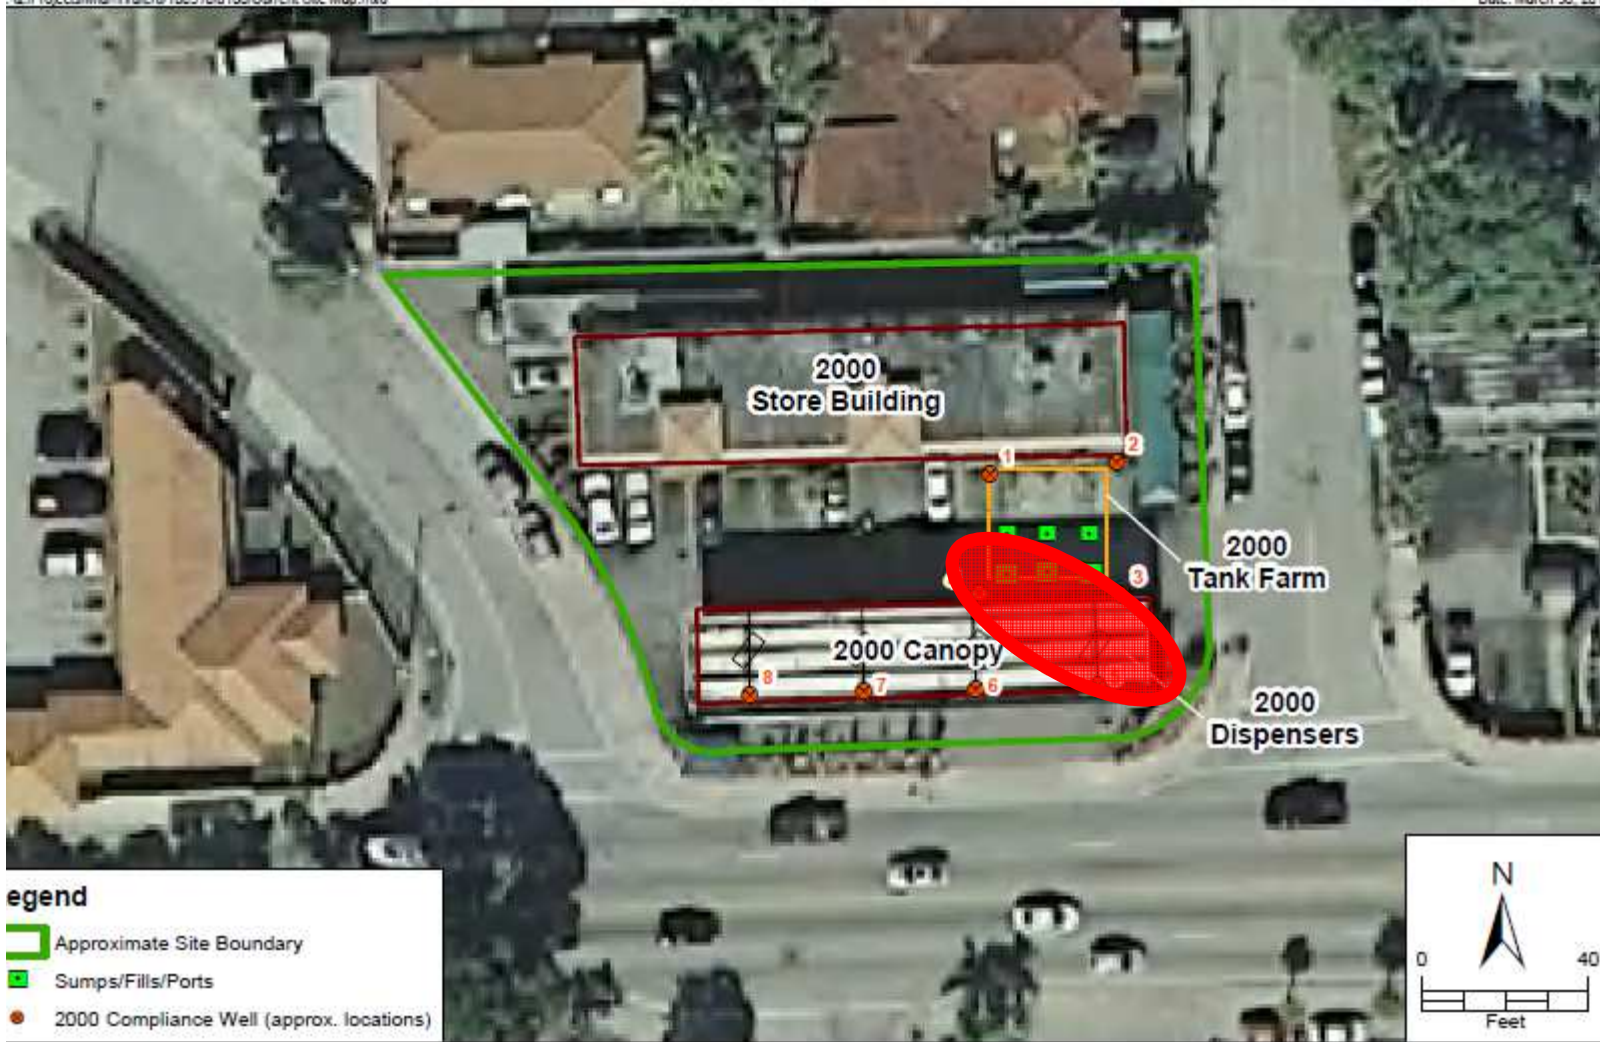
FIGURE 2.
CURRENT SITE LAYOUT ON 2009 AERIAL PHOTOGRAPH MAP

2010 Inspect. → 1/4" Free Product

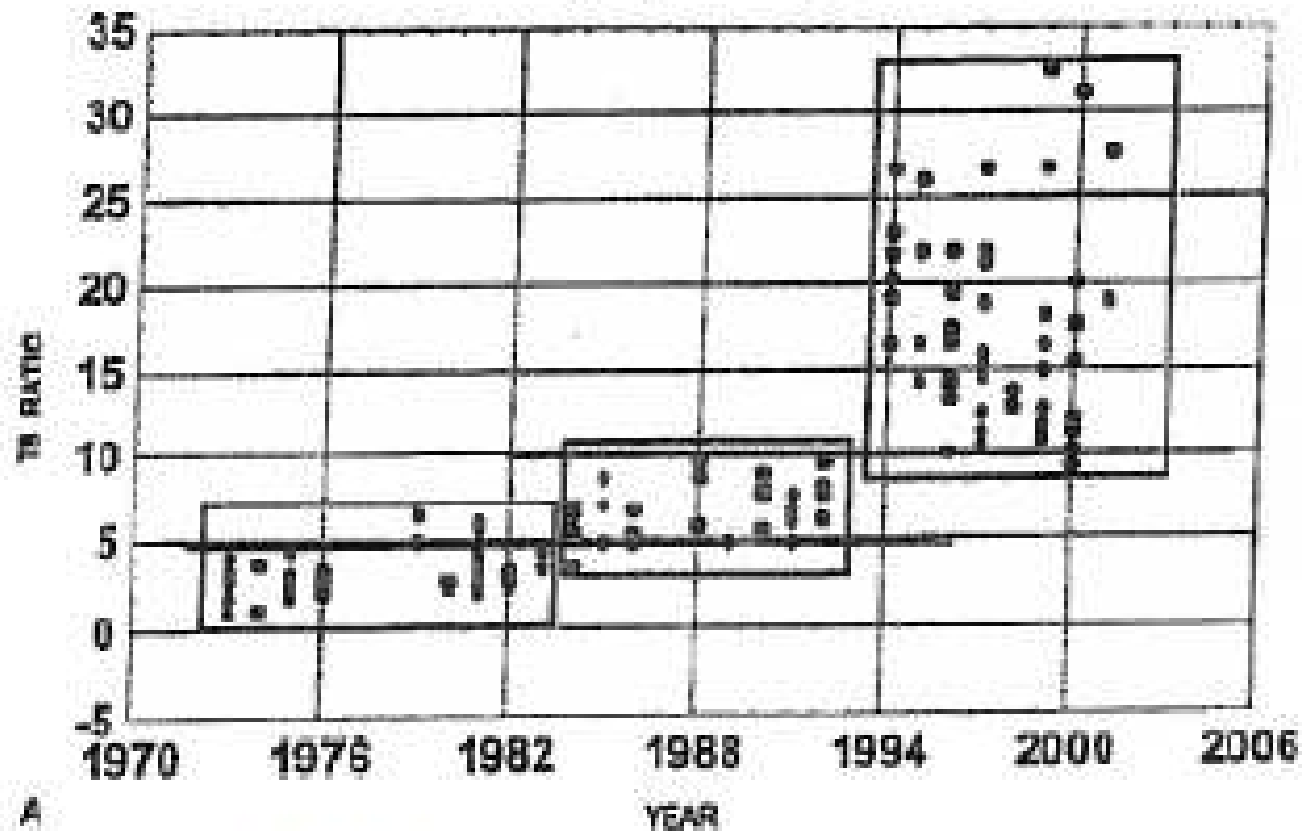
Figure 11(a) T/S Ratio versus year,
from Schmidt, et al., 2002 (publisher Taylor & Francis, Inc.)

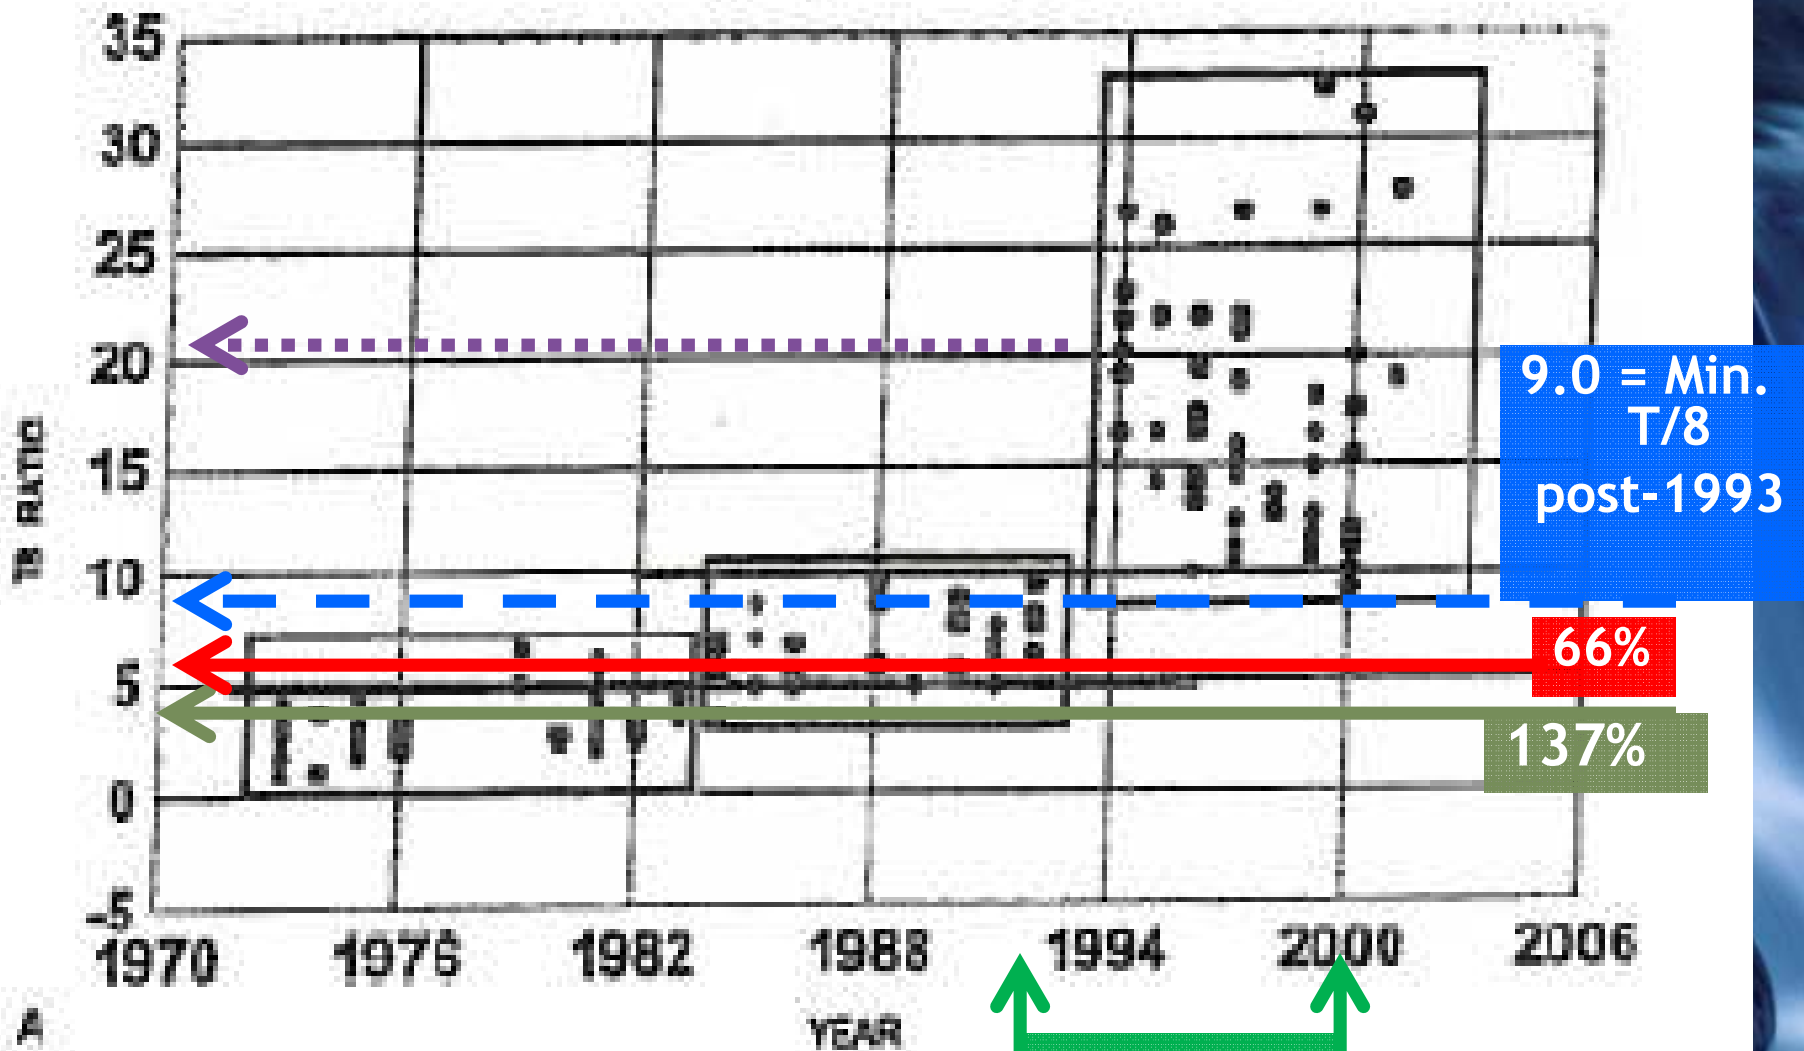
“T/8” ratio = 3.8 uncorrected, 5.4 corrected

Figure 11(a) T/8 Ratio versus year, from Schmidt, et al., 2002 (publisher Francis, Inc.)

1. Lines of Evidence
 1. for NEW release
 2. for OLD release, incl. statistically derived T/8 ratio, with significant factor of safety
2. Most probable: FFP old, pre-dated the current fuel system.
