Bioremediation of Weathered Crude Oil in Complex Soils: Introduction

Bioremediation of Weathered Crude Oil in Complex Soils: A Southern Minnesota Field Study

22nd IPEC Conference

Jeff Powell, Pinnacle Engineering, Inc.
Keith Rapp, Pinnacle Engineering, Inc.
Minneapolis, MN

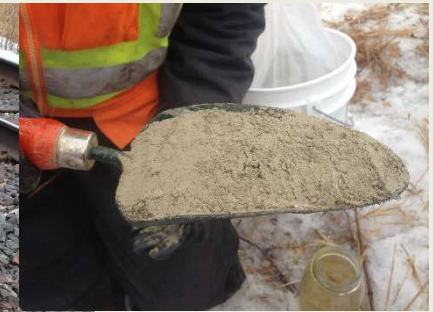
↑
Bioremediation
Product in
powder form

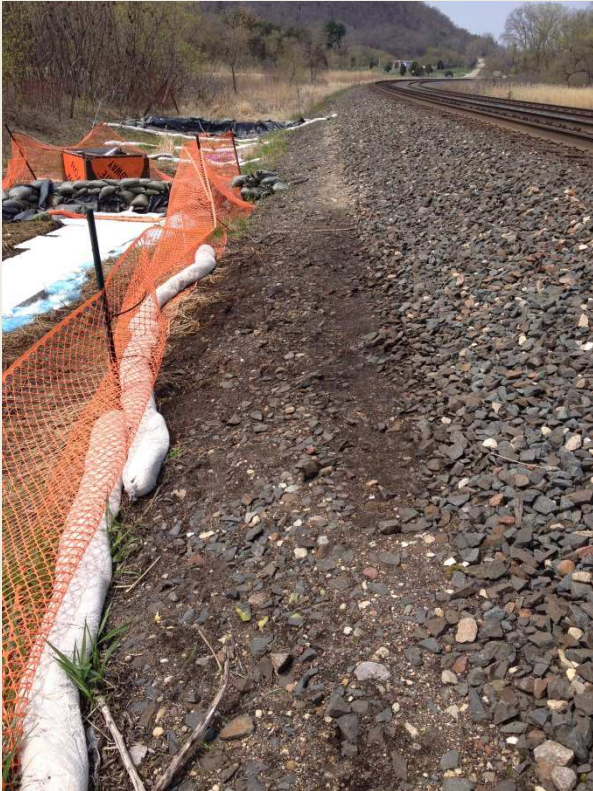
Visual surface staining

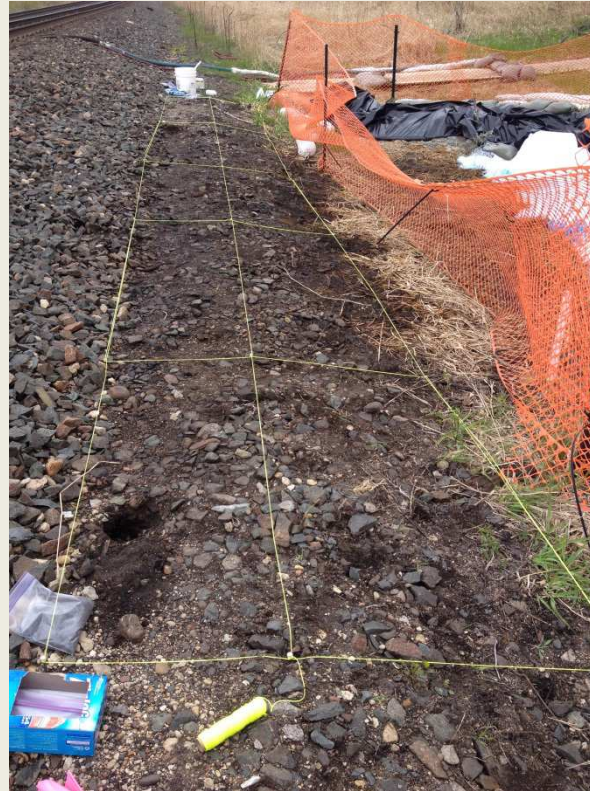
Defining study area by PID screening and baseline sampling

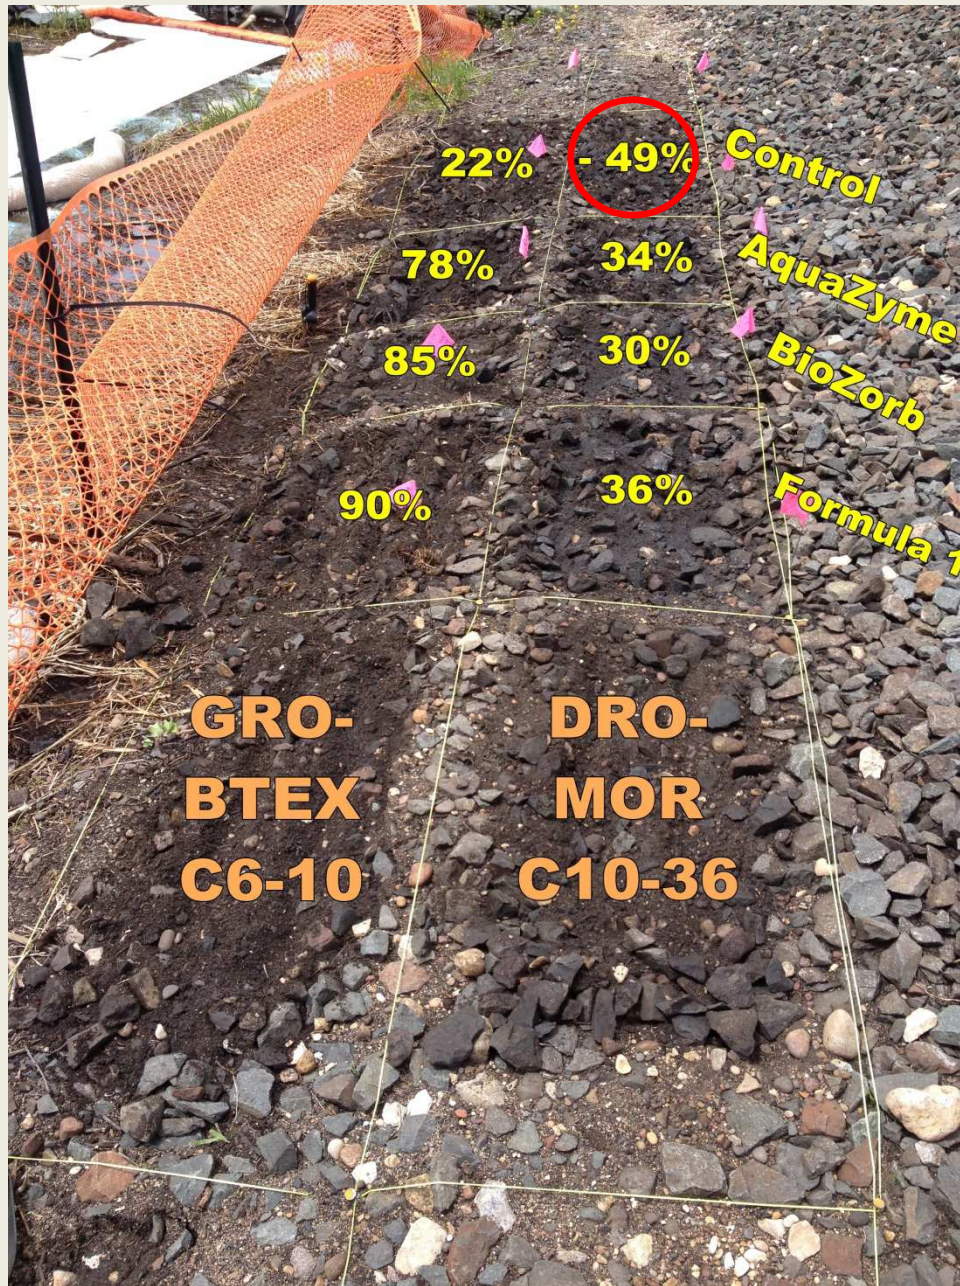
Hydrocarbon Reduction (%) Per Week - Day 0 - 60

Average
Temperature
Day 0-60:
69.7 °F

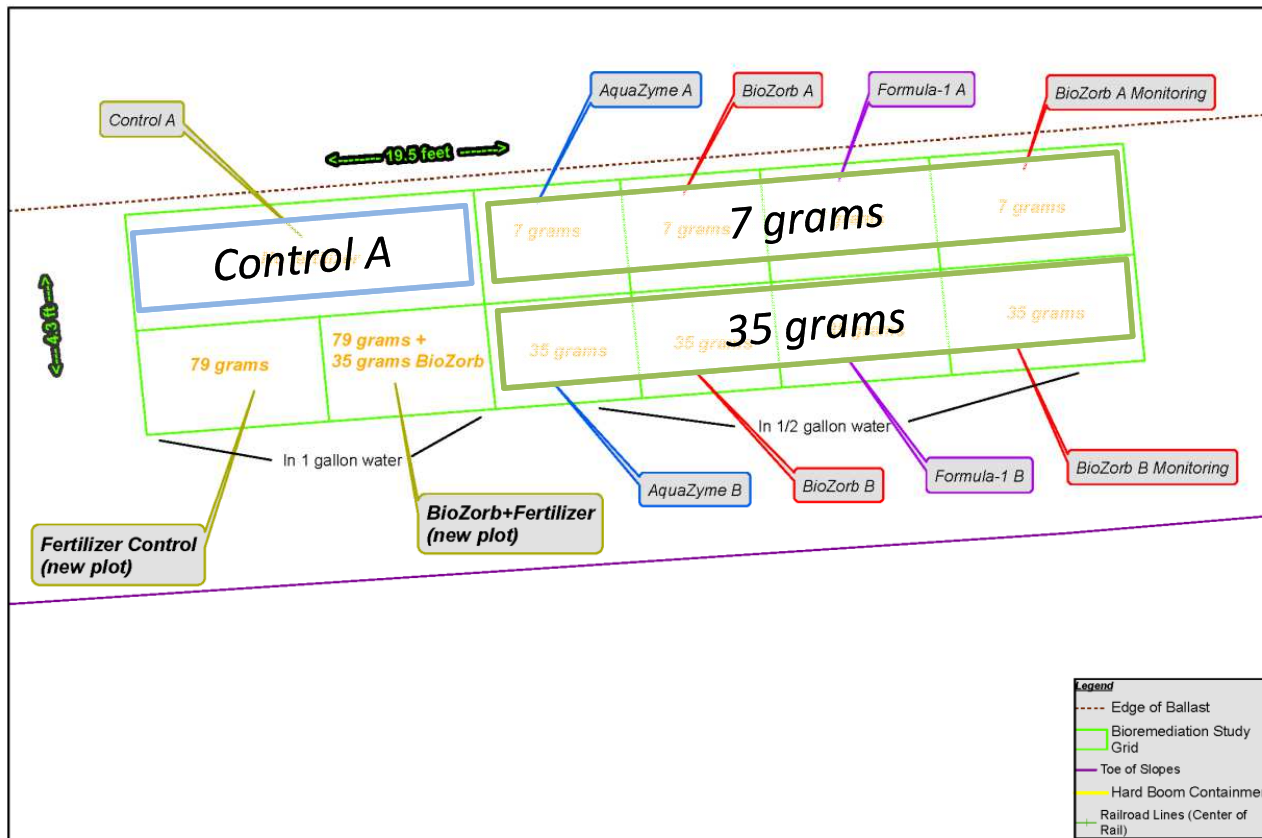
Figure 7: Fertilizer Application Dosages

Oppenheimer Nutrient Formula

21-10-10 plus trace minerals

- Ammoniacal N 12.8%
- Nitrate 8.2%
- P₂O₅ 10%
- K₂O 10%
- S 7%
- Minerals: B, Cu, chelated Fe, Mn, Mo, Zn

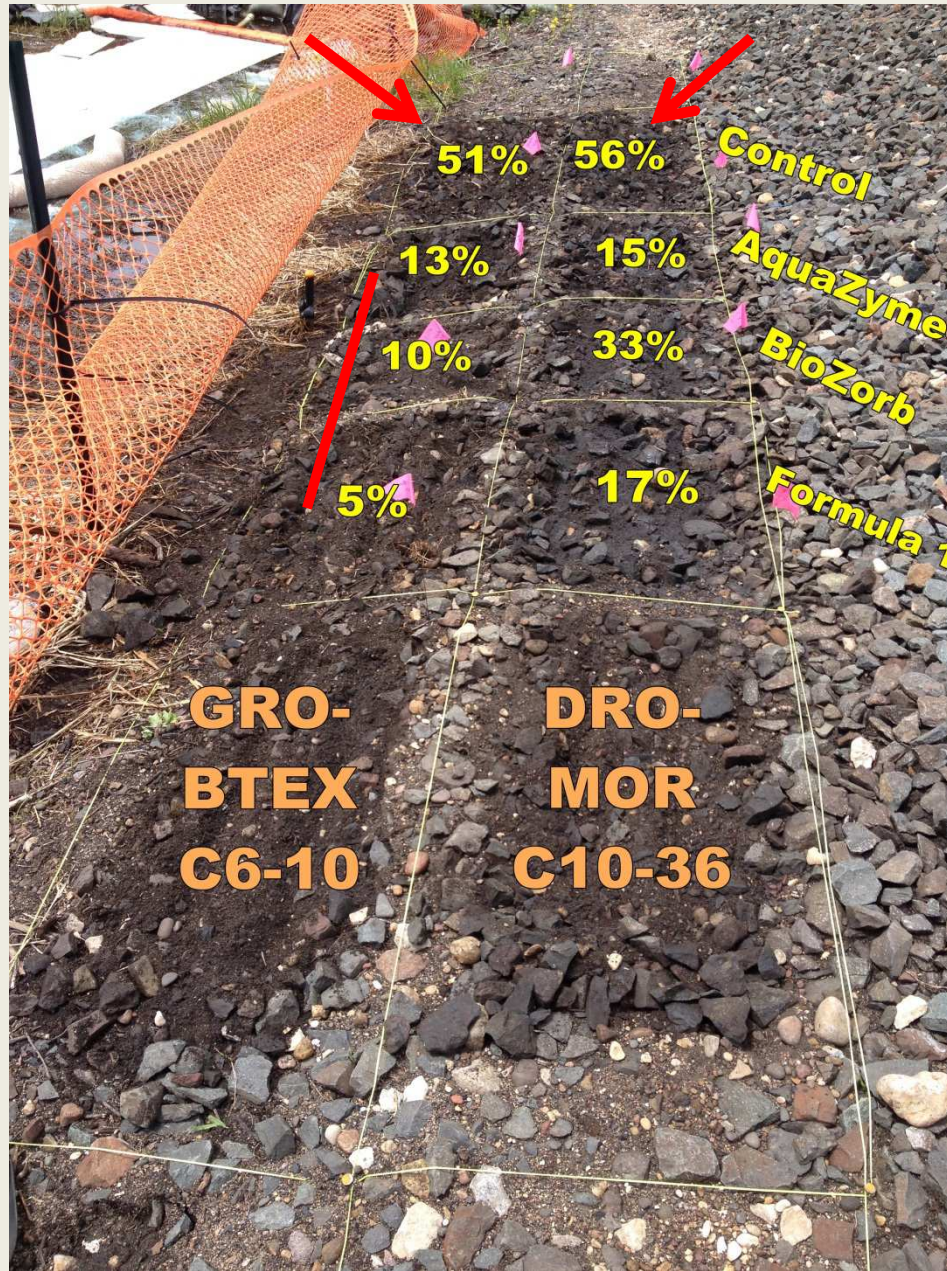
Hydrocarbon Reduction (%) Per Week - Day 61-99

Average
Temperature
Day 61-99:

73.6 °F

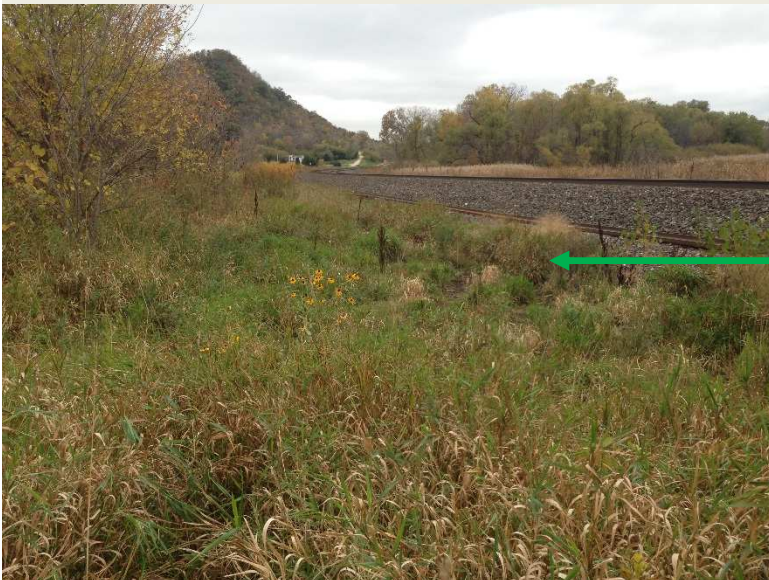
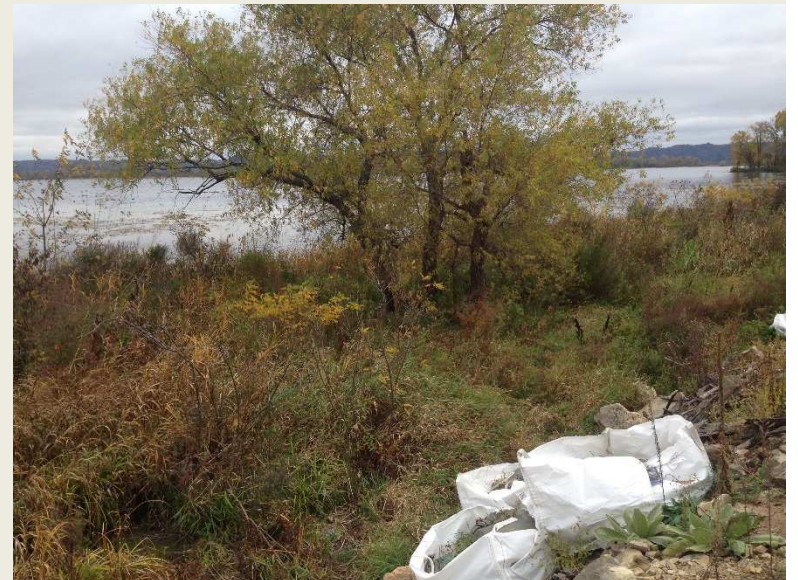
Experiment
Plot and
Interceptor
Trench

Refuge
→

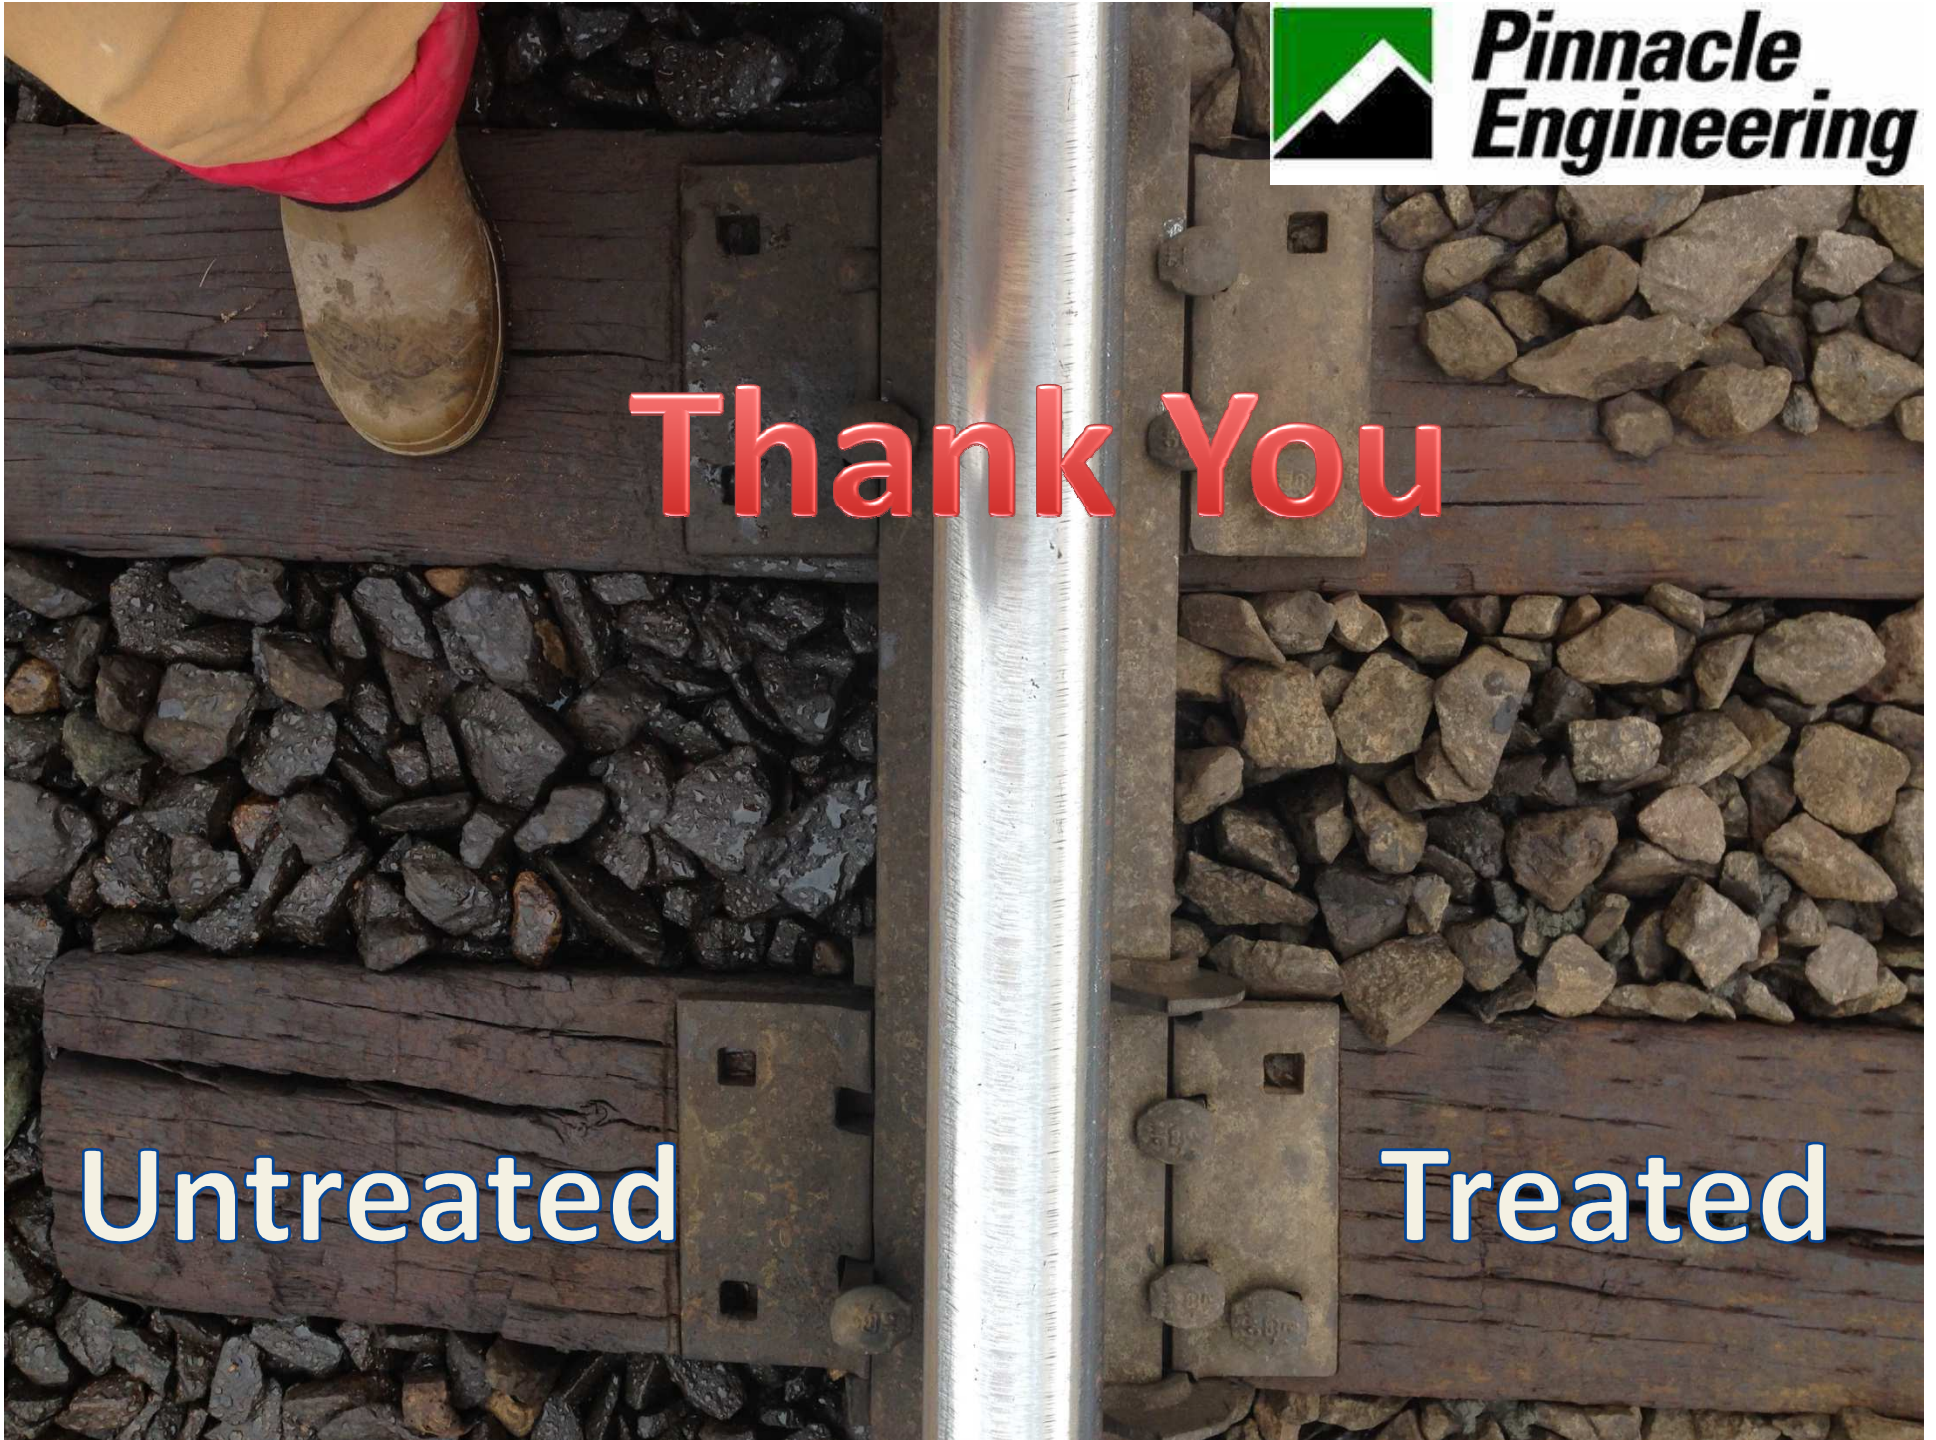
Untreated

Treated
