R RANGE RESOURCES®
Marcellus Shale Production Facility
Emissions: Leak Detection Field Study

NOVEMBER 9, 2017

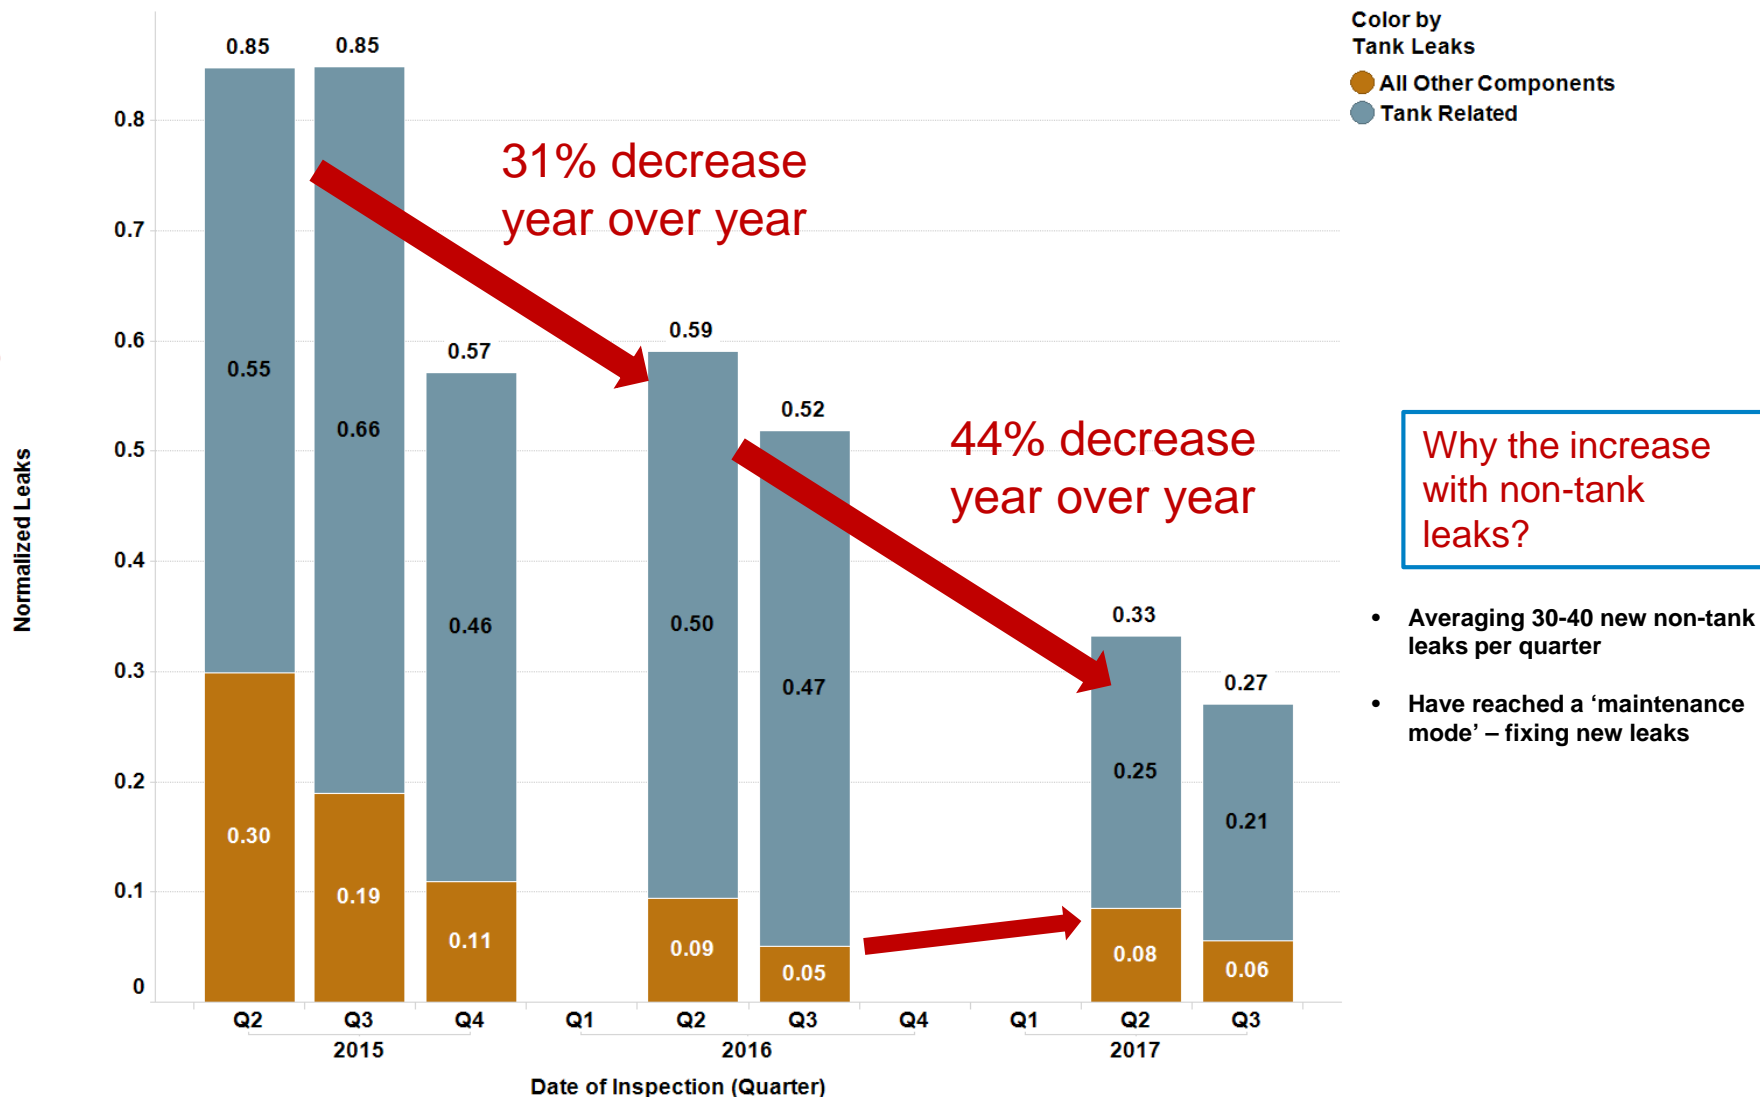
REDUCTION IN OPTICAL GAS IMAGING LEAKS

(Leaks per Producing Wells)

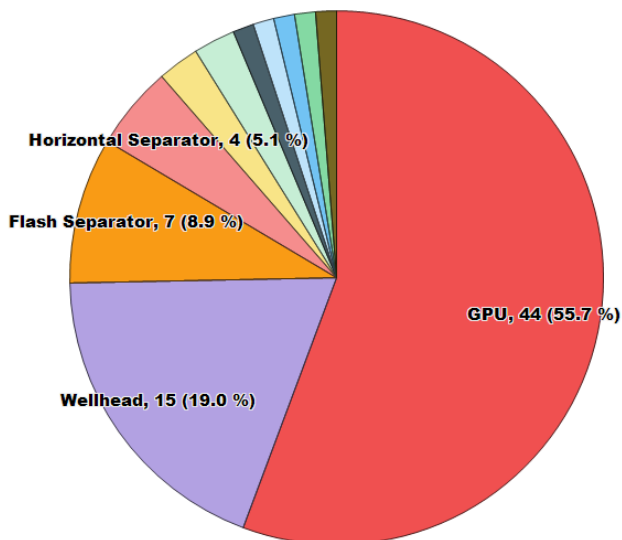
79

No prior quarter inspection

- Two quarters without inspections/leak corrected prior to Q2 2017 – More leaks started during that timeframe
- Q2 2016 and Q2 2017 leak distributions are very similar
- Data shows 30-40 new non-tanks leaks per quarter

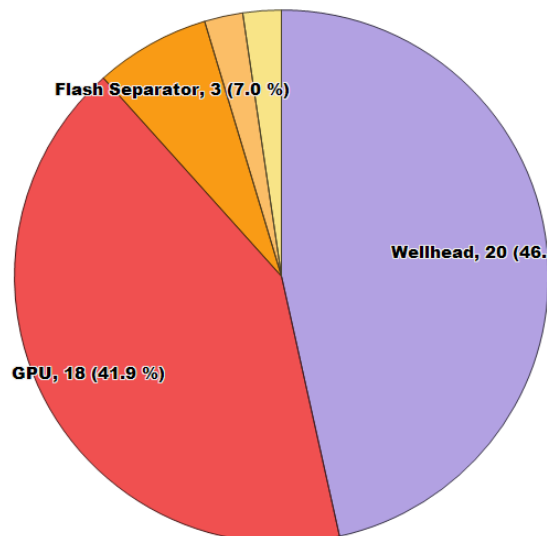
Q3 2016

43
