Petroleum Fingerprinting and Environmental Sleuthing Identifies Archeological Contamination Not Associated with Site Activities... Site Achieves Closure saving Millions

24th IPEC, San Antonio, TX

November 2017

Richard H. Christensen, PhD LPG, Andrea Jesudian

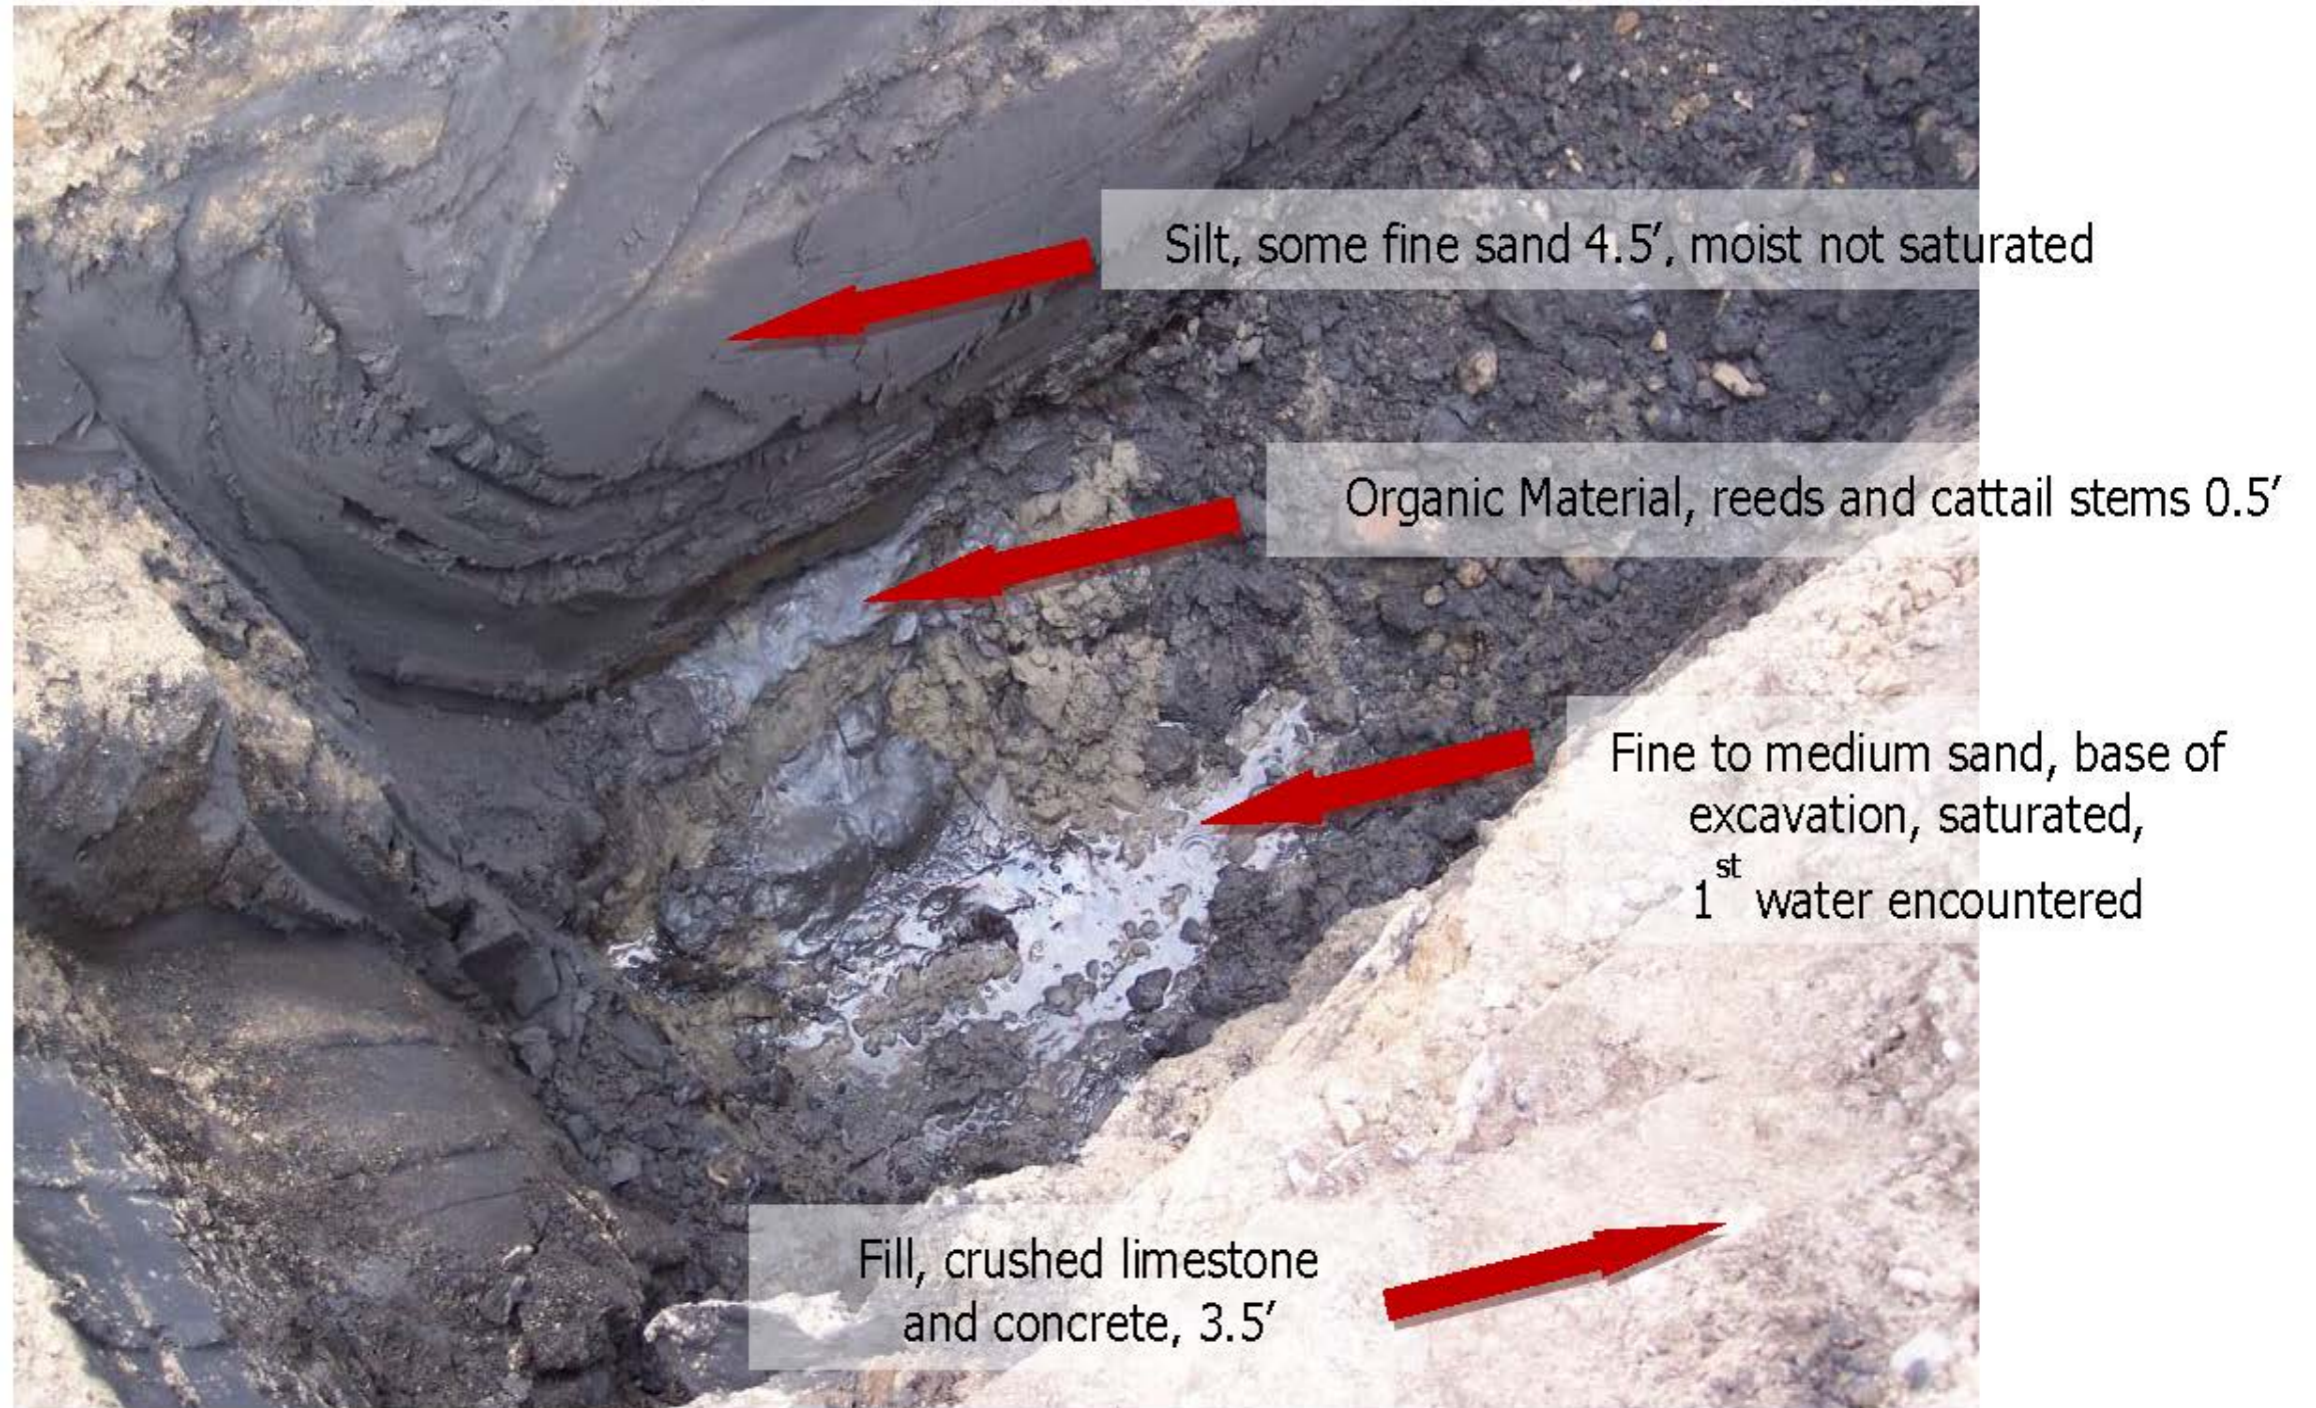
Excavation of Test Pit 2 - 1

GPB Test Pit No.2 (Center of Site)

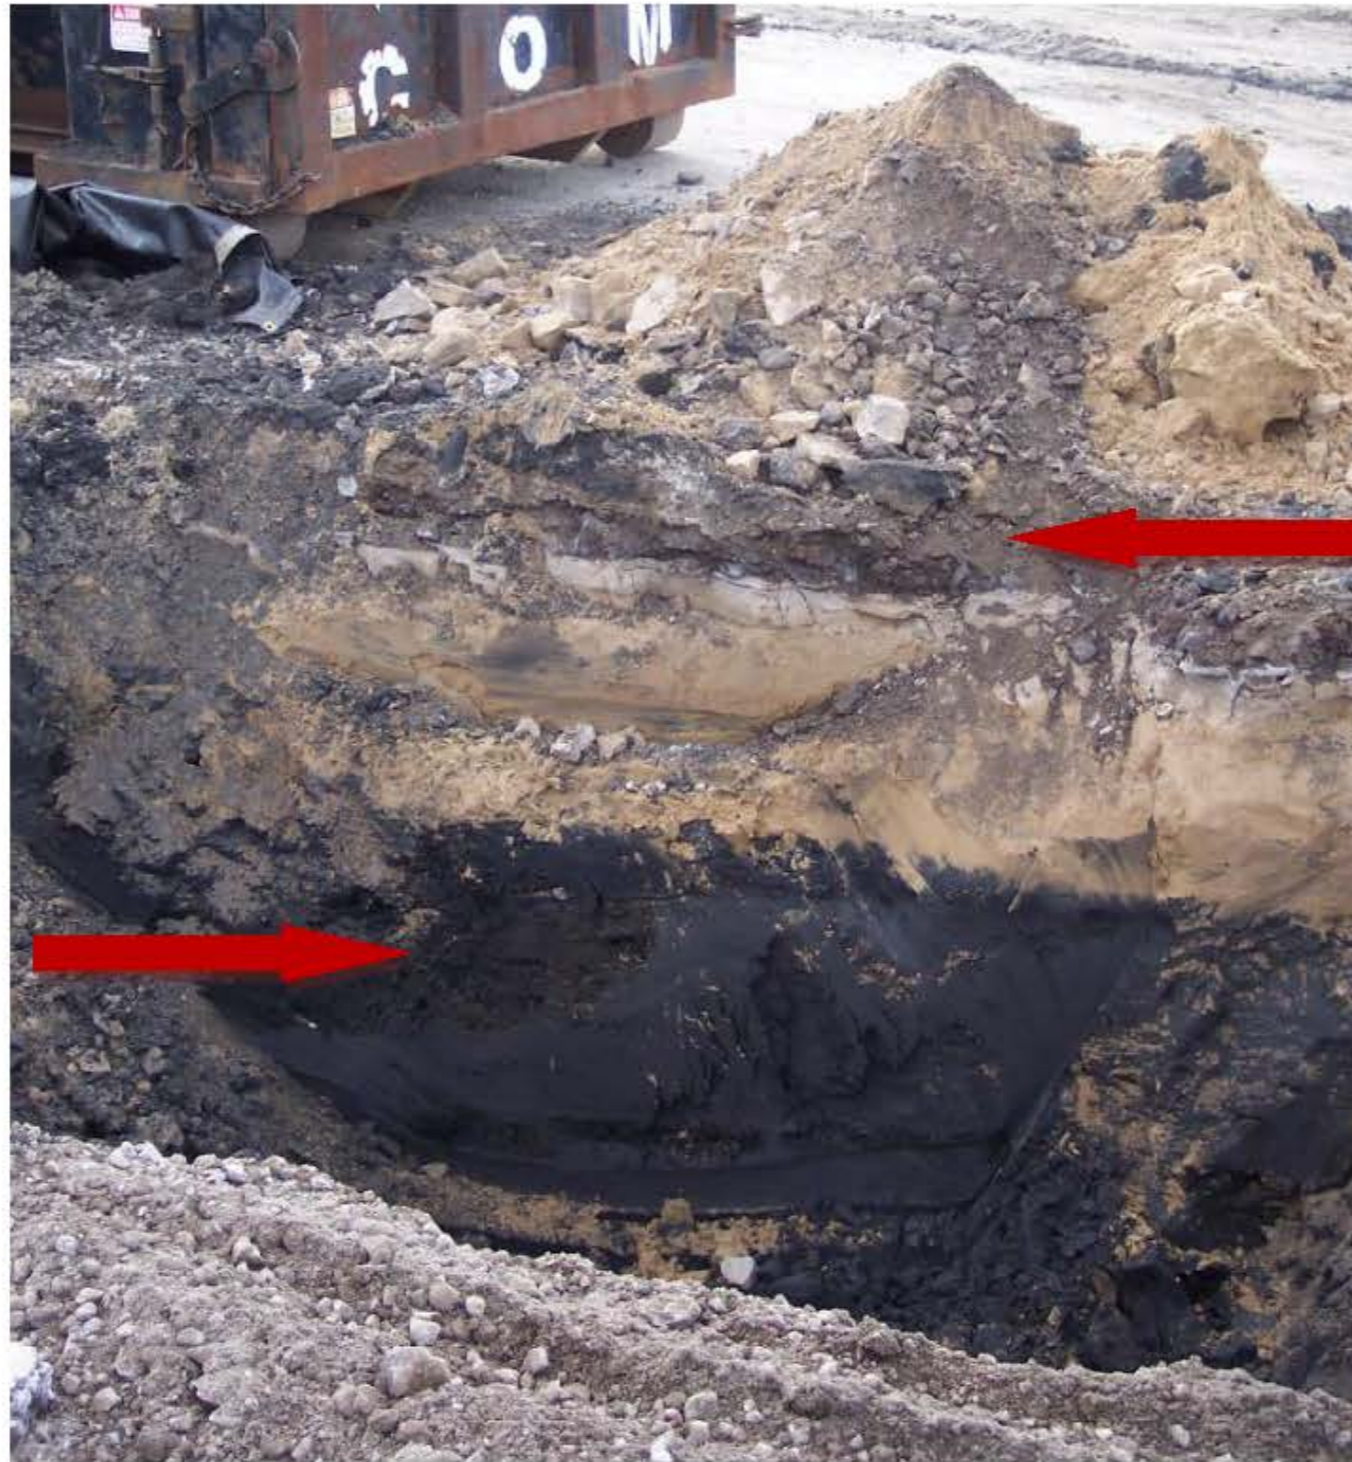
Excavation of Test Pit 3 - 1

GPB Test Pit No.3 (East Side of Site)

Black sand, contains relic industrial debris and grease

Fill, brown sand, gravel, cinder or crushed concrete

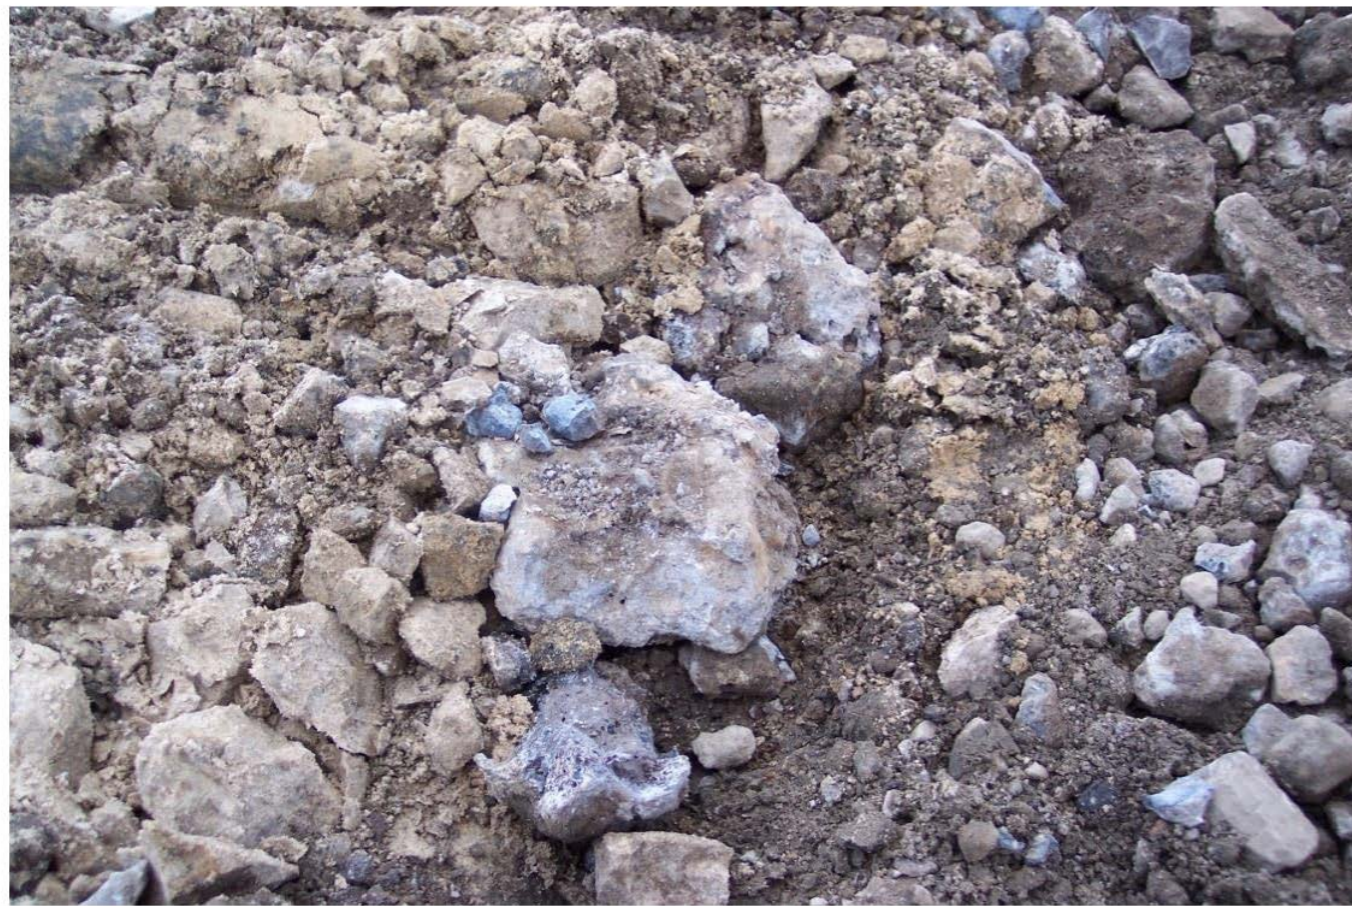
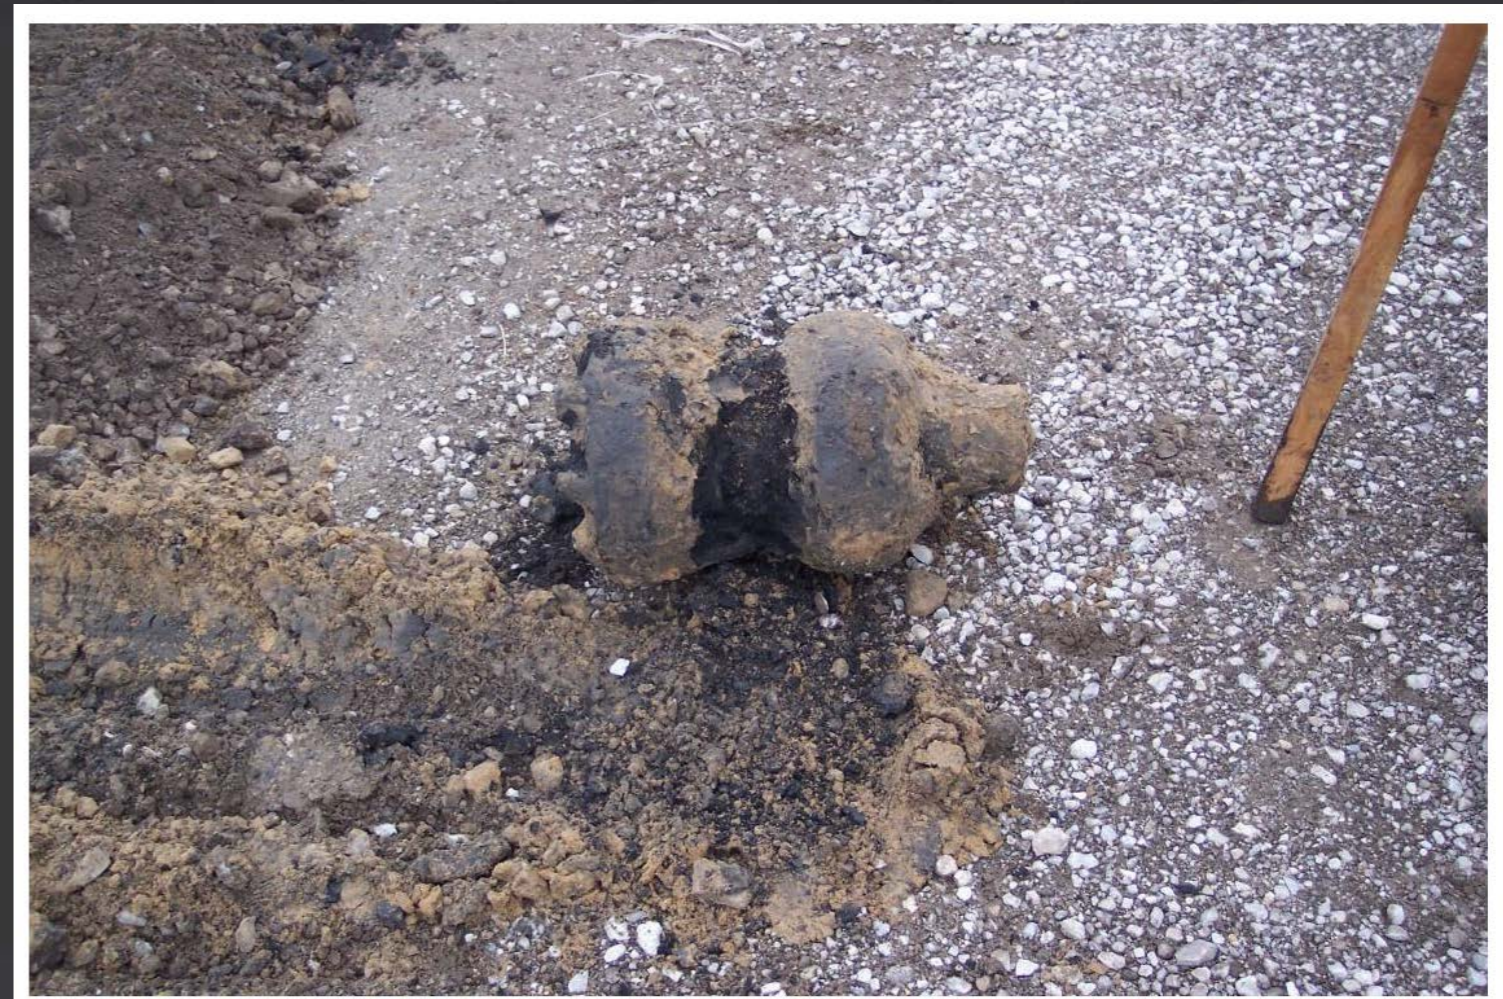
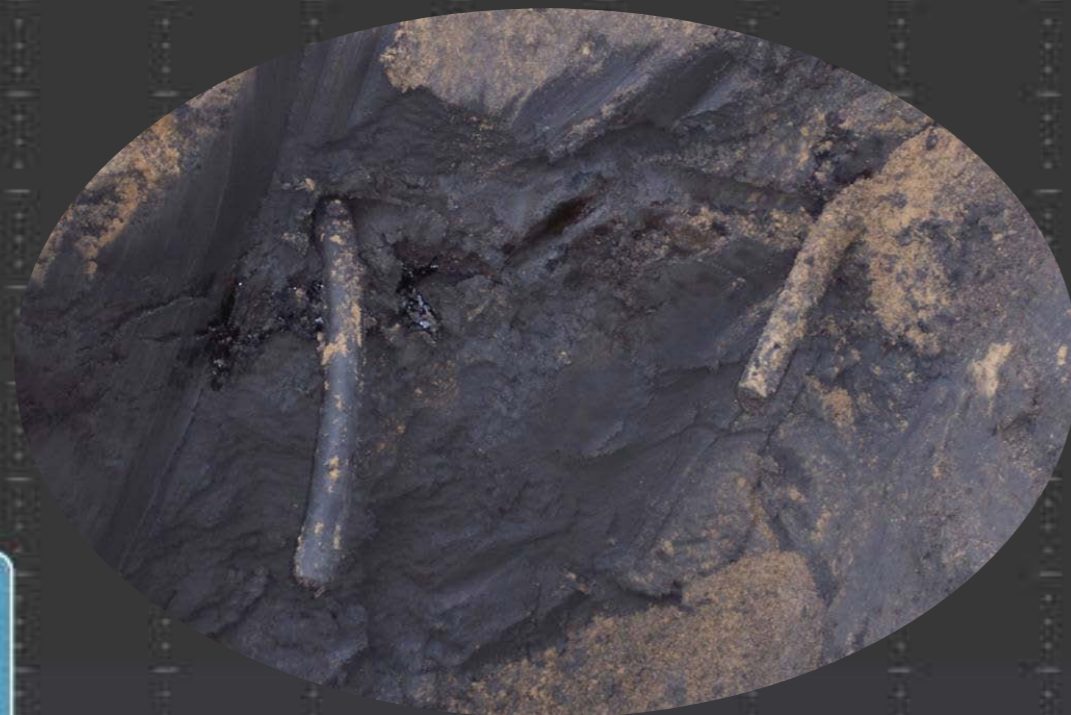
GPB Relics / Discoveries

Debris Associated with Steel Mill Operations:
Slag, Piping Flanges, Rubber Hoses, Glass, Pipes, etc.

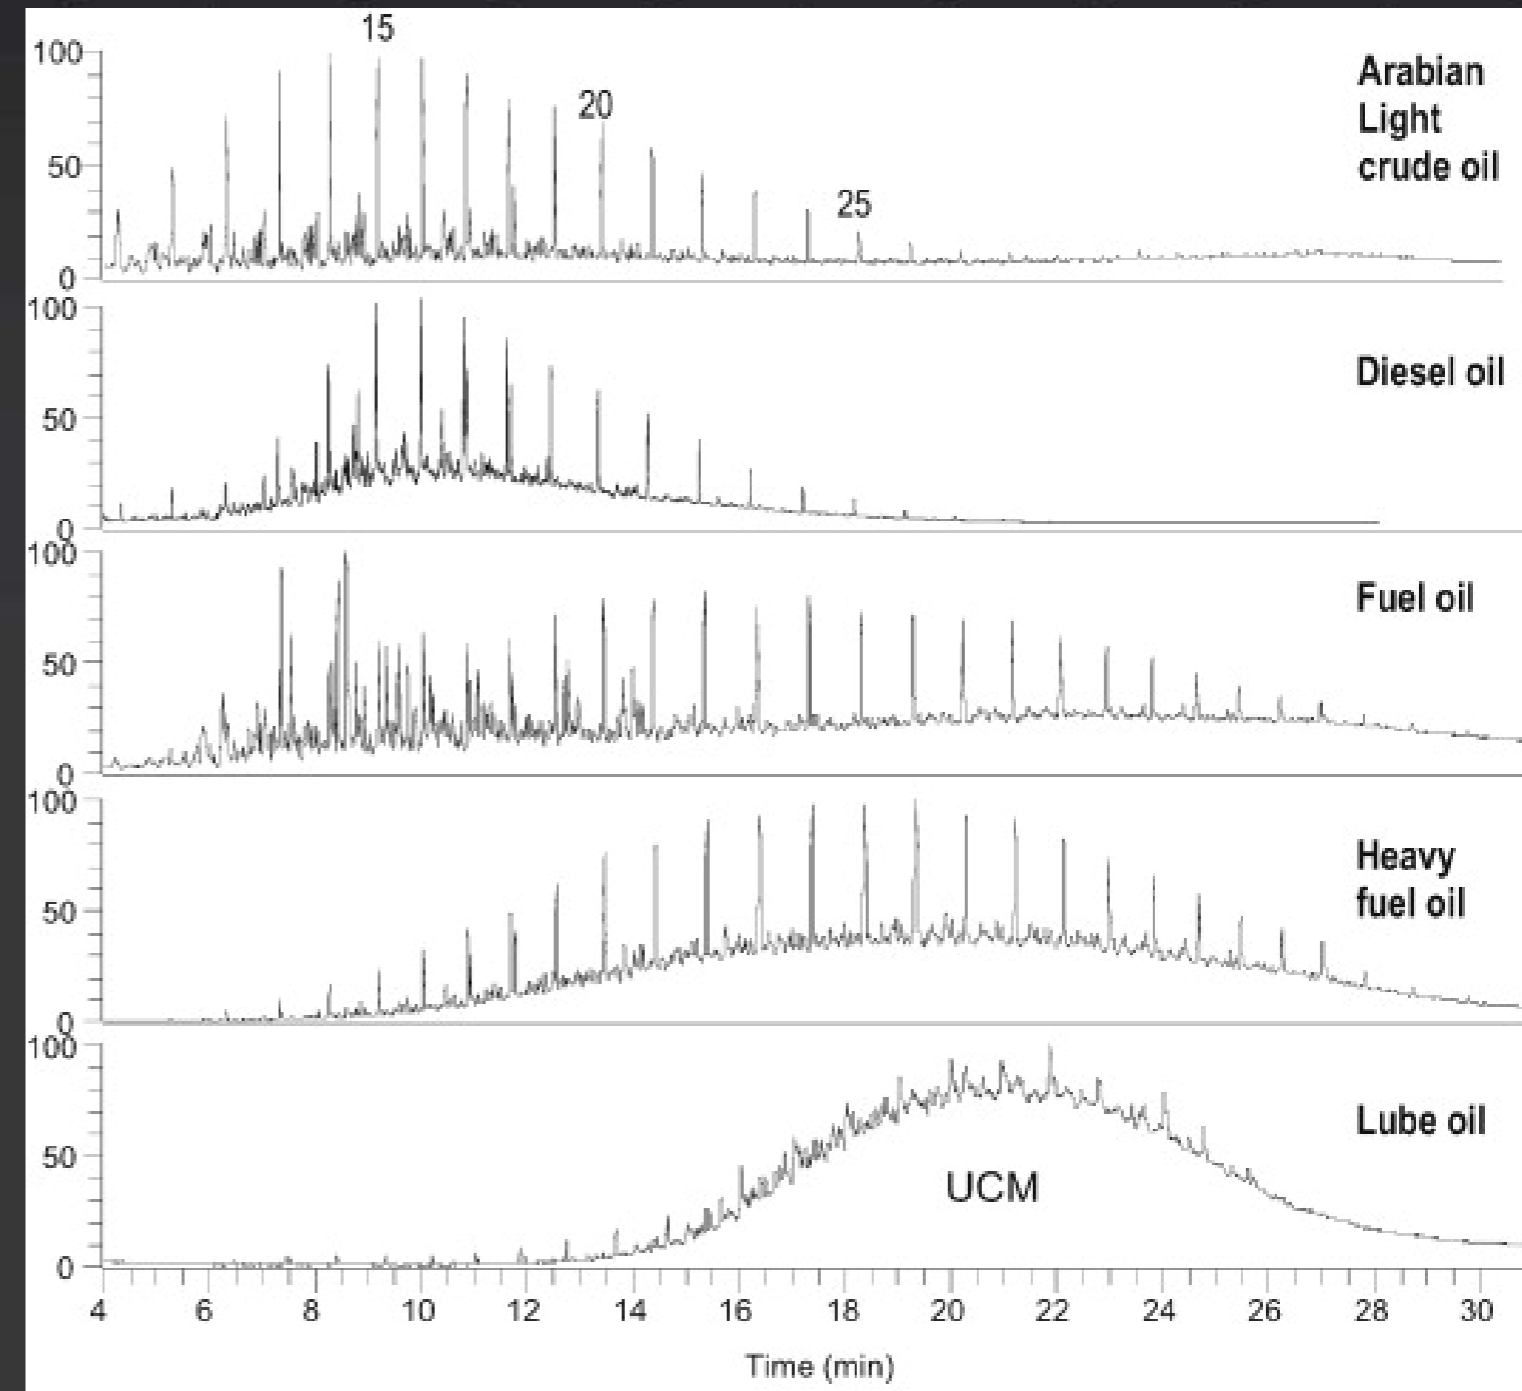
Example of various fuel "fingerprints"

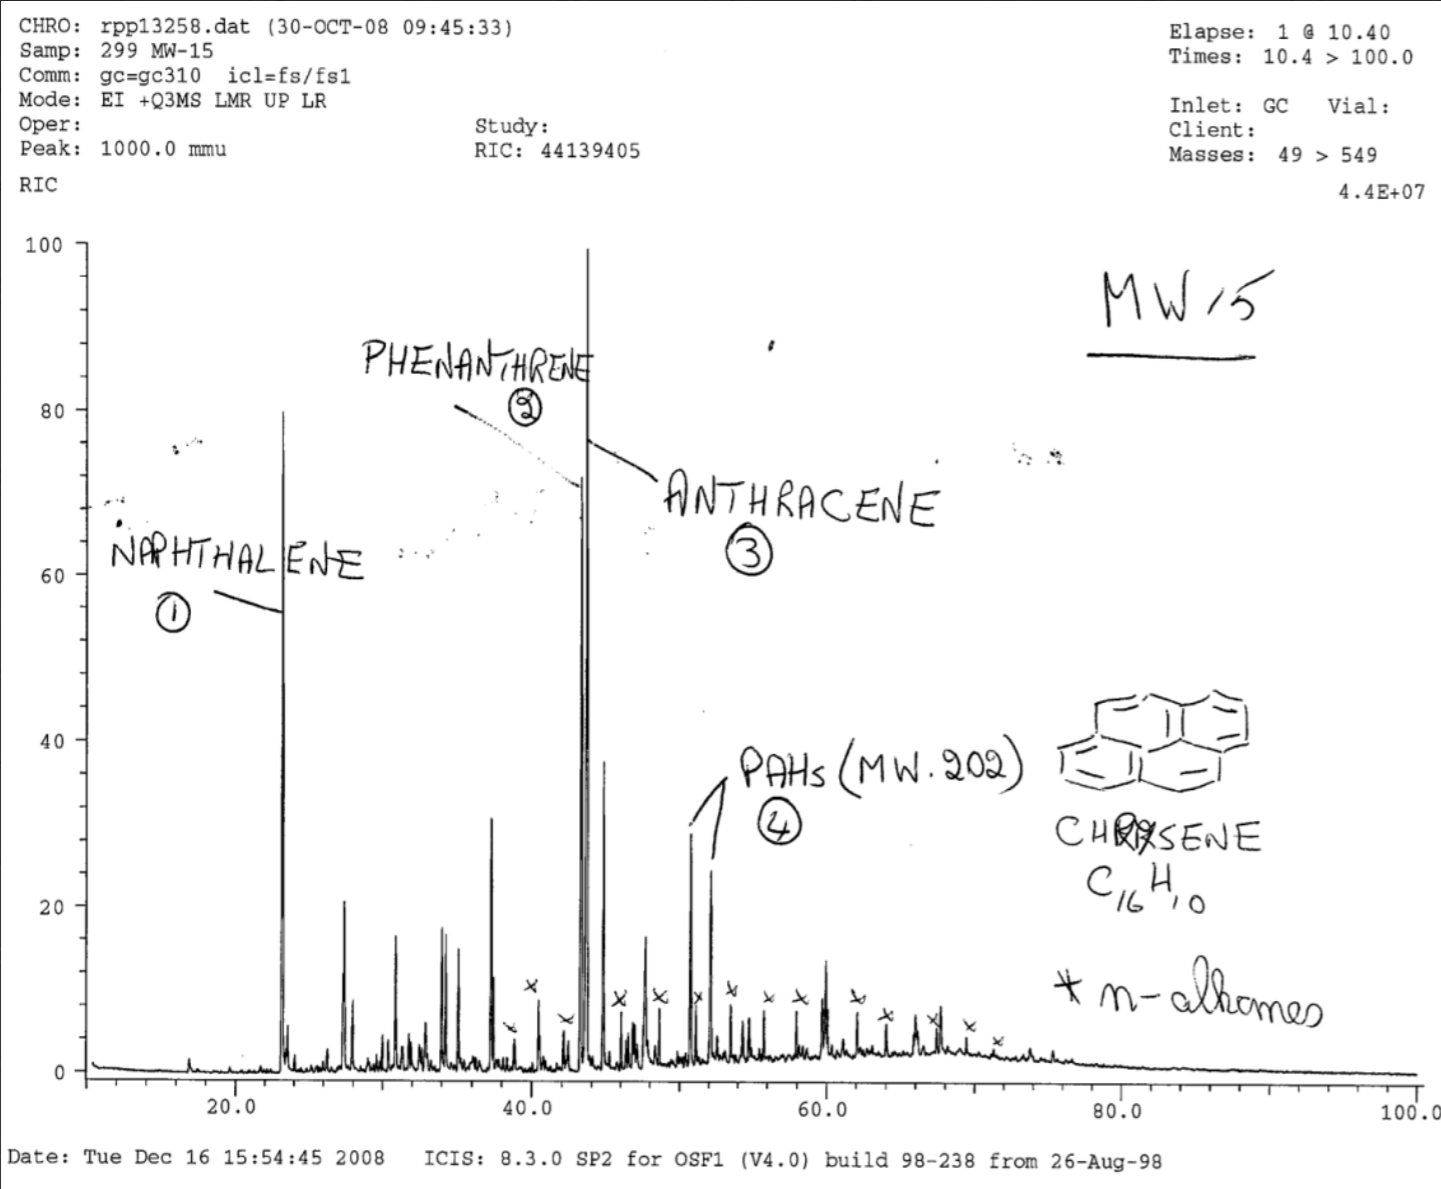
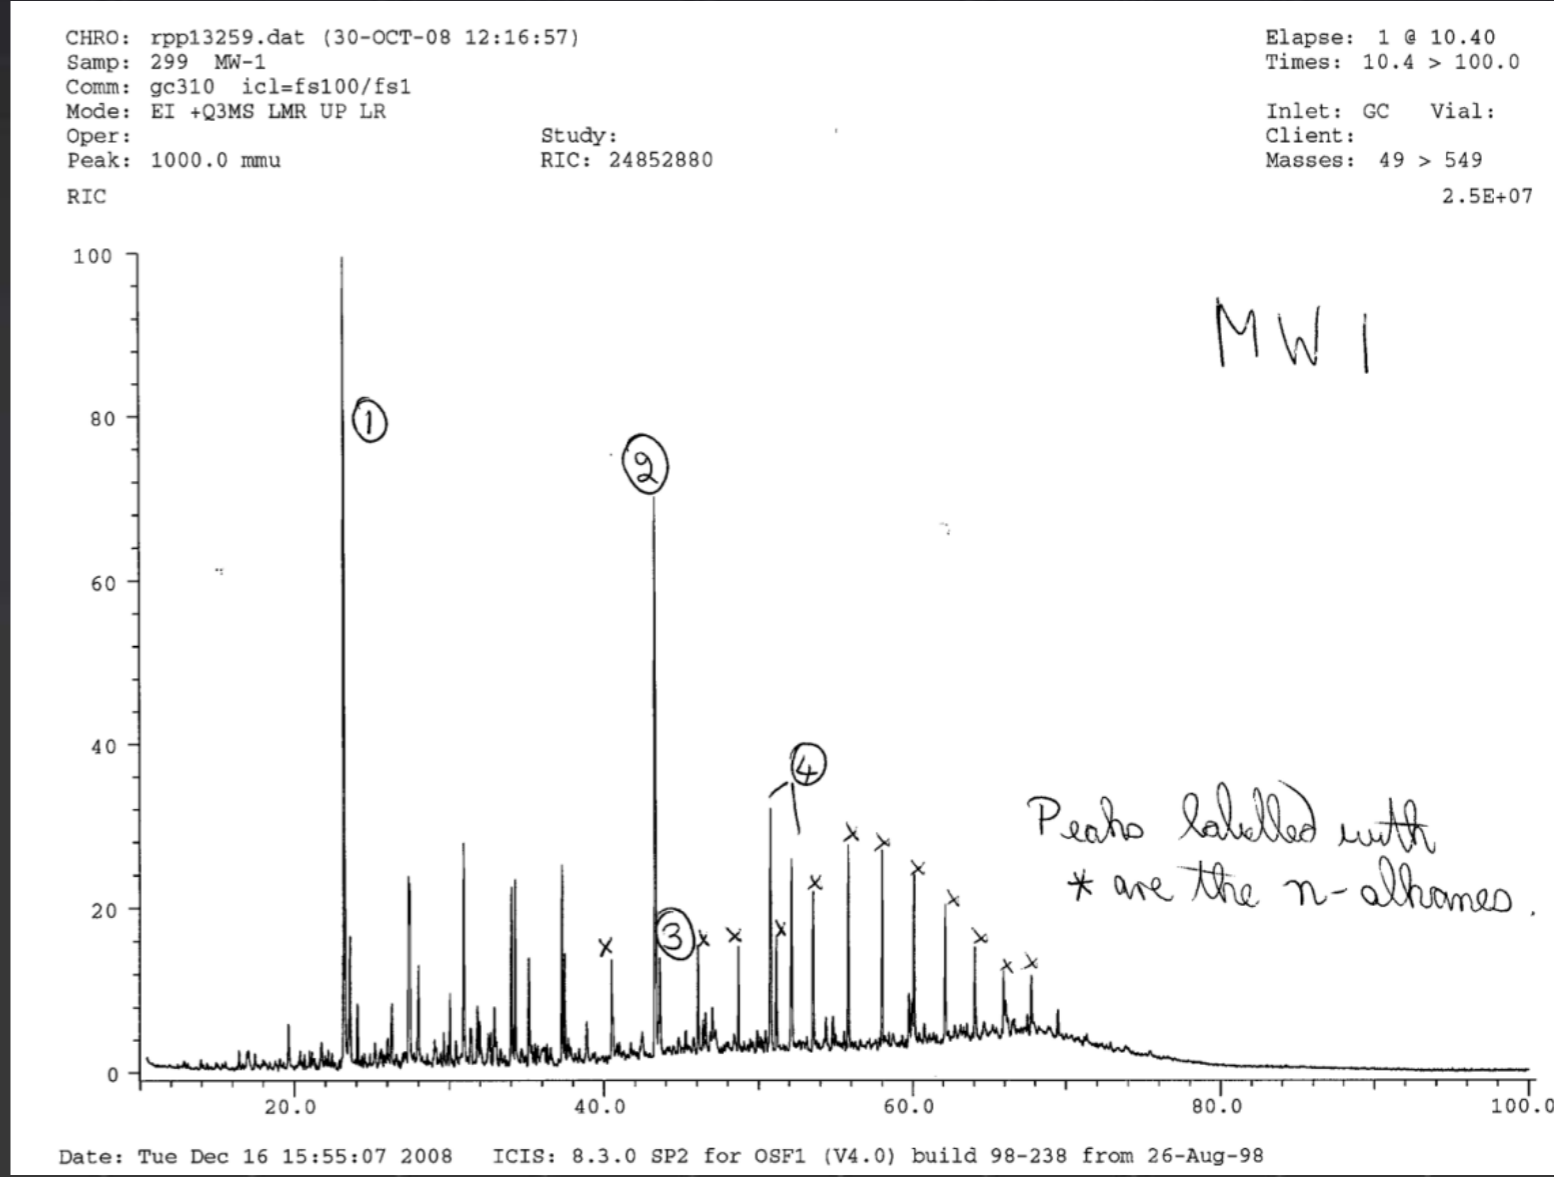
- Strong HRGC correlation between MW-15 & MW-1
- Numerous PAH peaks consistent with motor fuels

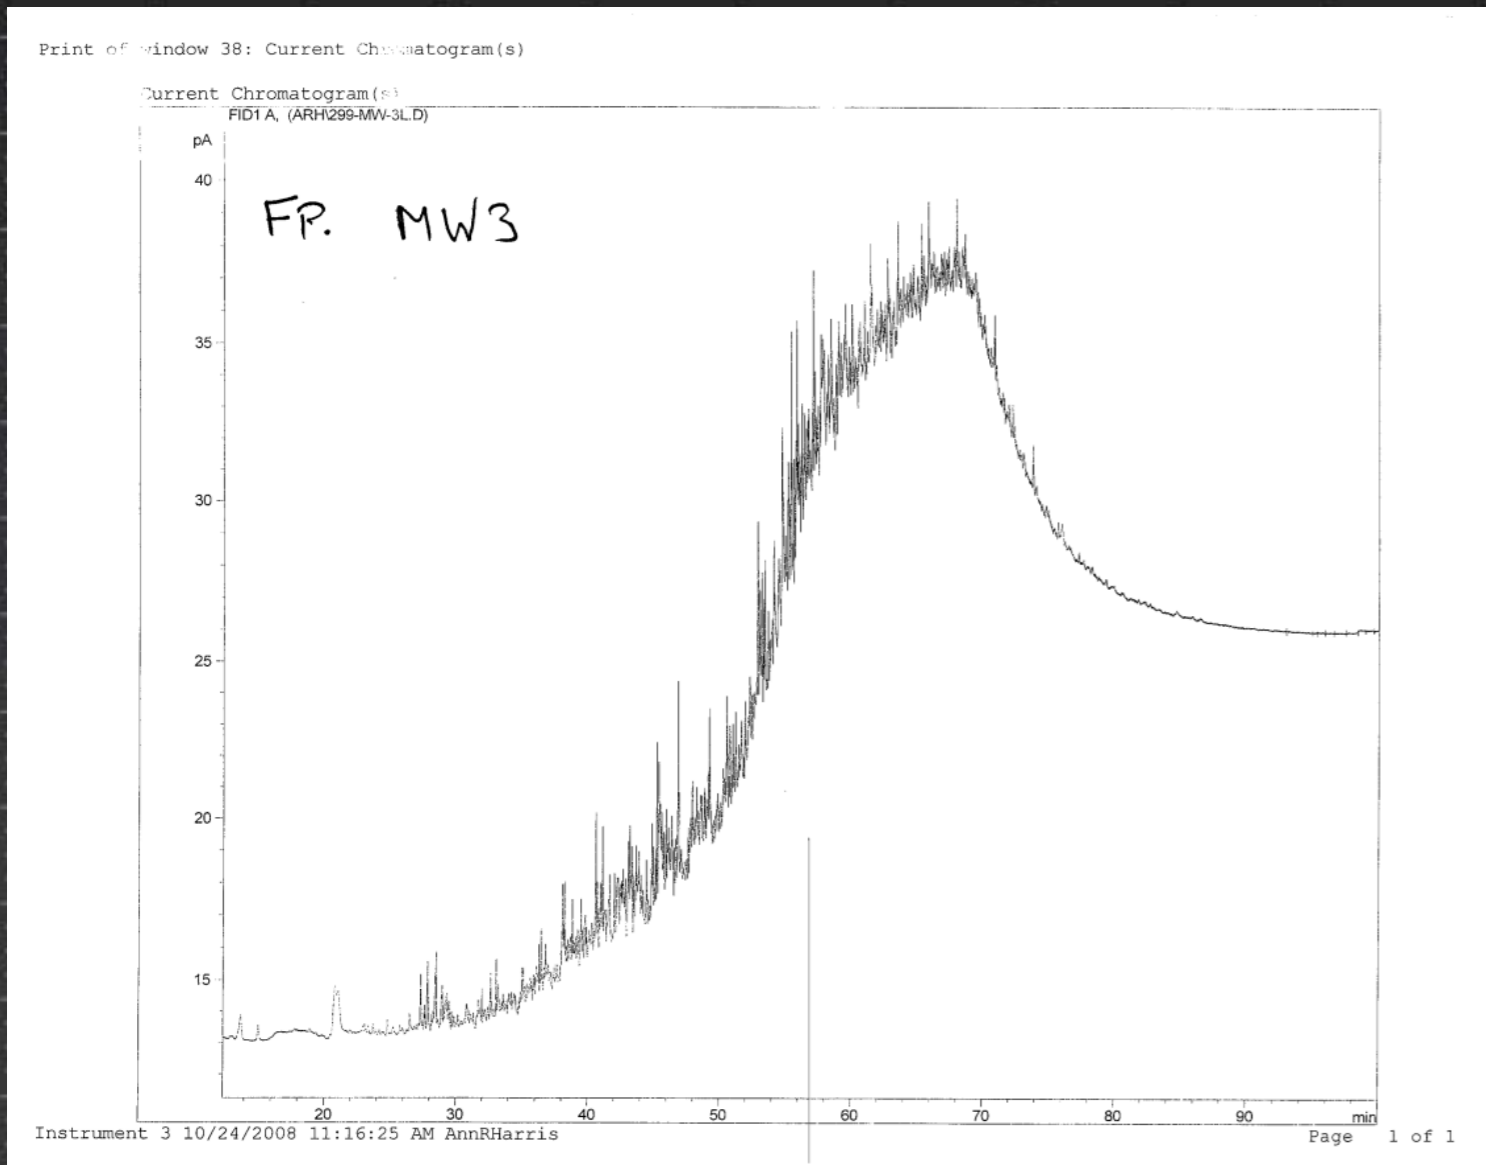
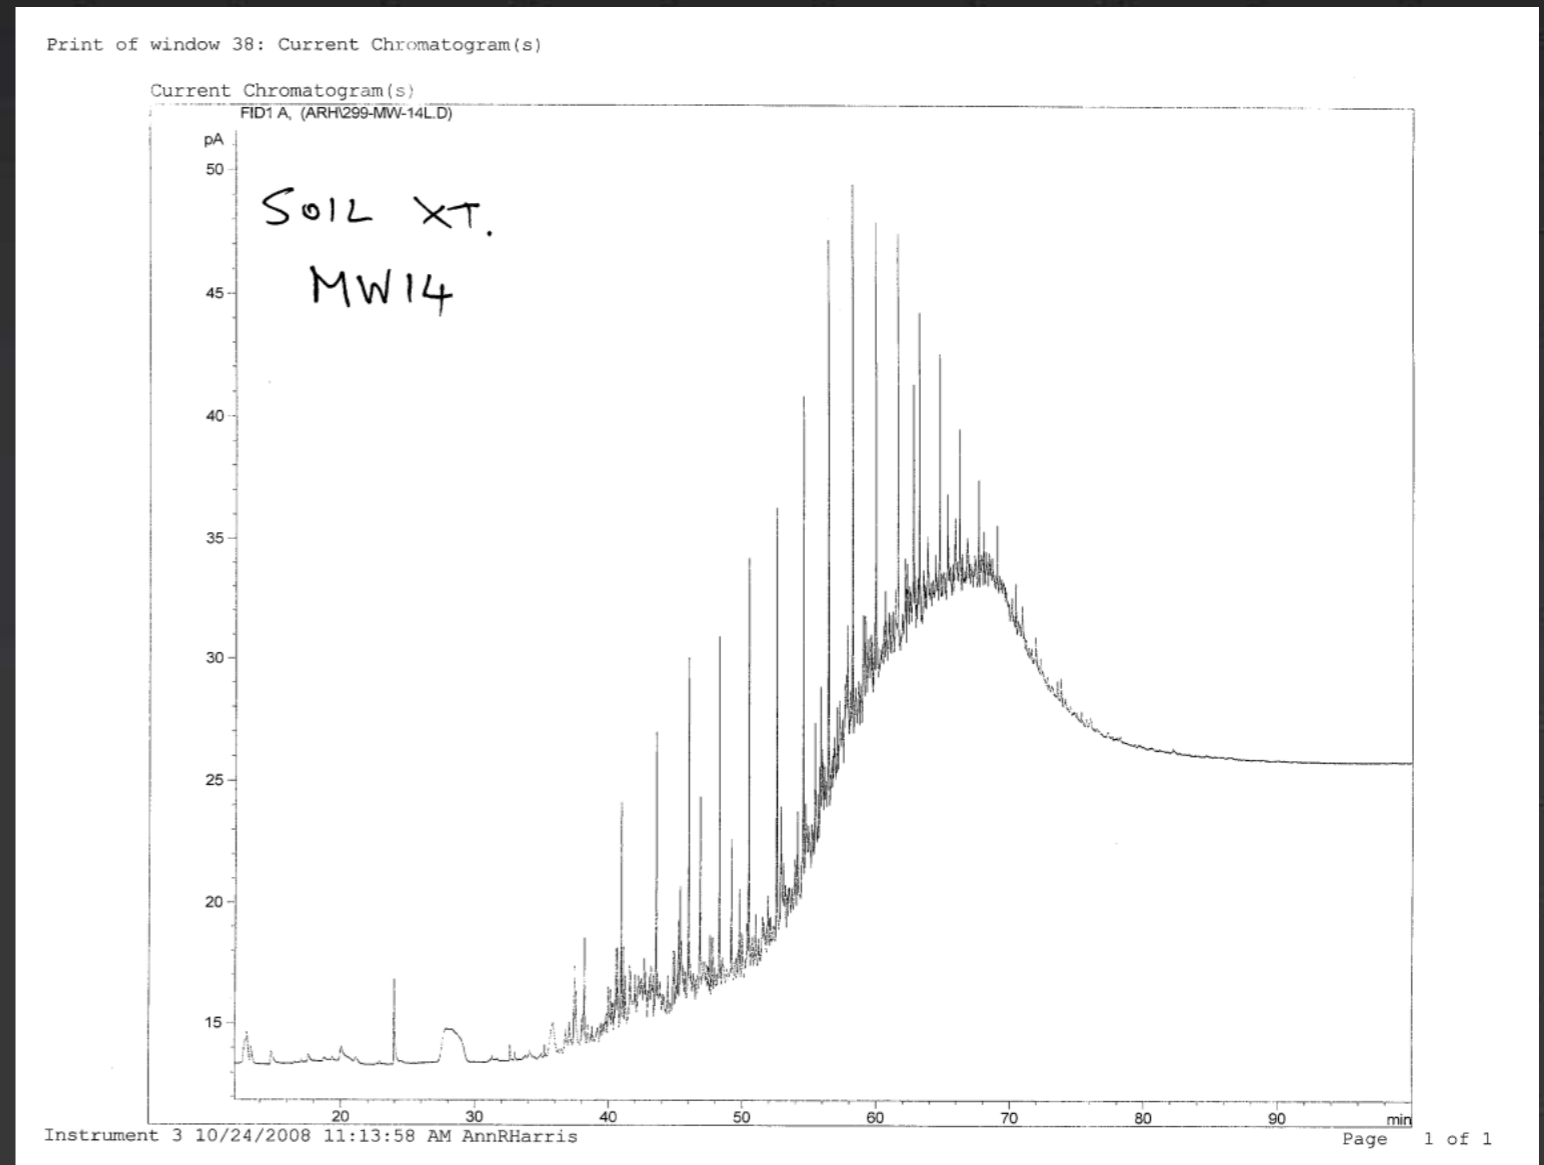
- Strong HRGC correlation between free-phase in MW-3 and soil at MW-14
- Peaks and distribution are consistent with lubricating oil

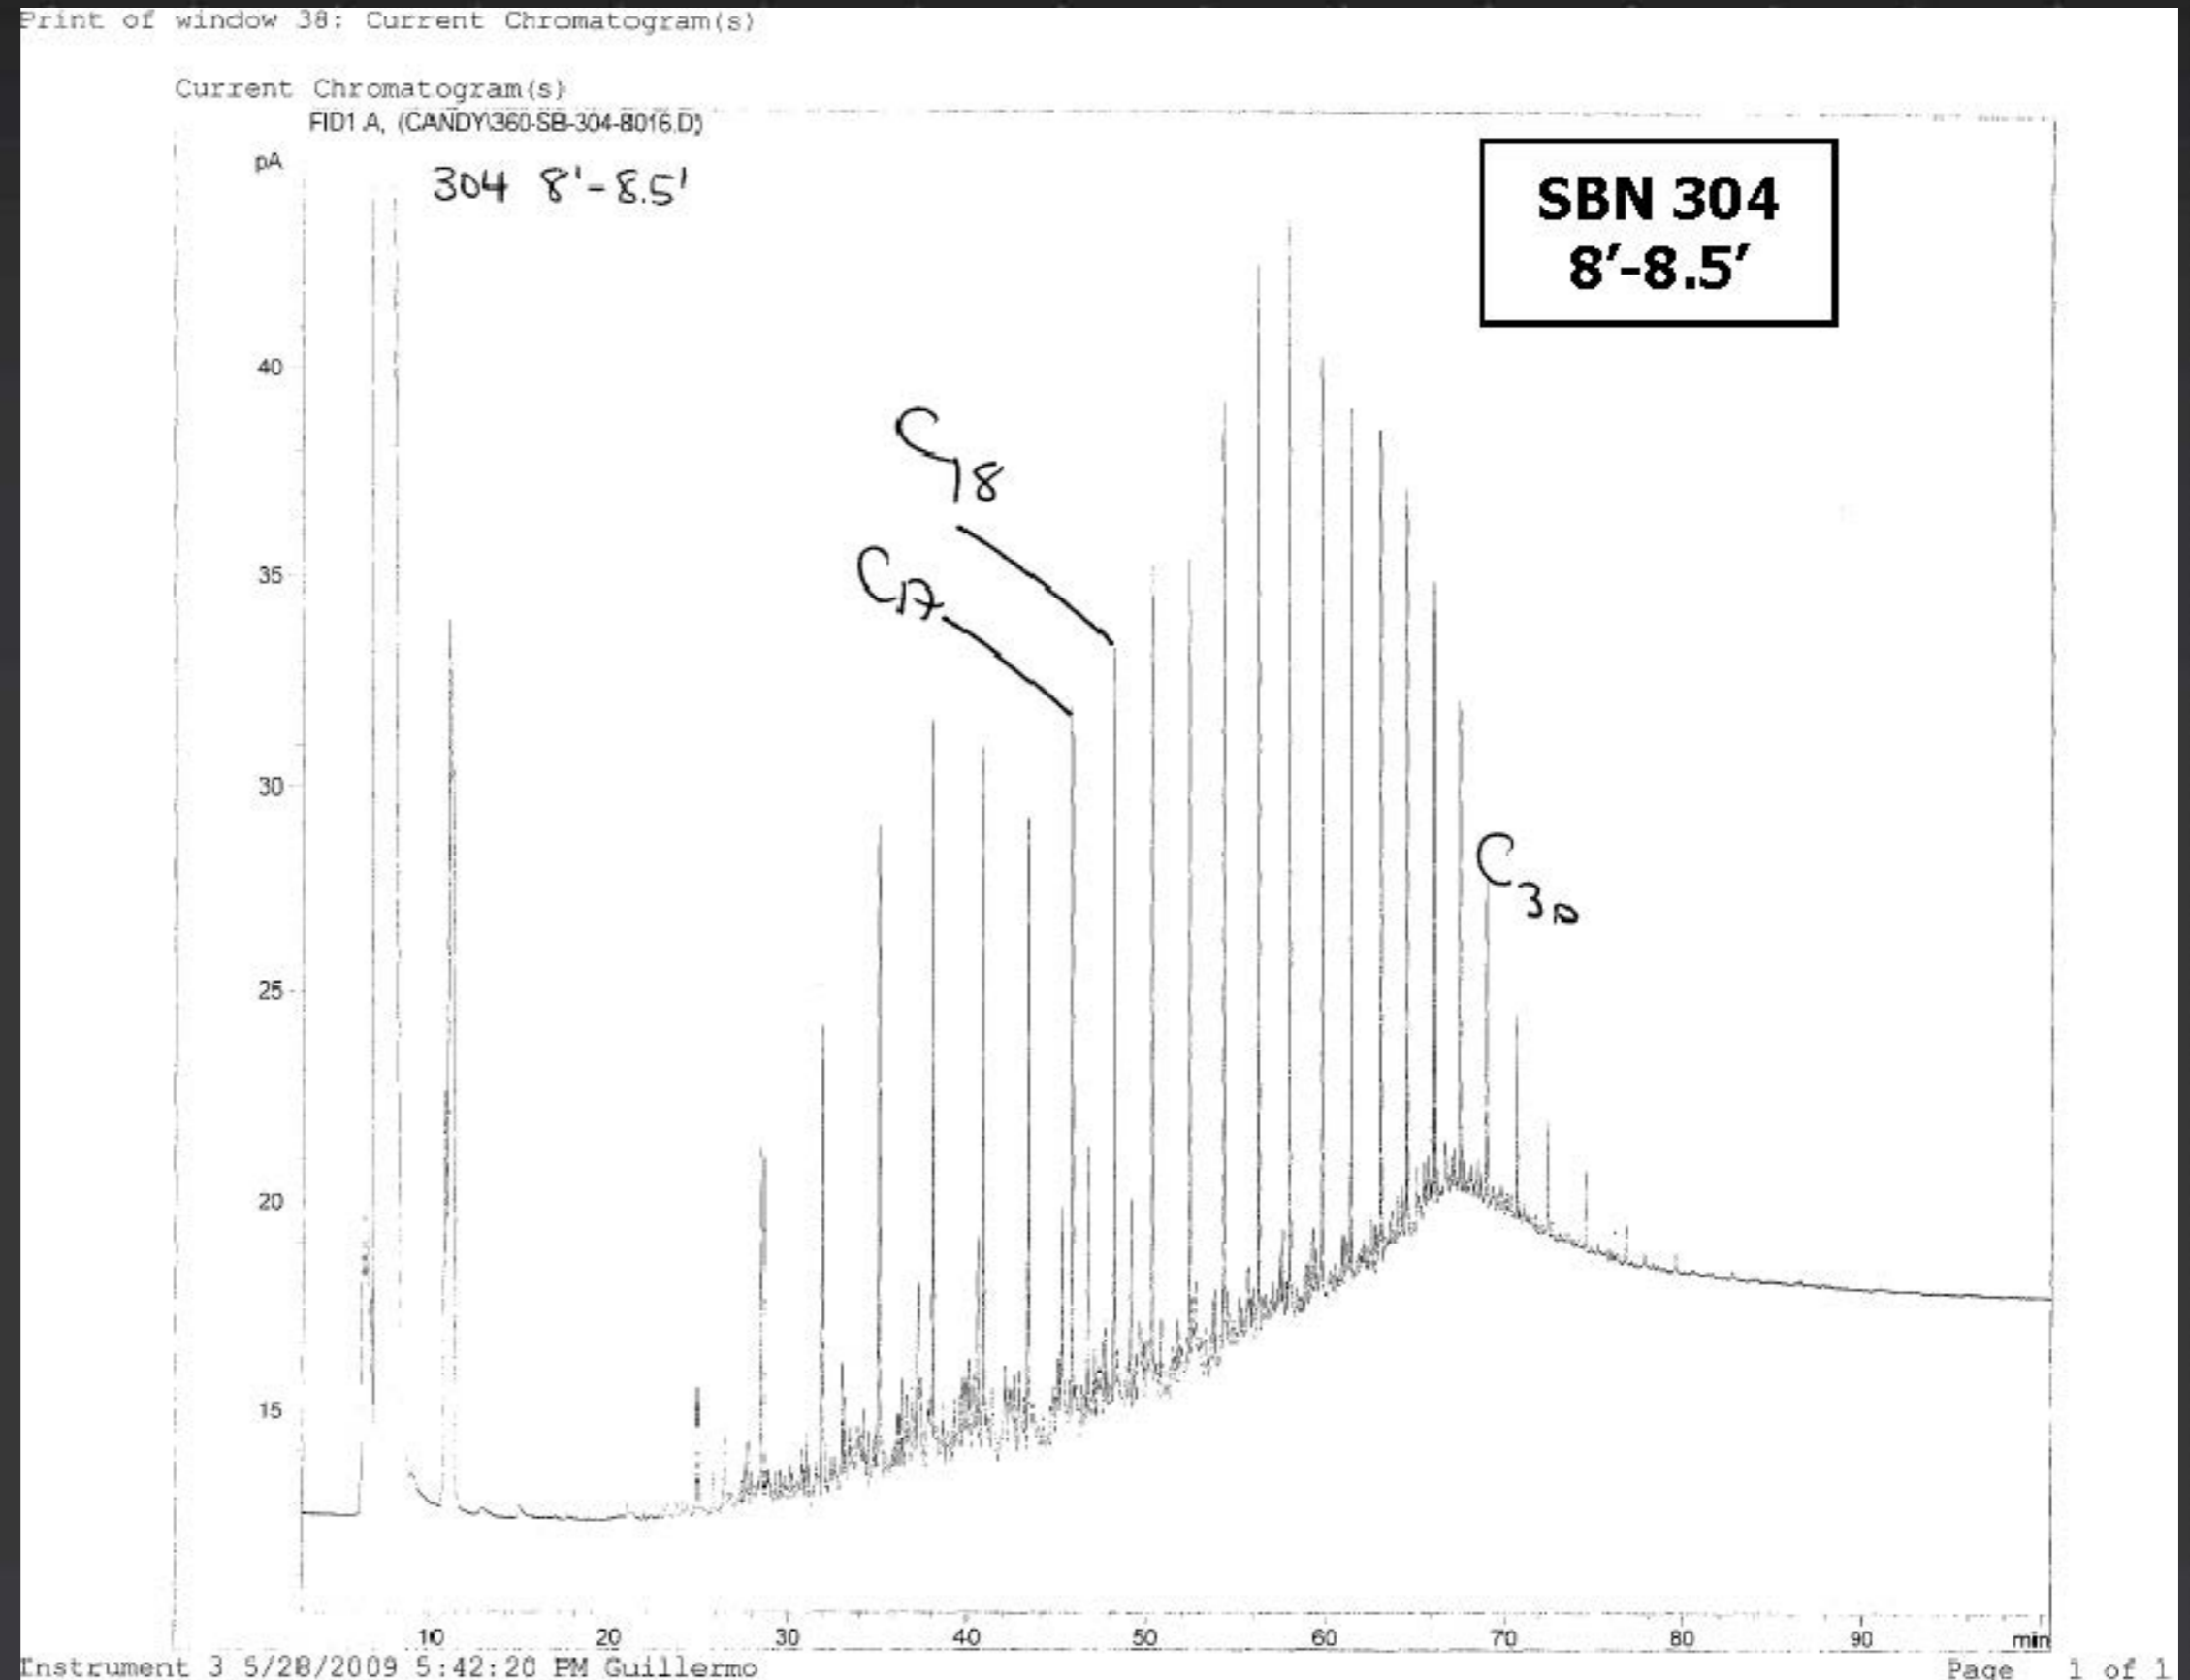
Sample 304:
Located between
MW-1 (Motor Fuel)
&
MW-3 (Lube Oil)

HRGC detections
of both VOCs and
PAHs were identified
