Petroleum Fingerprinting and Environmental Sleuthing Identifies Archeological Contamination Not Associated with Site Activities... Site Achieves Closure saving Millions

24th IPEC, San Antonio, TX

November 2017

Richard H. Christensen, PhD LPG, Andrea Jesudian

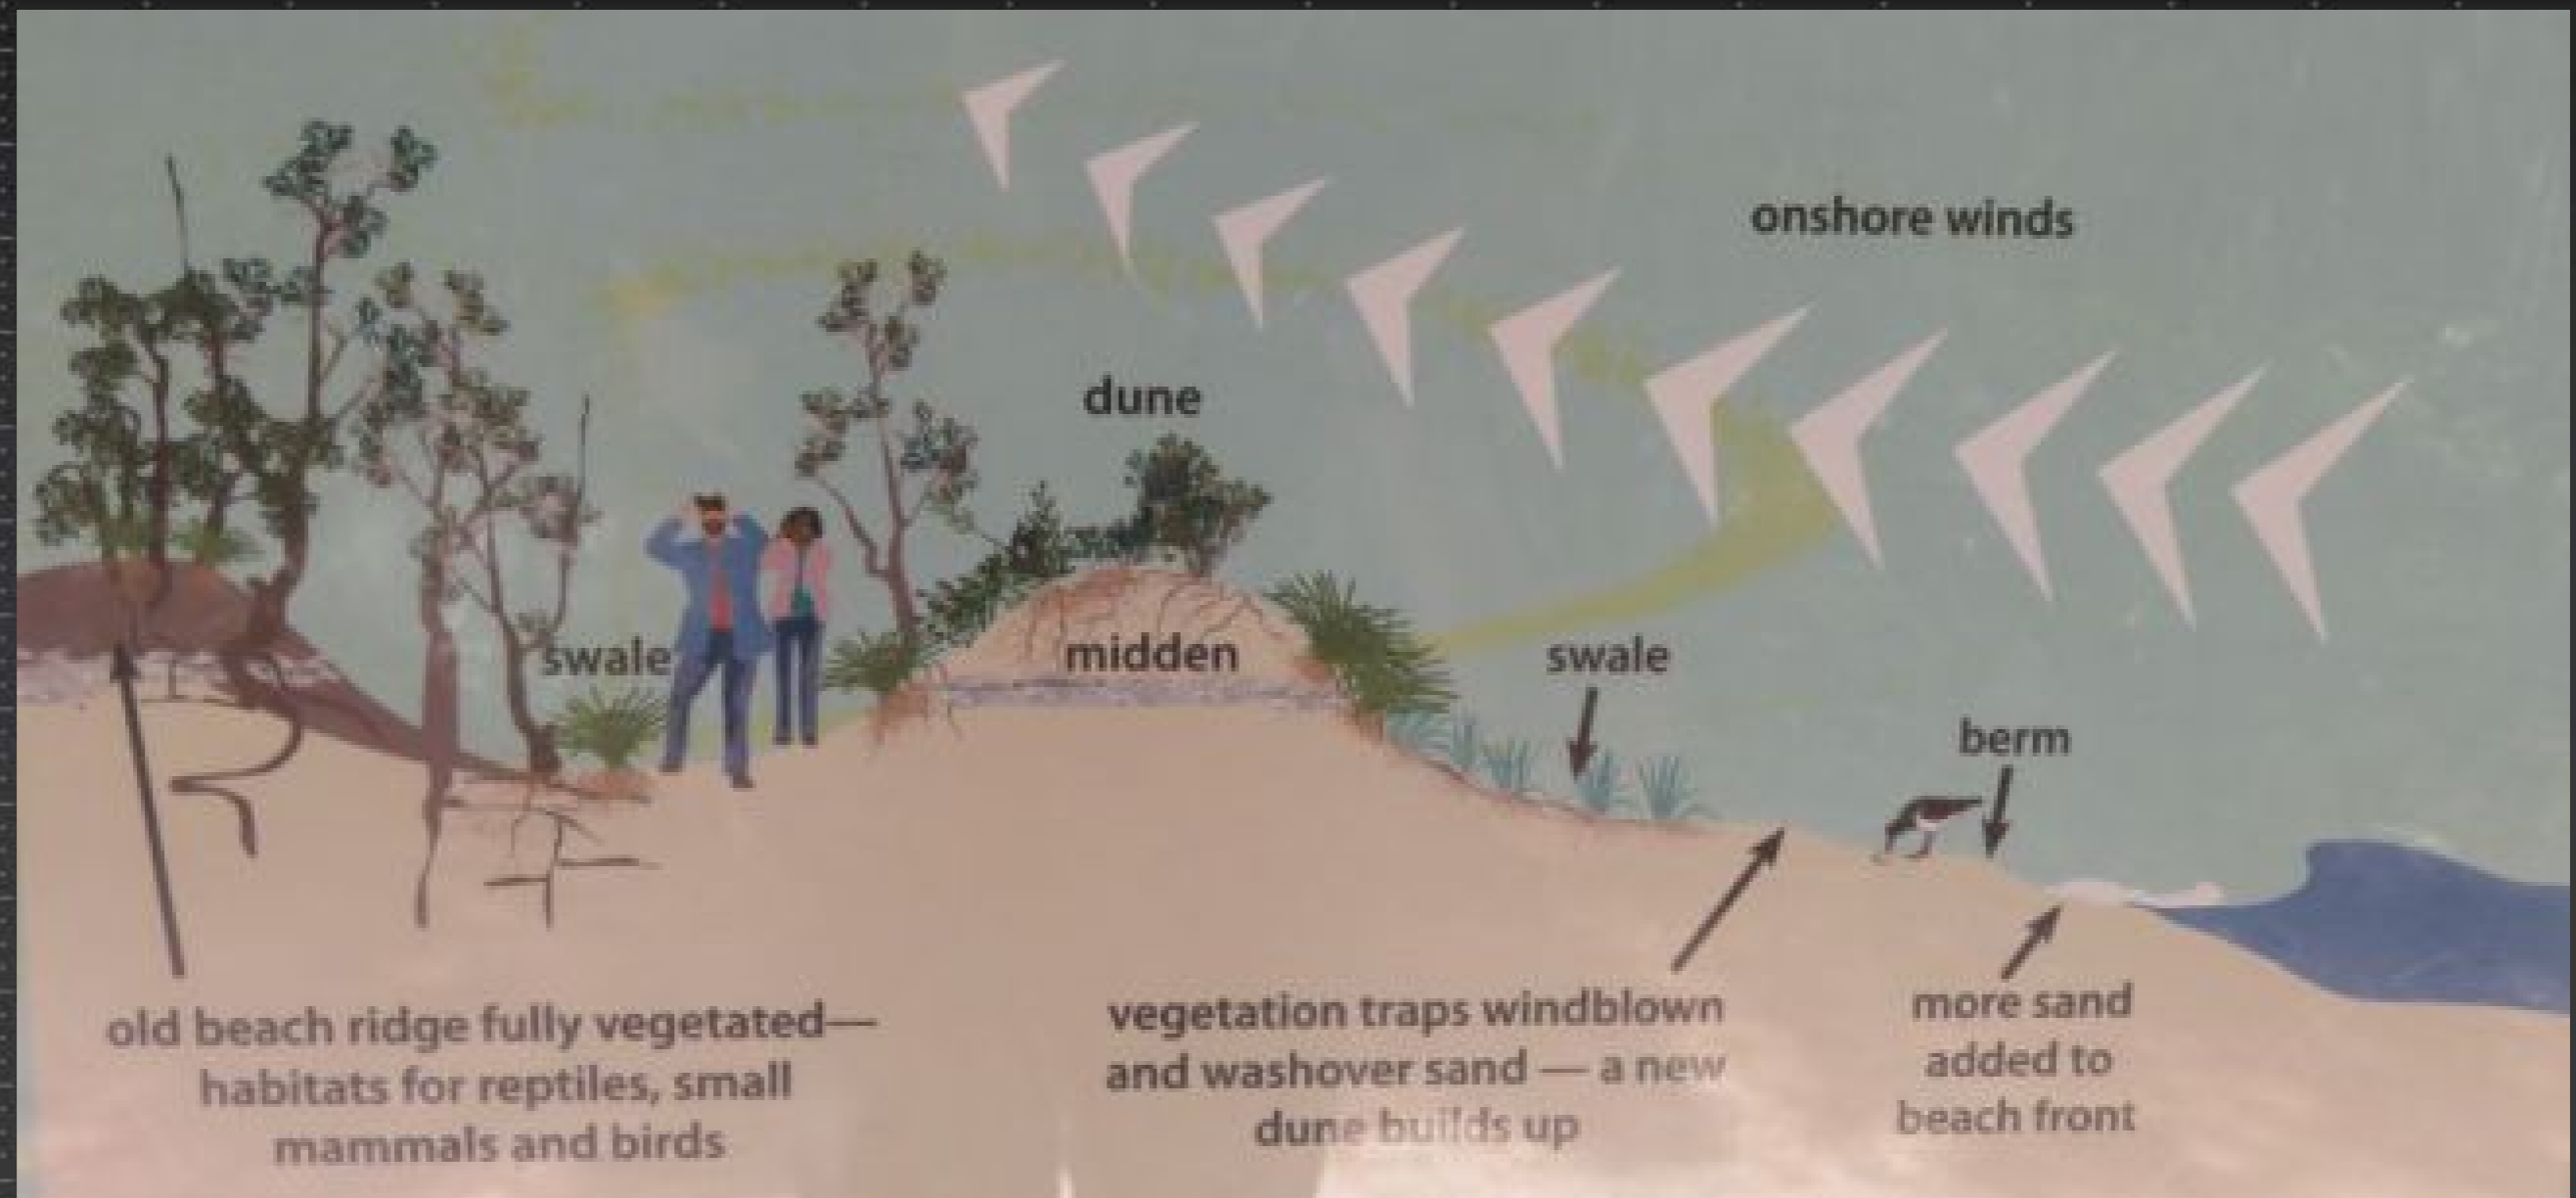
Dune Swell & Swale

- Alternating low sand ridges with marshy zones
- Laid down as off-shore deposits of Lake Michigan

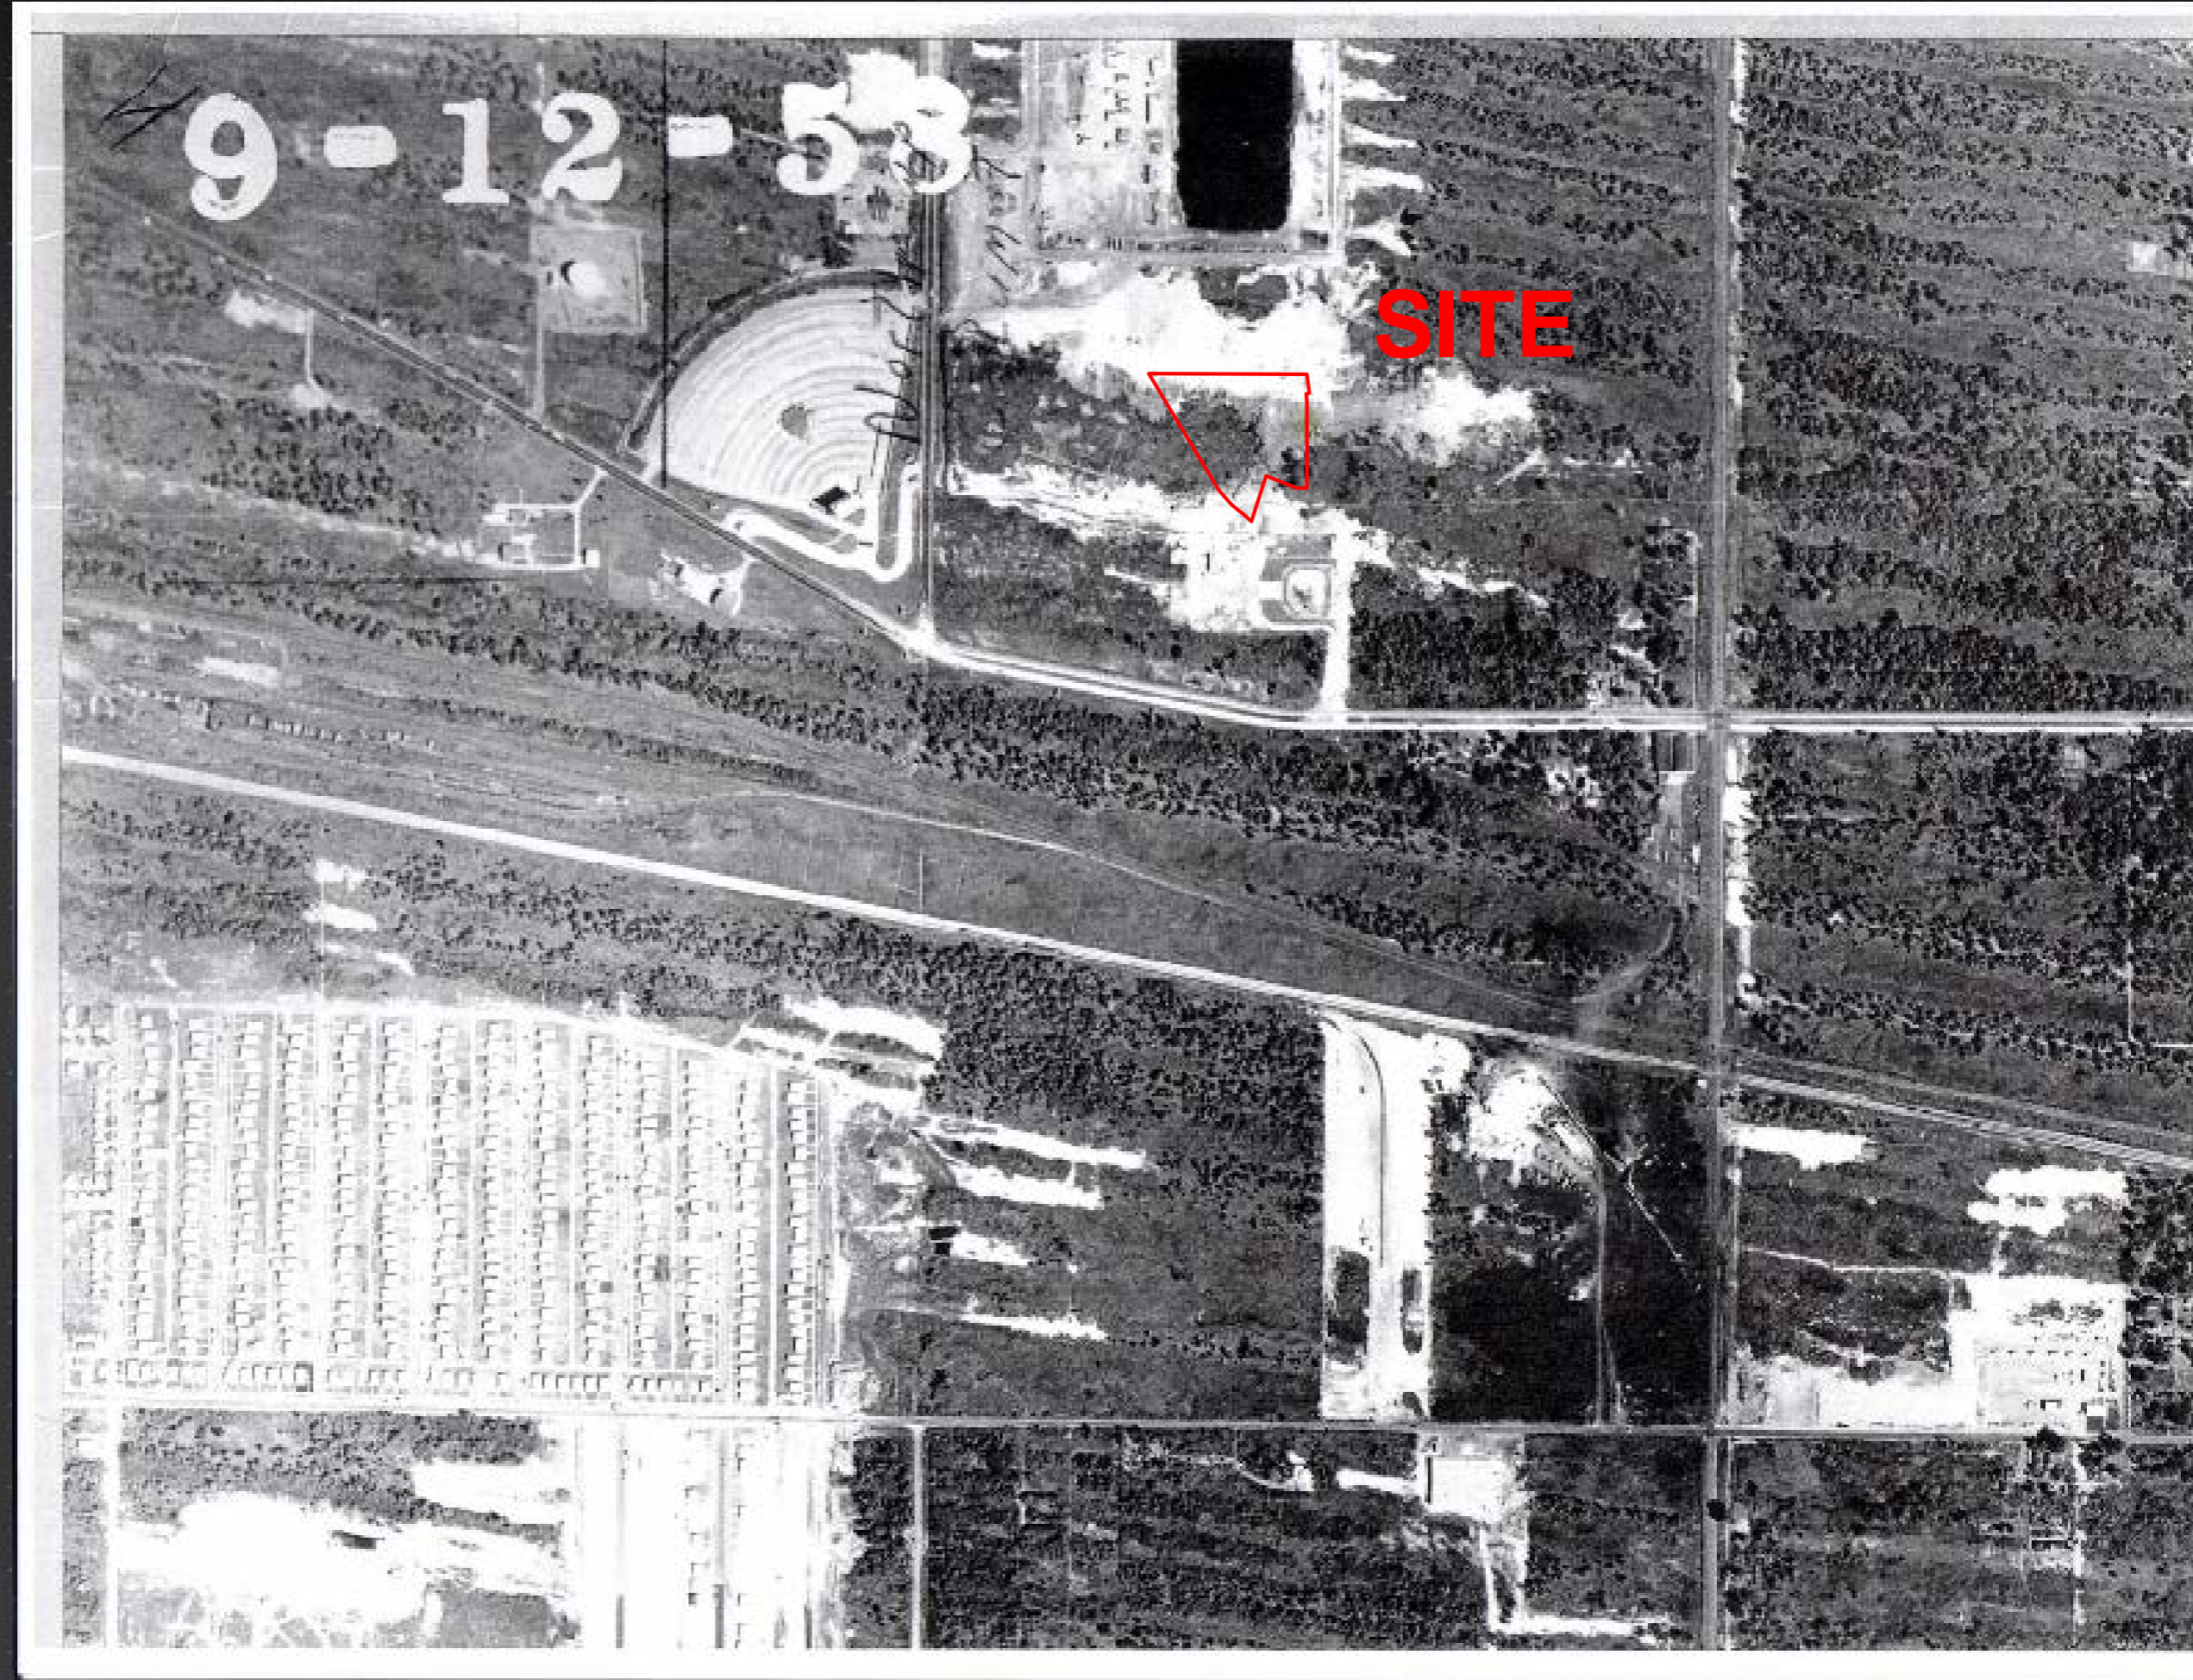
1958 Aerial of Site Region

Significant fill activity noted in area of Site.

Swale land features on the property have been filled in.

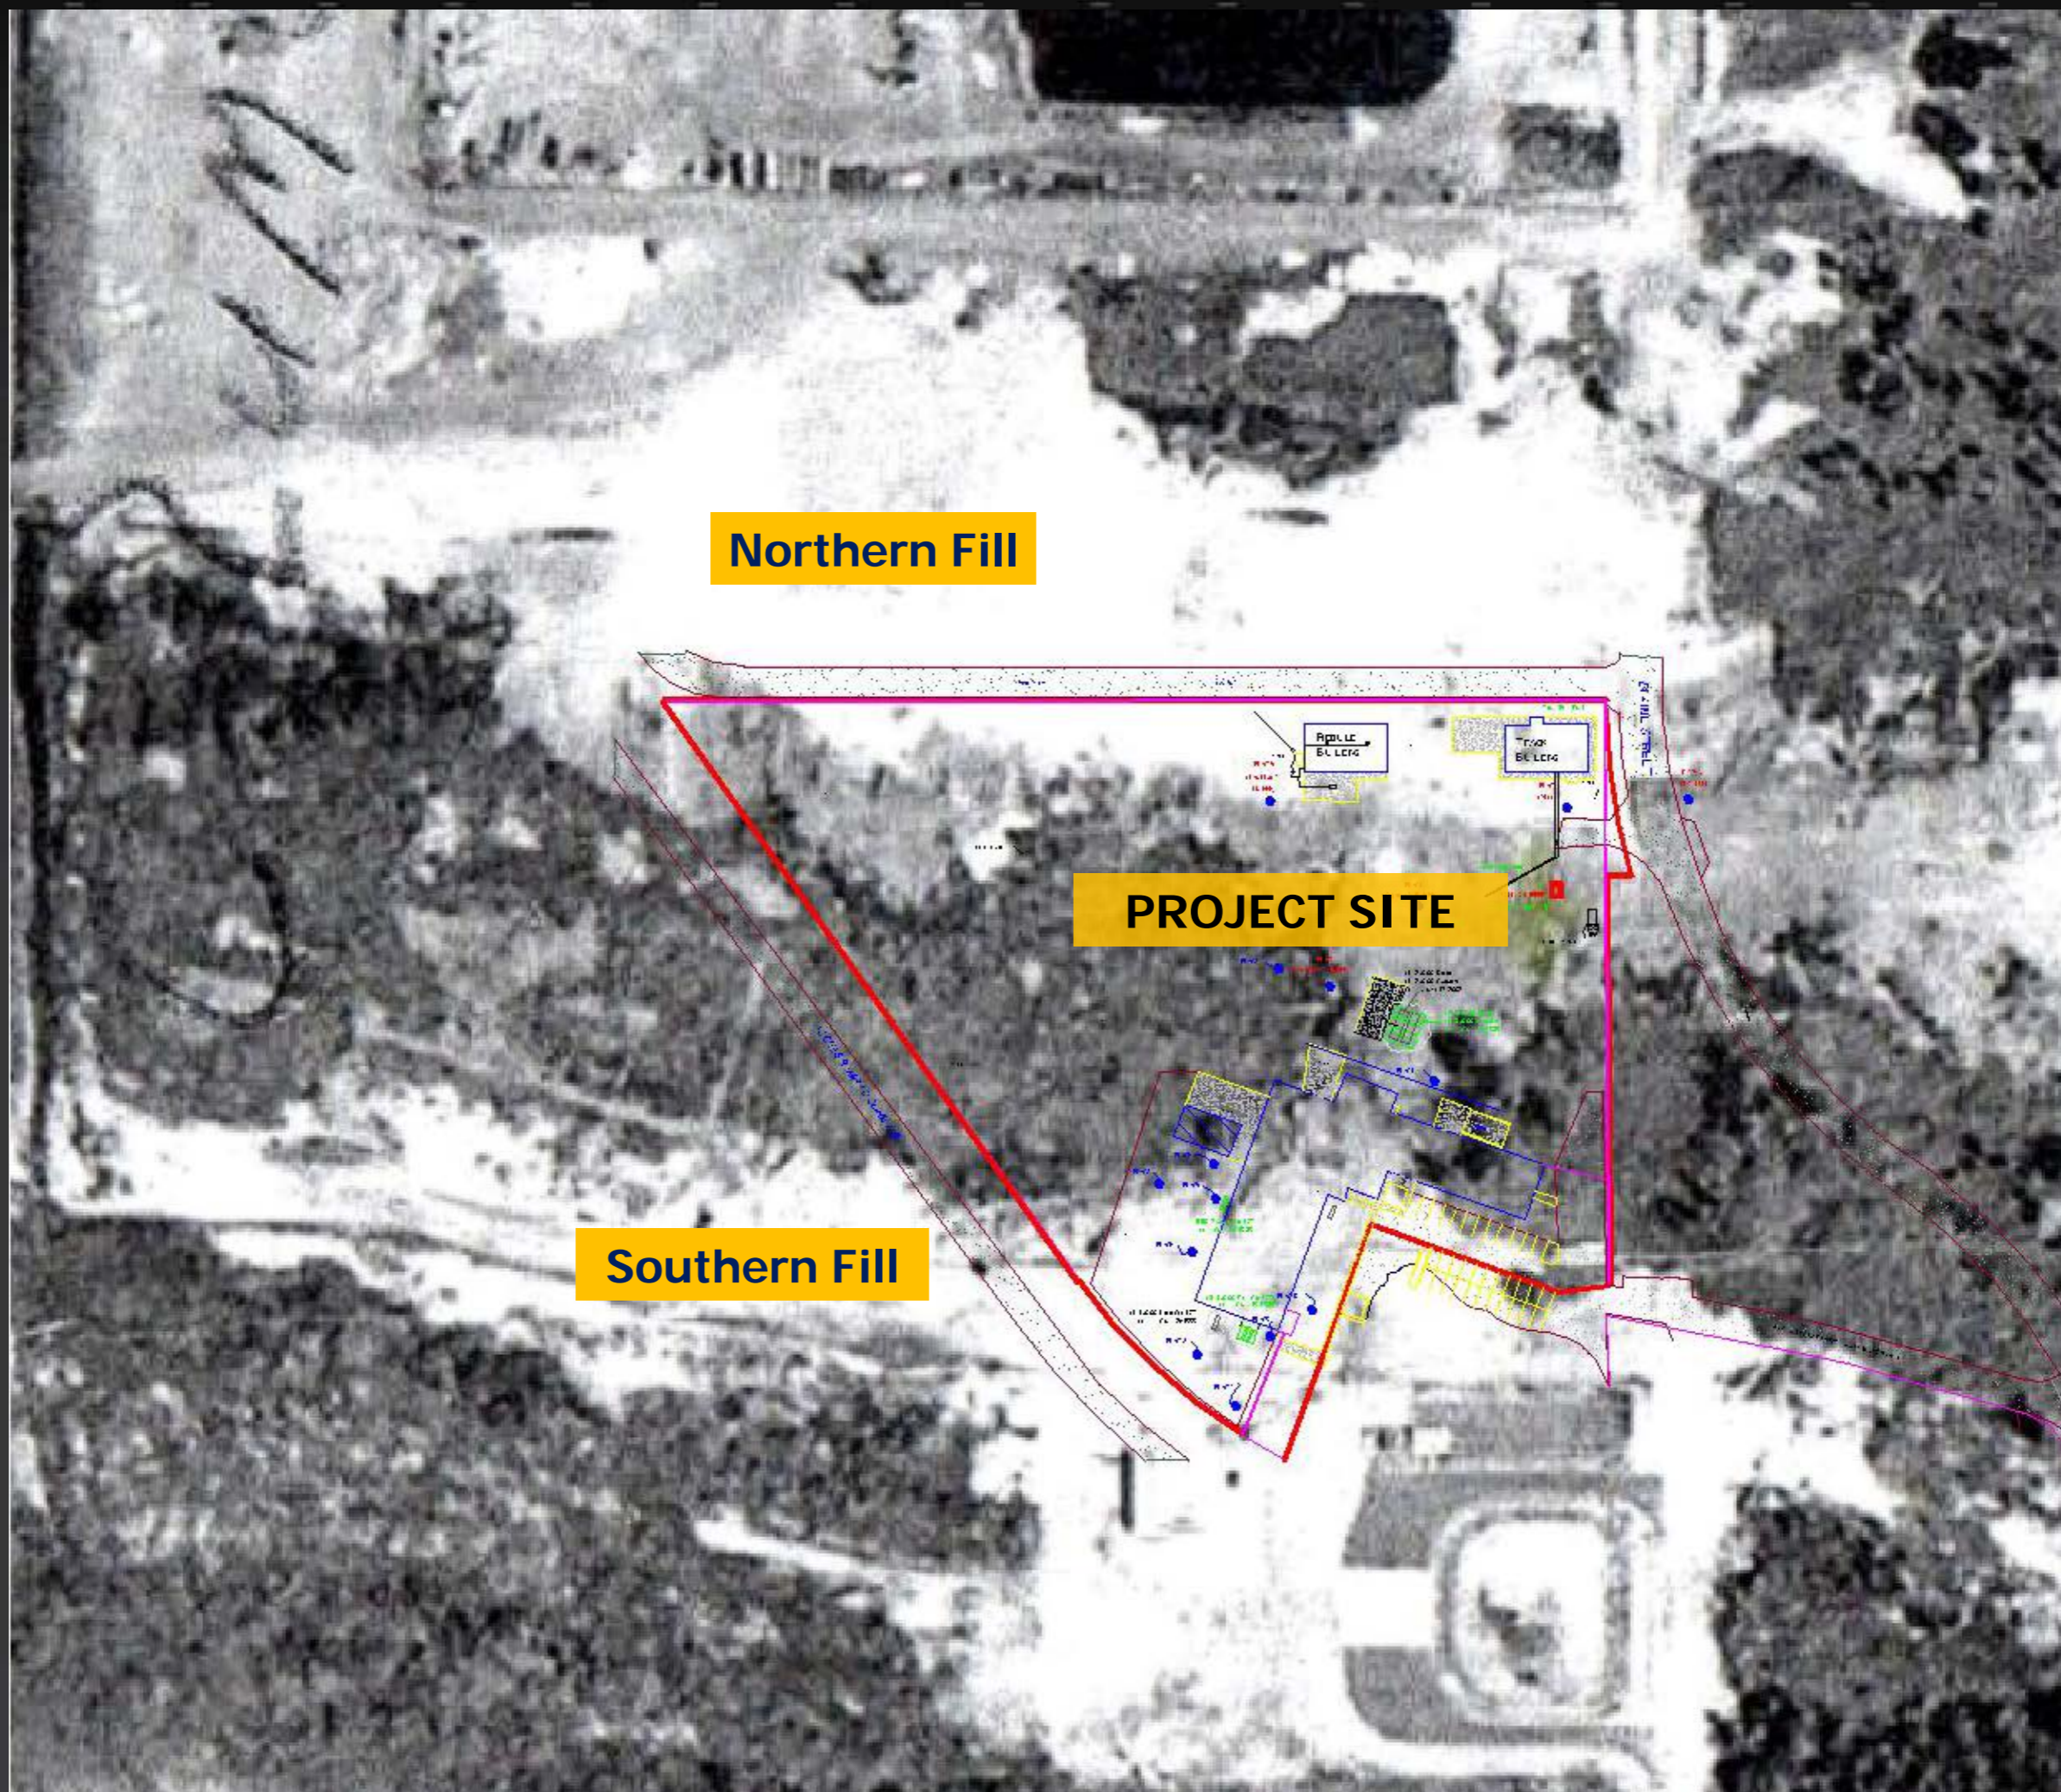
1958 Aerial Photo

(with Site
Overlay)
