# Commercial Project Management:

## Vapor Intrusion Mitigation in Large Buildings

IPEC – San Antonio, TX - 10.30.17

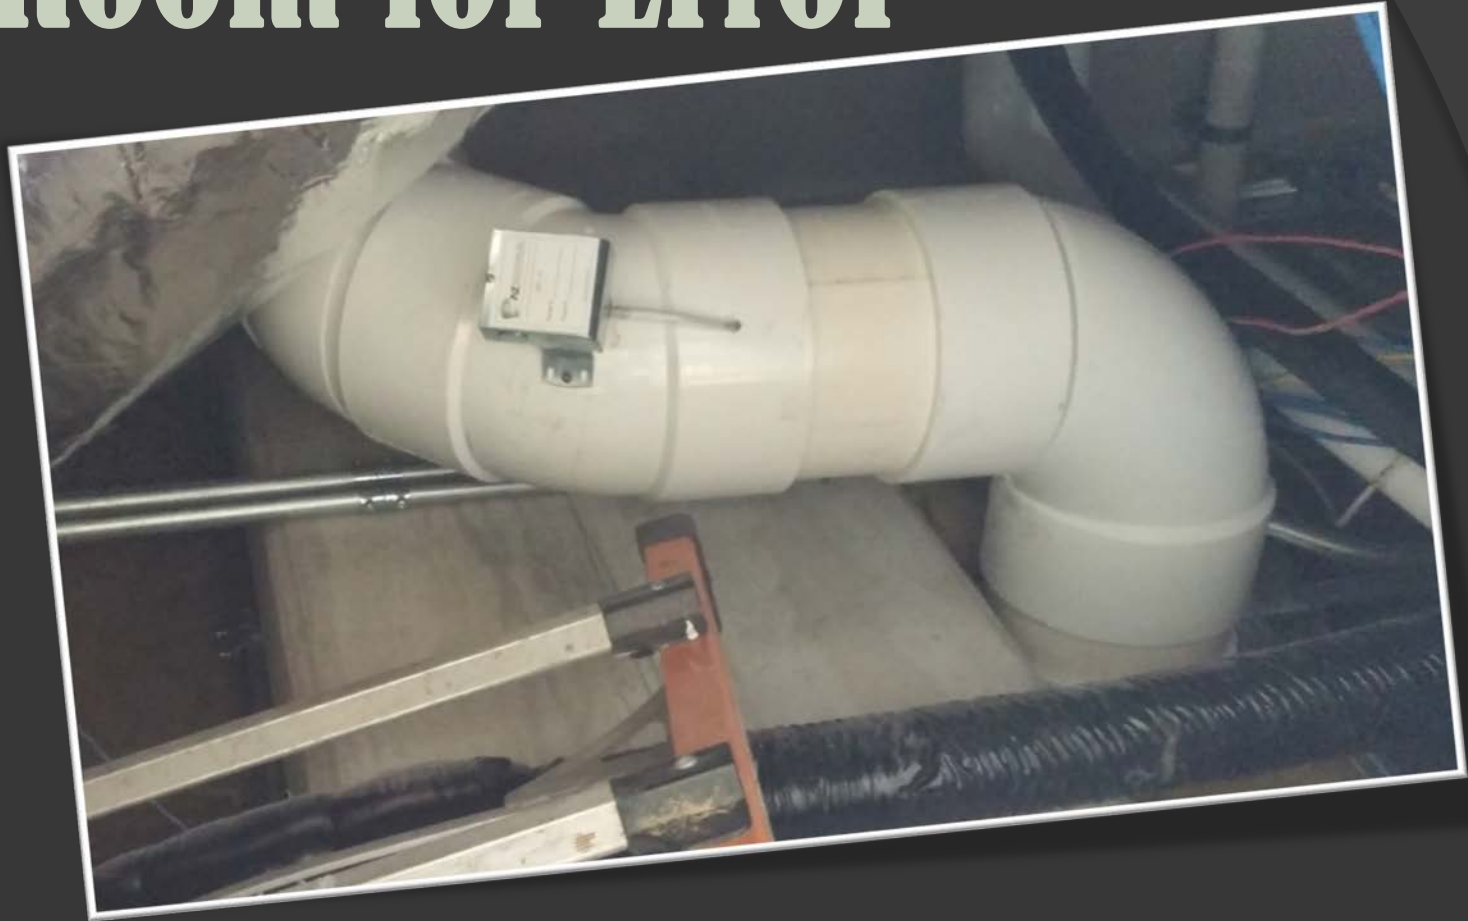
This picture shows ALL of the accessible piping on the first floor when the fans were energized.

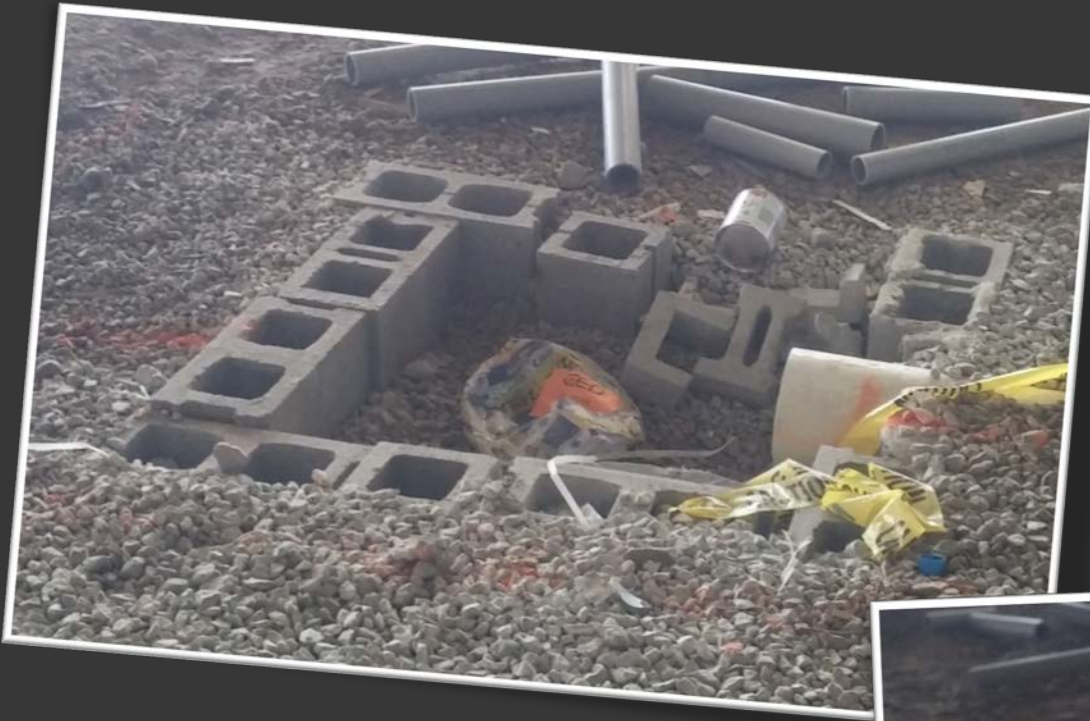
This debris was found inside a suction pit. The pit was also 6" too low and the block were mortared together.

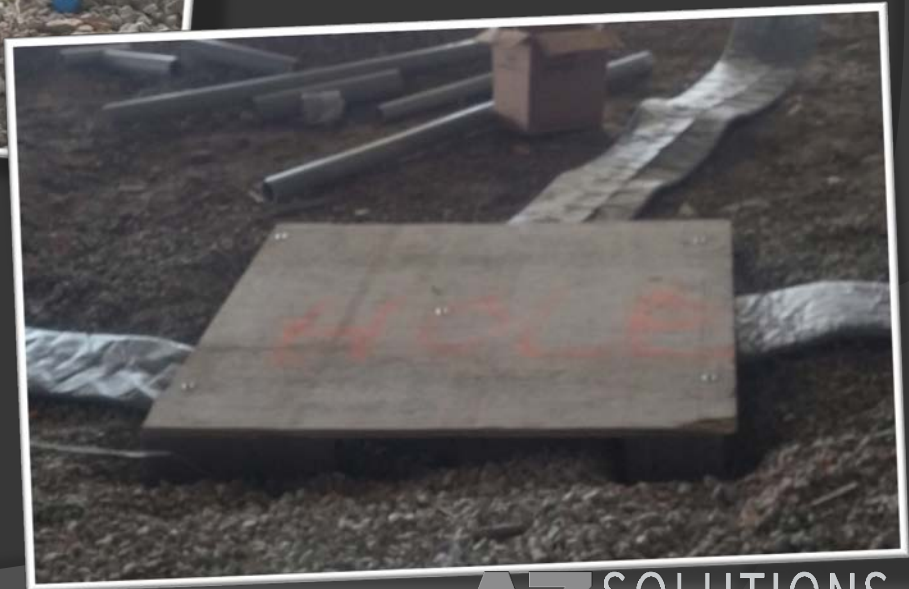
Repaired suction pit  
by A-Z at correct height.

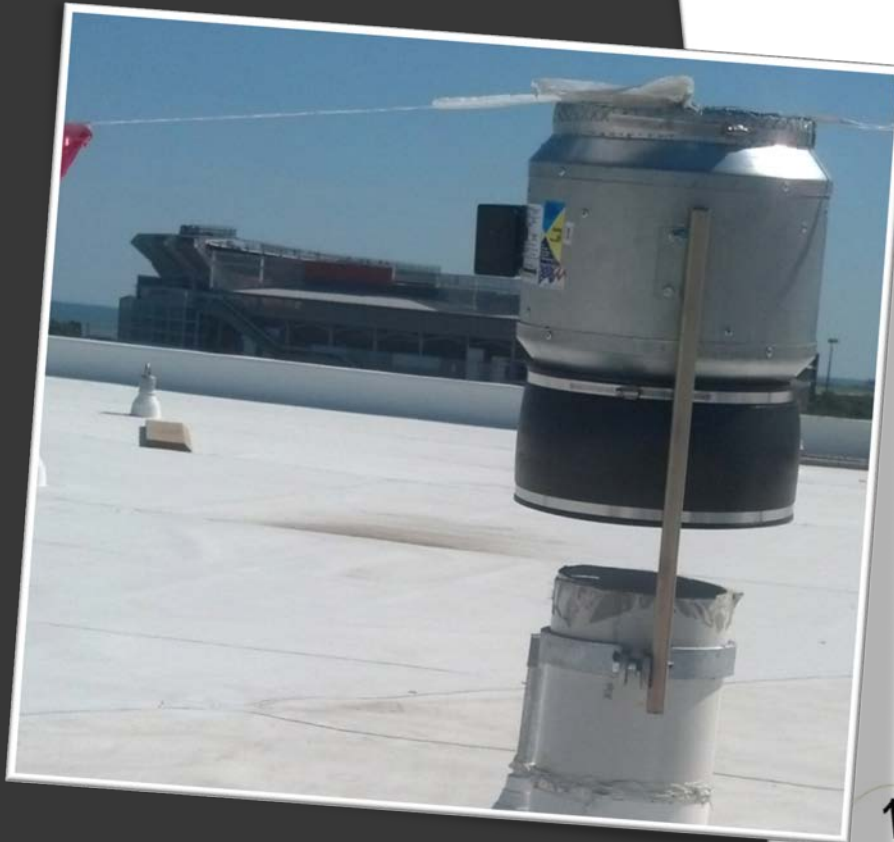
③ TYPICAL SSD SYSTEM FAN ASSEMBLY  
SCALE: 1" = 1'

TYPICAL FAN ASSEMBLY DETAIL  
SCALE: 3/4" = 1'-0"

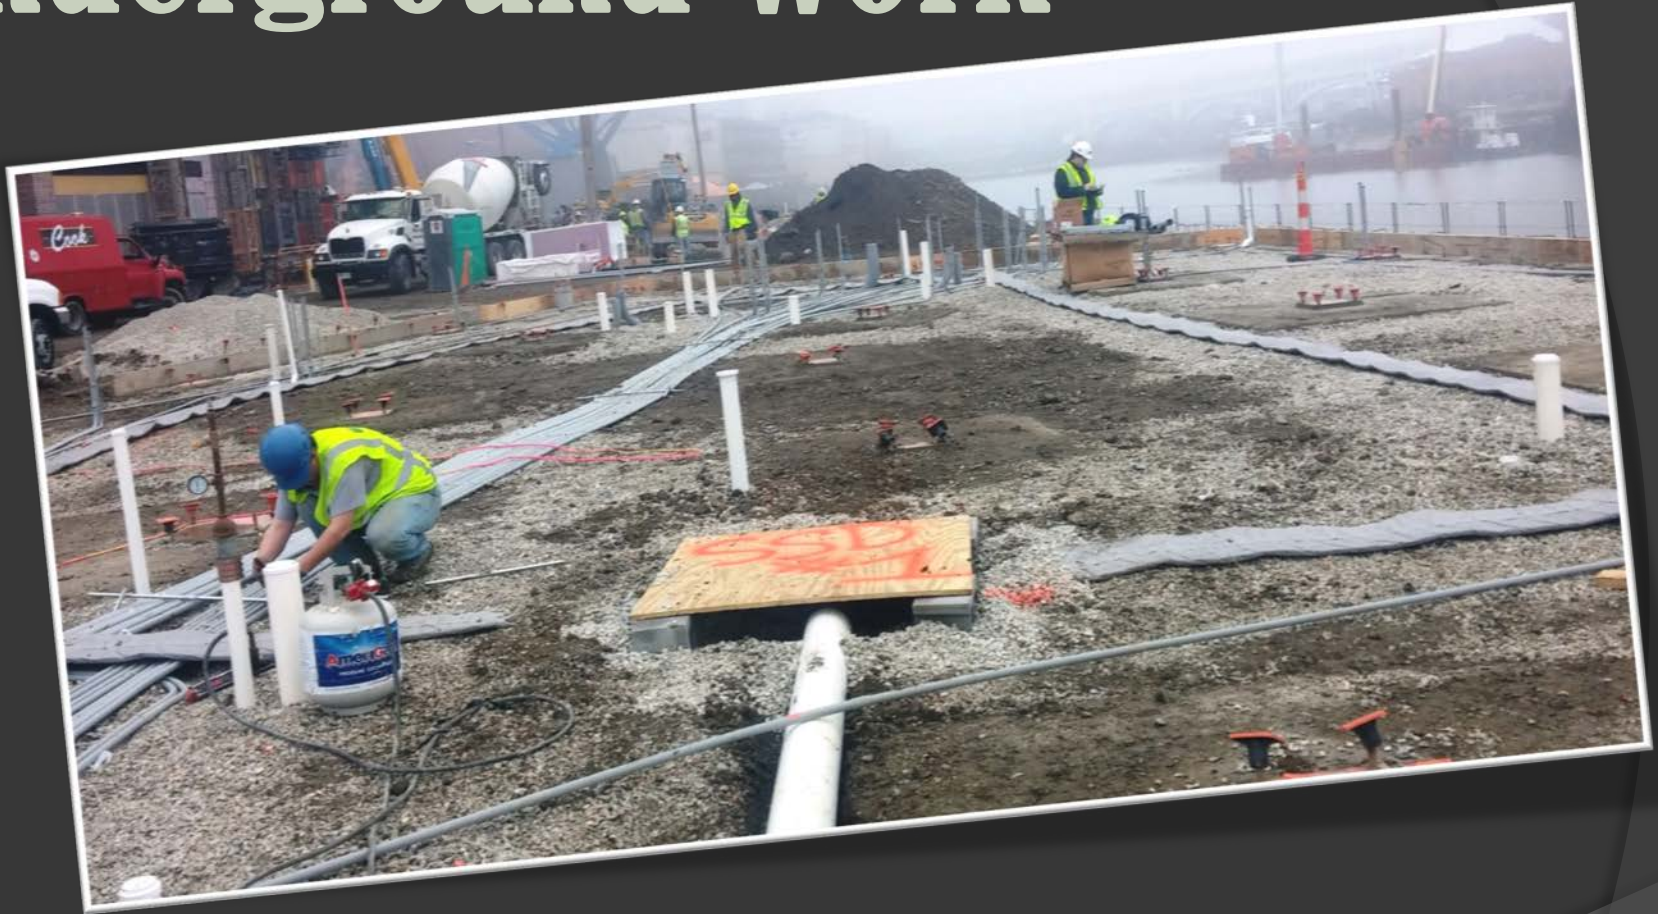
A-Z installed the undergrounds at this property. The concrete company was uncomfortable installing the system.

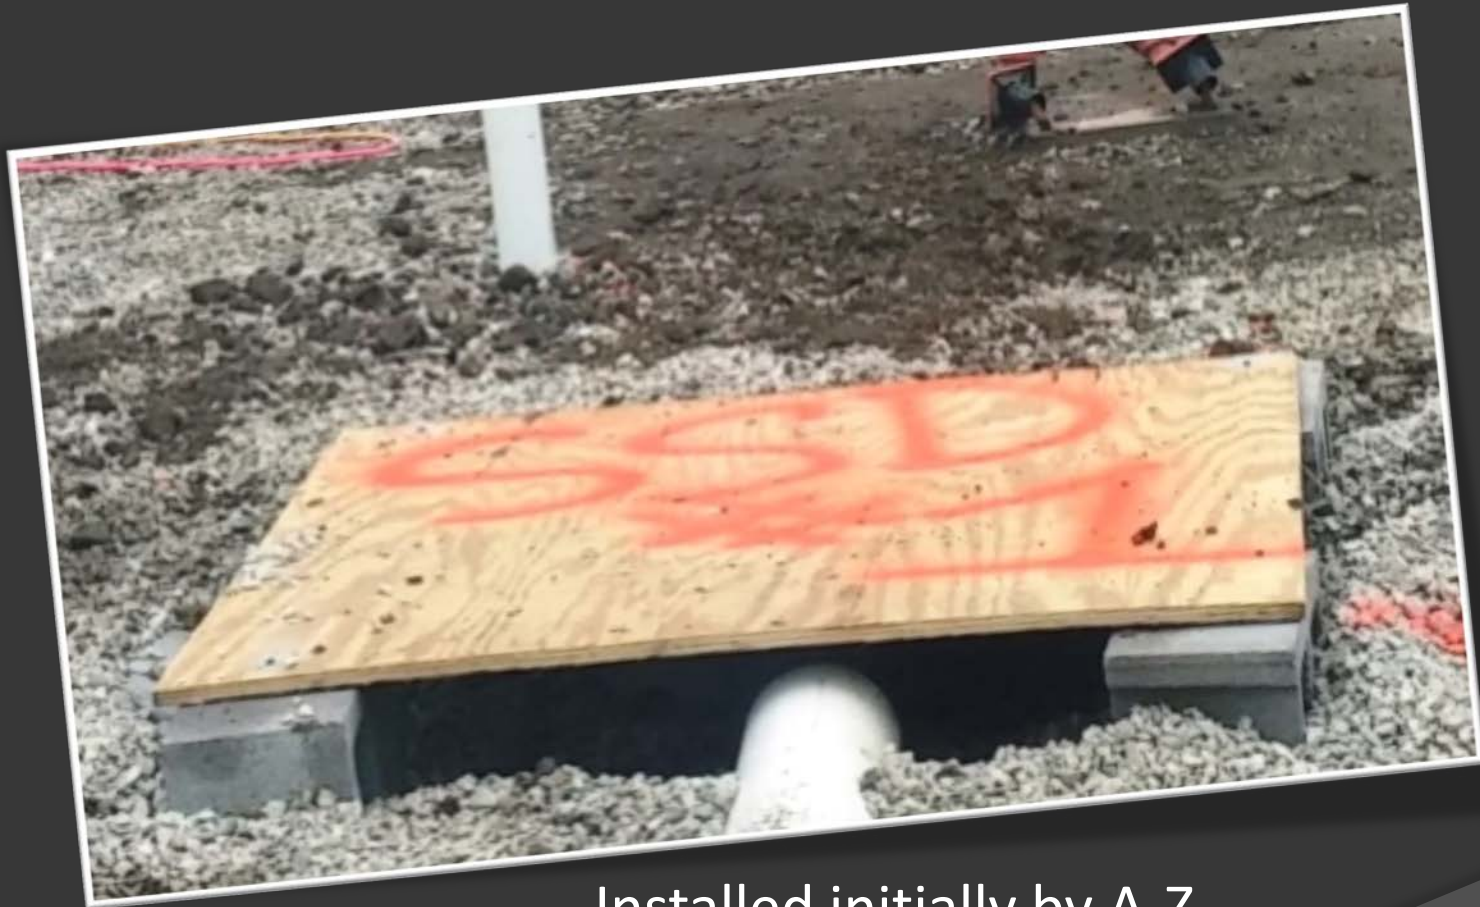
Installed initially by A-Z.

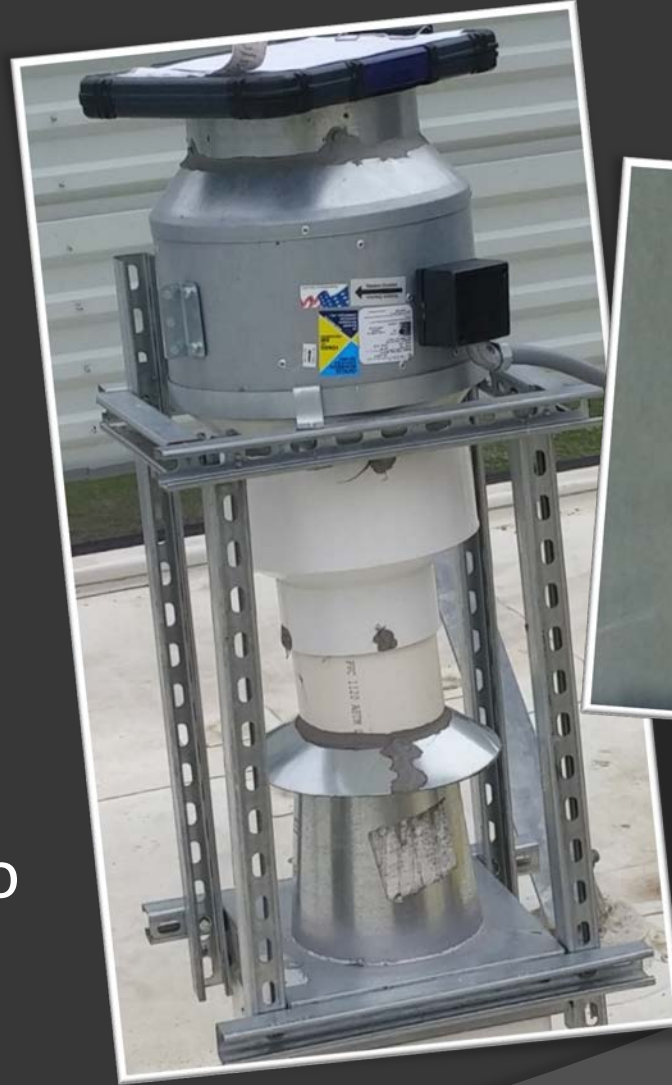
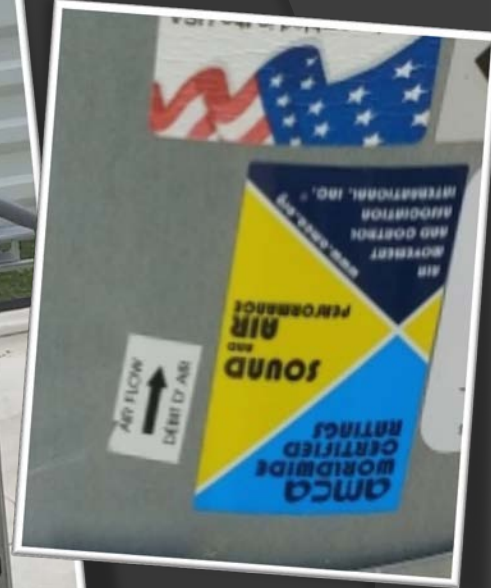
- No rubber coupling
- Wrong support assembly
- Motor seized
- Wrong size motor
- Fan upside down
- Sticker flipped over to show proper flow

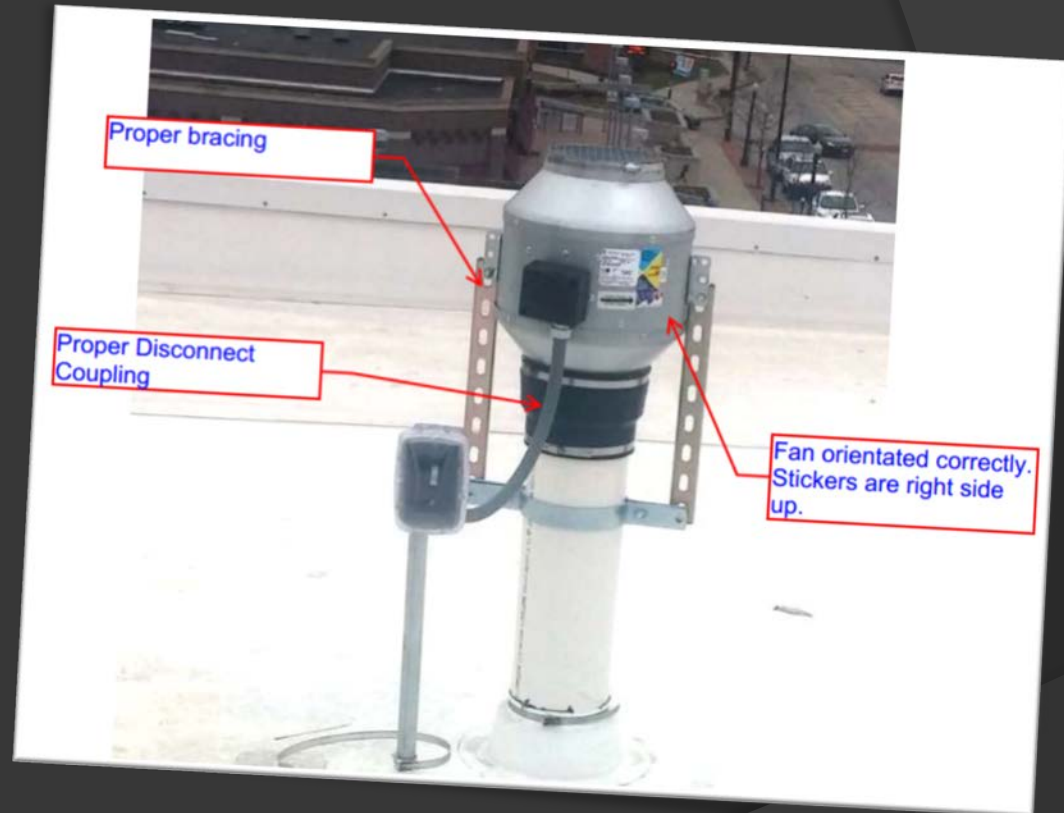
- Issued paperwork outlining necessary corrective action.
- Included this picture from previous project.

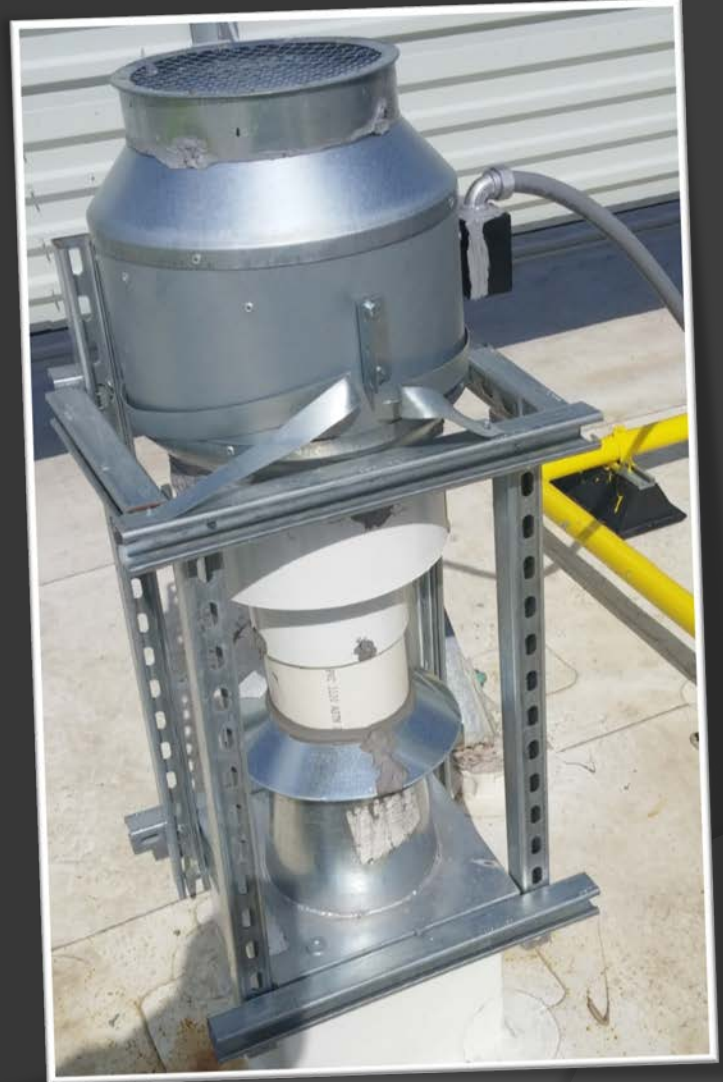
- Not much better
- New fan
  - Still wrong model
- Orientated correctly
- Still no rubber coupling
- Wrong support assembly
- Lots of caulking
