Electrokinetic Based Soil Desalinization System Achieves Closure at a Brine Contaminated Site

Christopher J. Athmer, P.E.
Terran Corporation

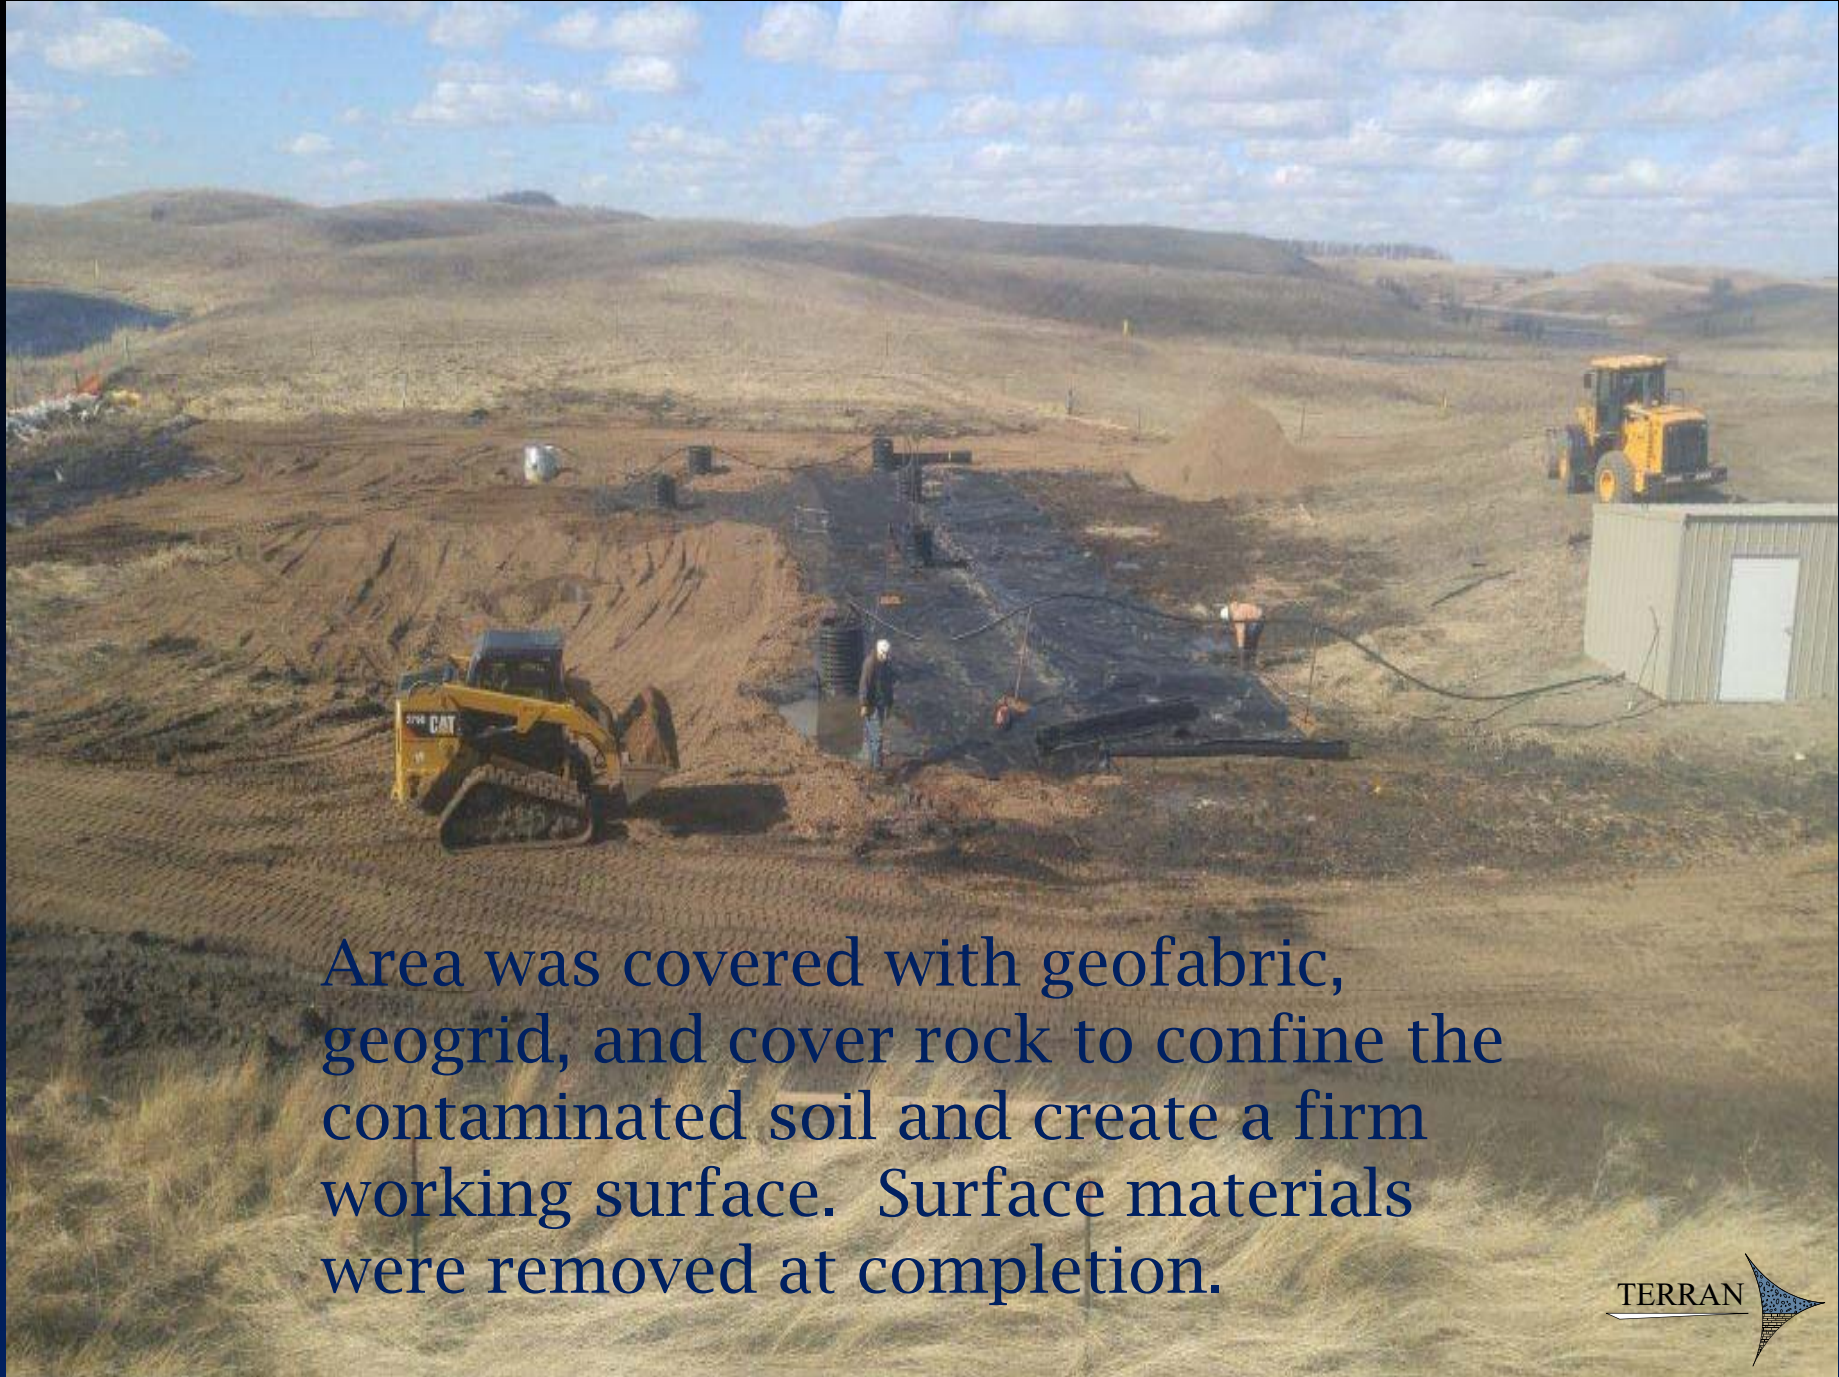
Area was covered with geofabric, geogrid, and cover rock to confine the contaminated soil and create a firm working surface. Surface materials were removed at completion.

Installation was accomplished
using a Geoprobe rig

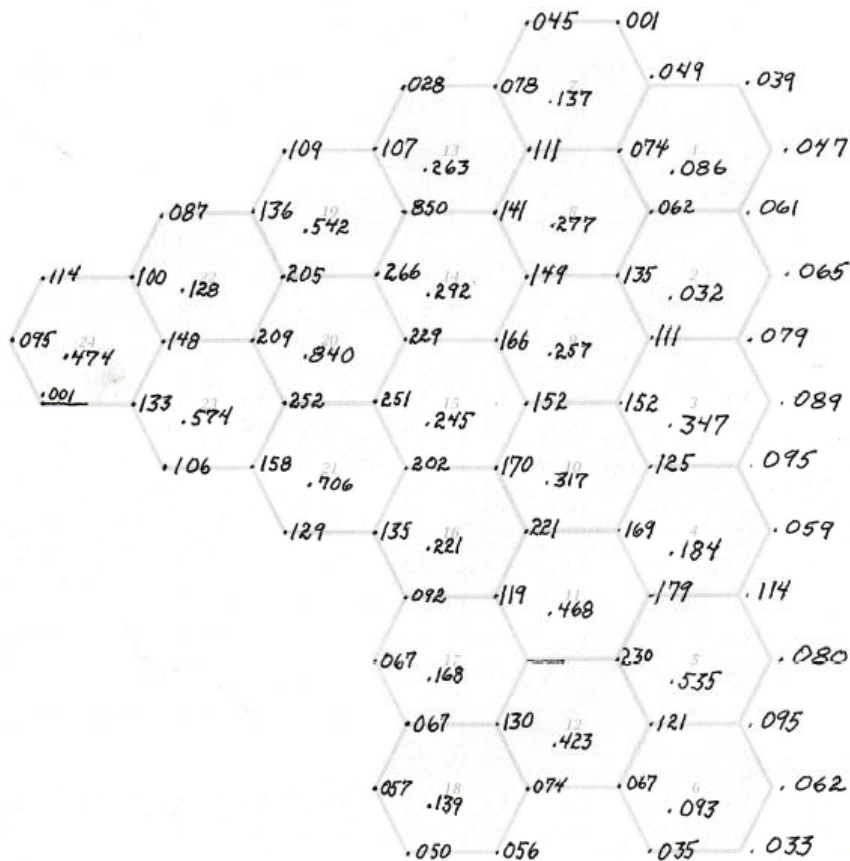
Site Current Mapping

Date 09/16/16
 Rectifier Voltage 40
 Rectifier Current 800

Current measurements were made at each electrode during operations help identify bad electrodes and general operating uniformity. (Readout is amps/100)

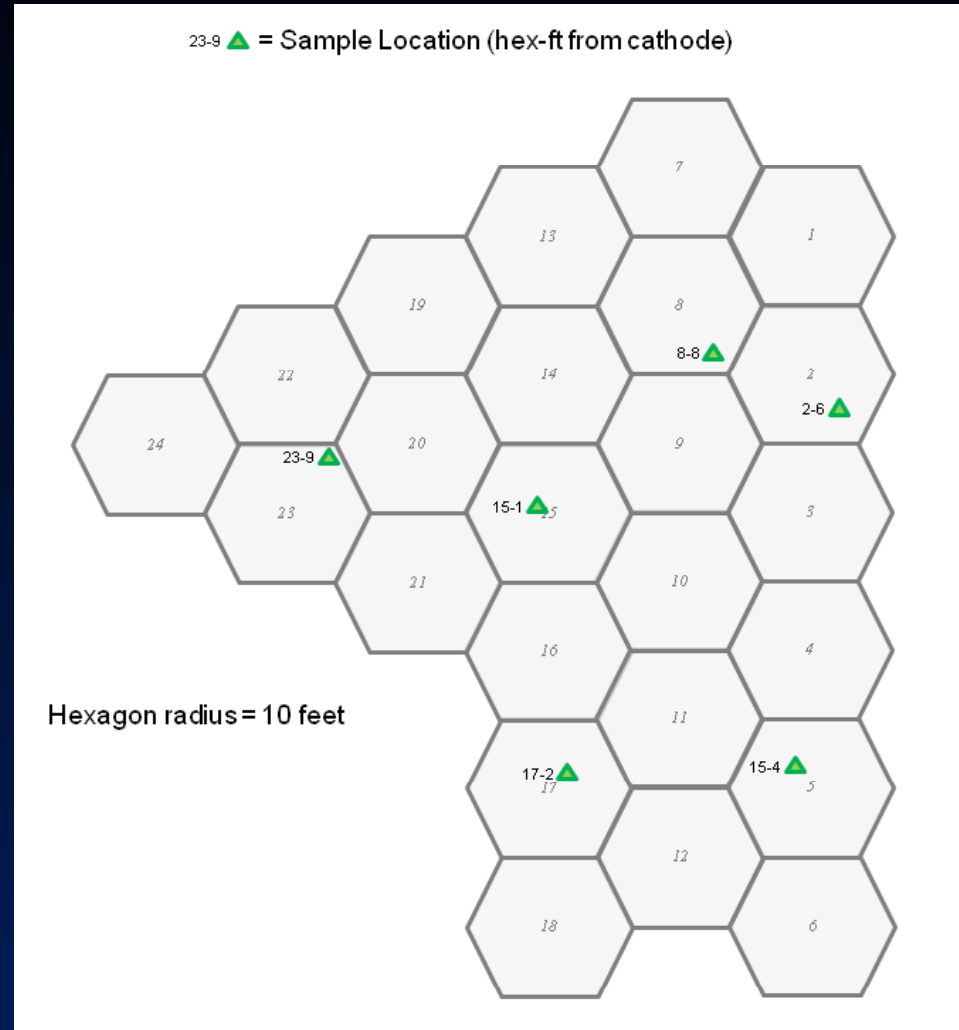
Soil Sampling Locations

Matched samples collected
before and during operations
(6 locations, 2 depths, n=12)

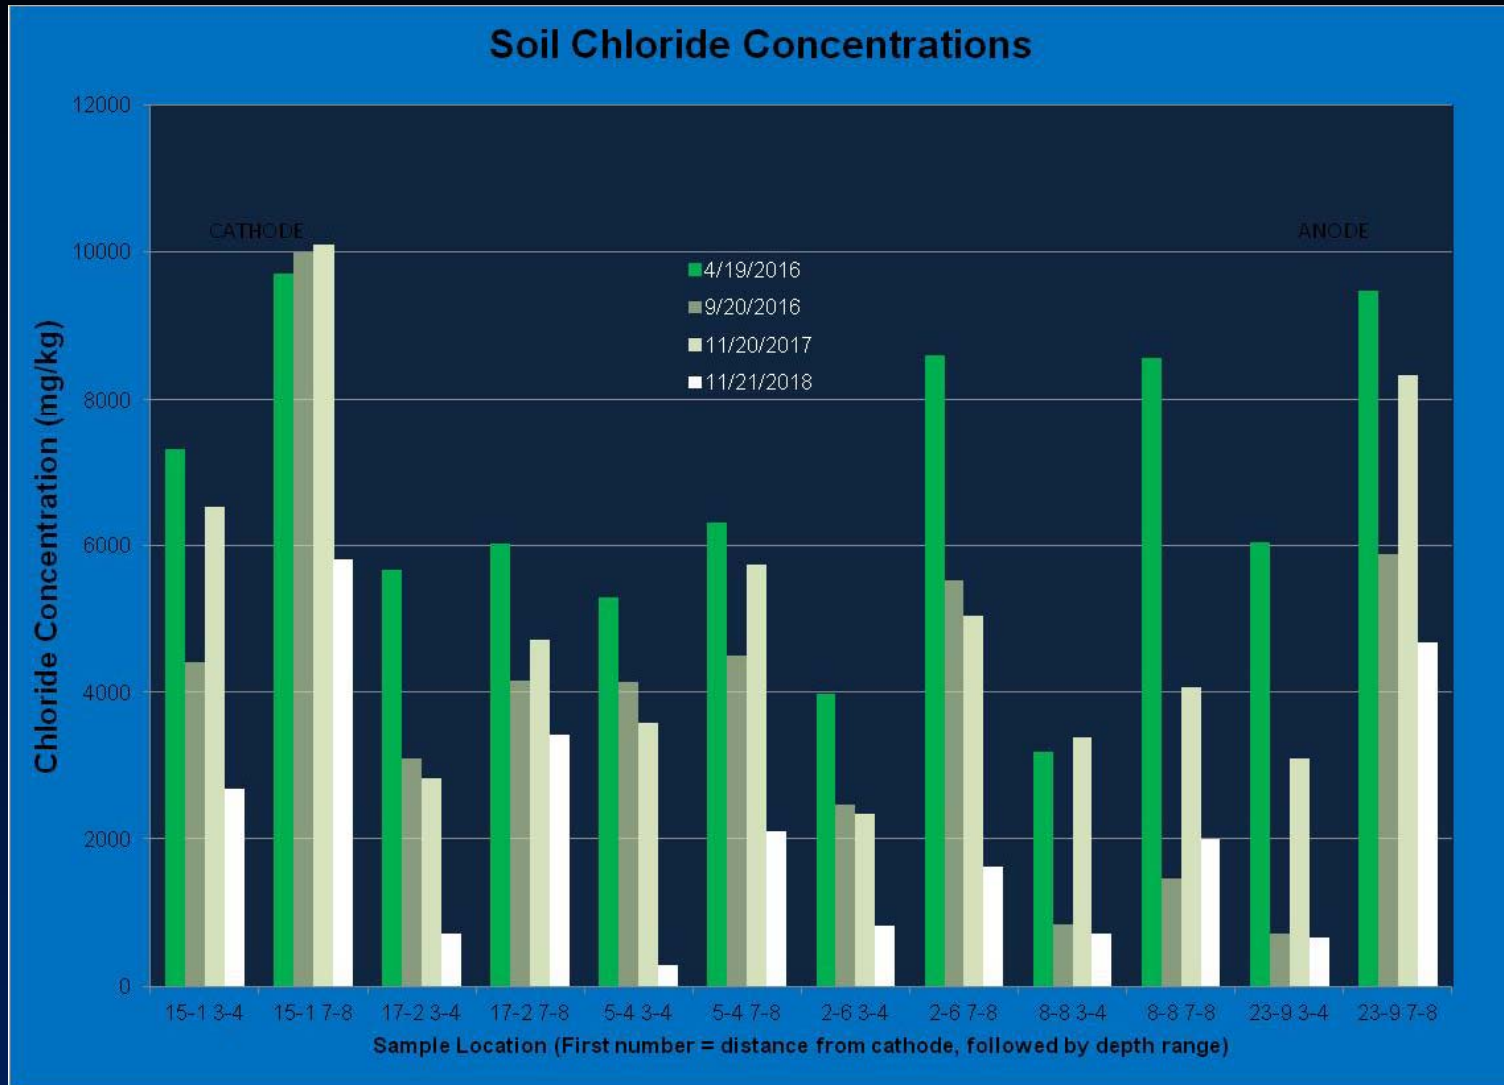
Chloride Soil Data

- For the 3rd summer (2018), the electrode conductors were replaced and operations went much smoother.
 - November 2018 results show an overall 68% removal – very close to the target of 70-80%.
 - **Site Closure was granted by the North Dakota Department of Health.**

- First summer (2016) operations went well: Removal after 1st summer was 41%.
- Poor electrode operations during second summer contributed to lower rates. July 2017 interim samples showed 47% removal. Conductance and EM surveys confirmed reductions.
- Results for November 2017 sampling indicated a regress to only 25% removal ????.
 - 2017 was a dry year and water was brought in to hydrate the electrodes and a reverse-pulse was attempted.
