# Innovative Techniques for Site Characterization and Remediation of Brine Impacted Soils

Jonathan B. Ellingson  
Terracon Consultants Inc.  
West Fargo, North Dakota

# North Dakota Industrial Commission RFP 405.2-17-010 – June 15, 2017 Brine Pond Remediation Techniques

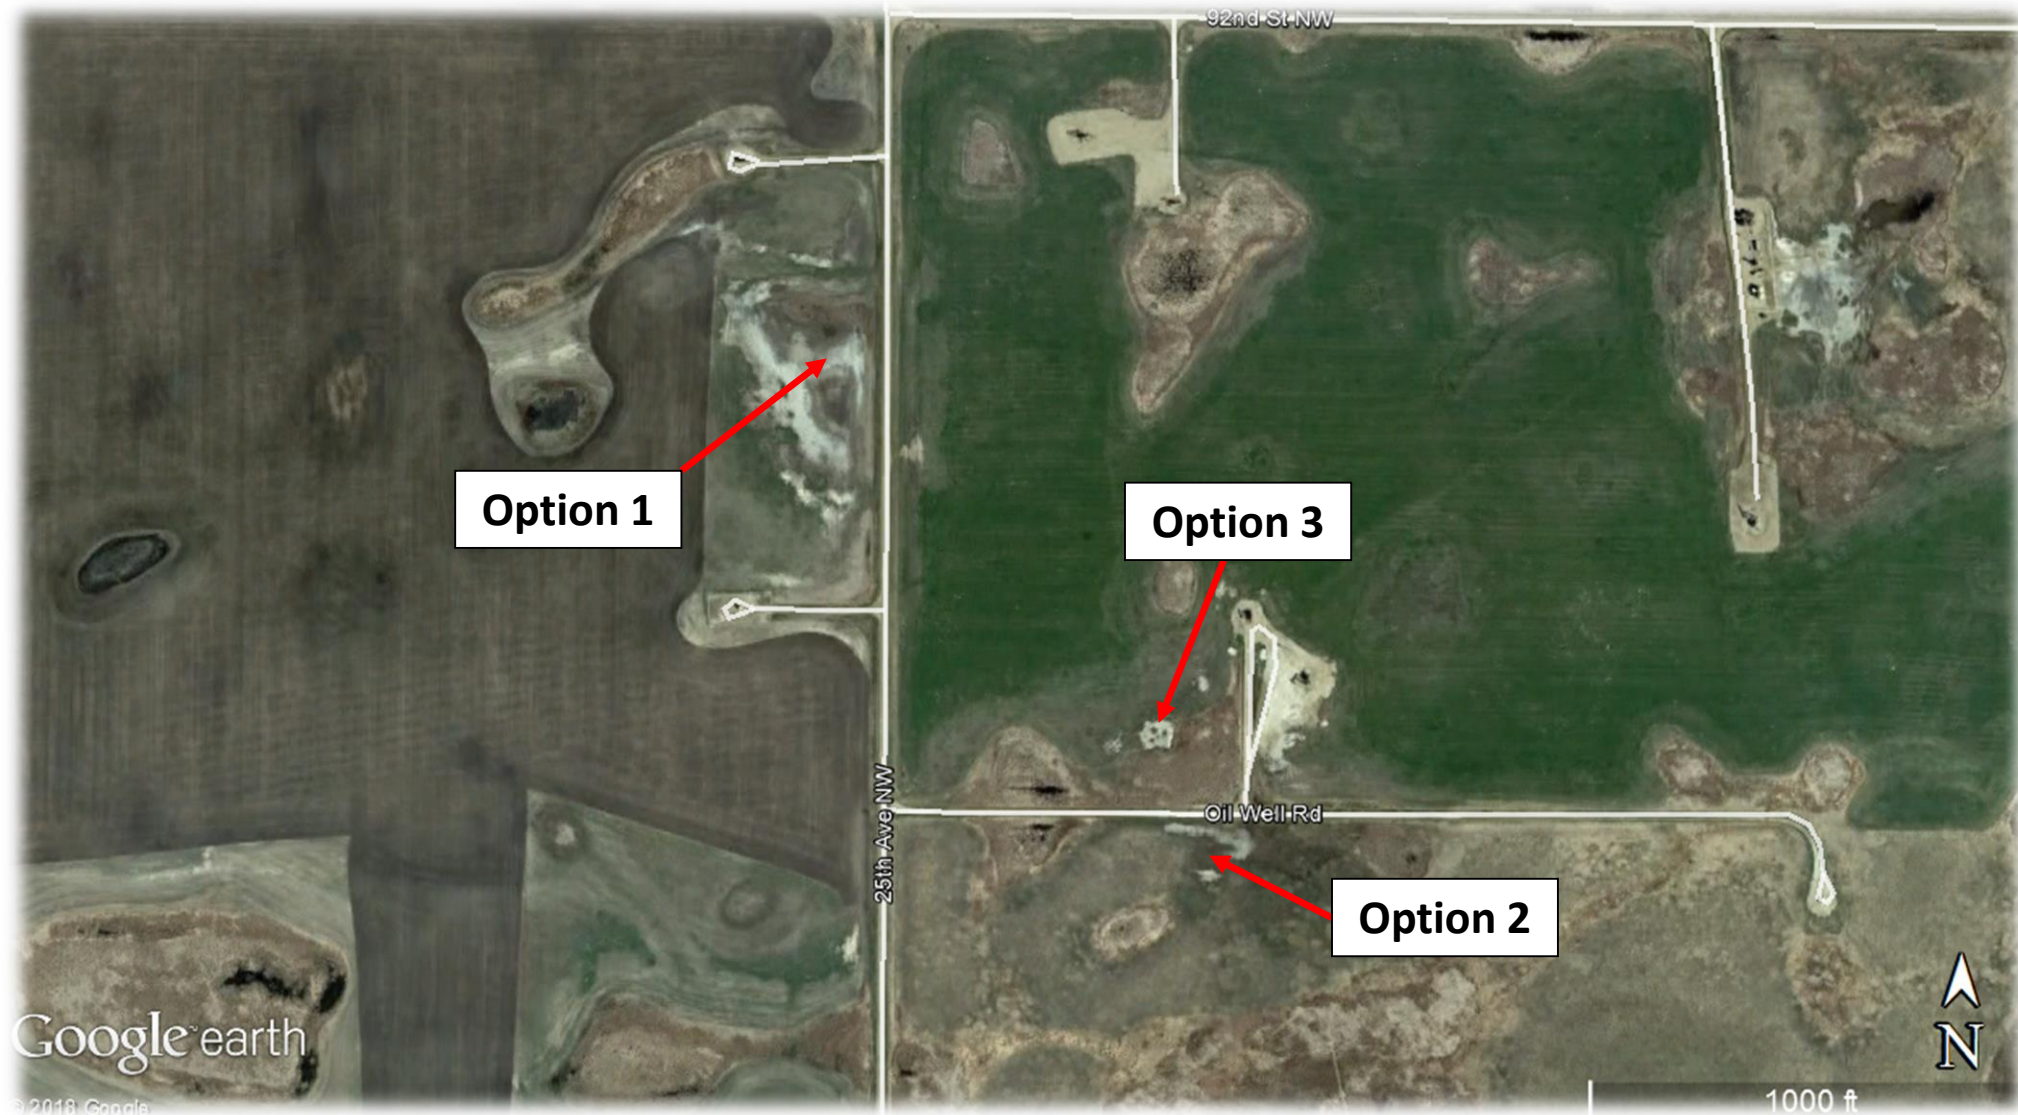
Options Image from Google Earth™ May 2016

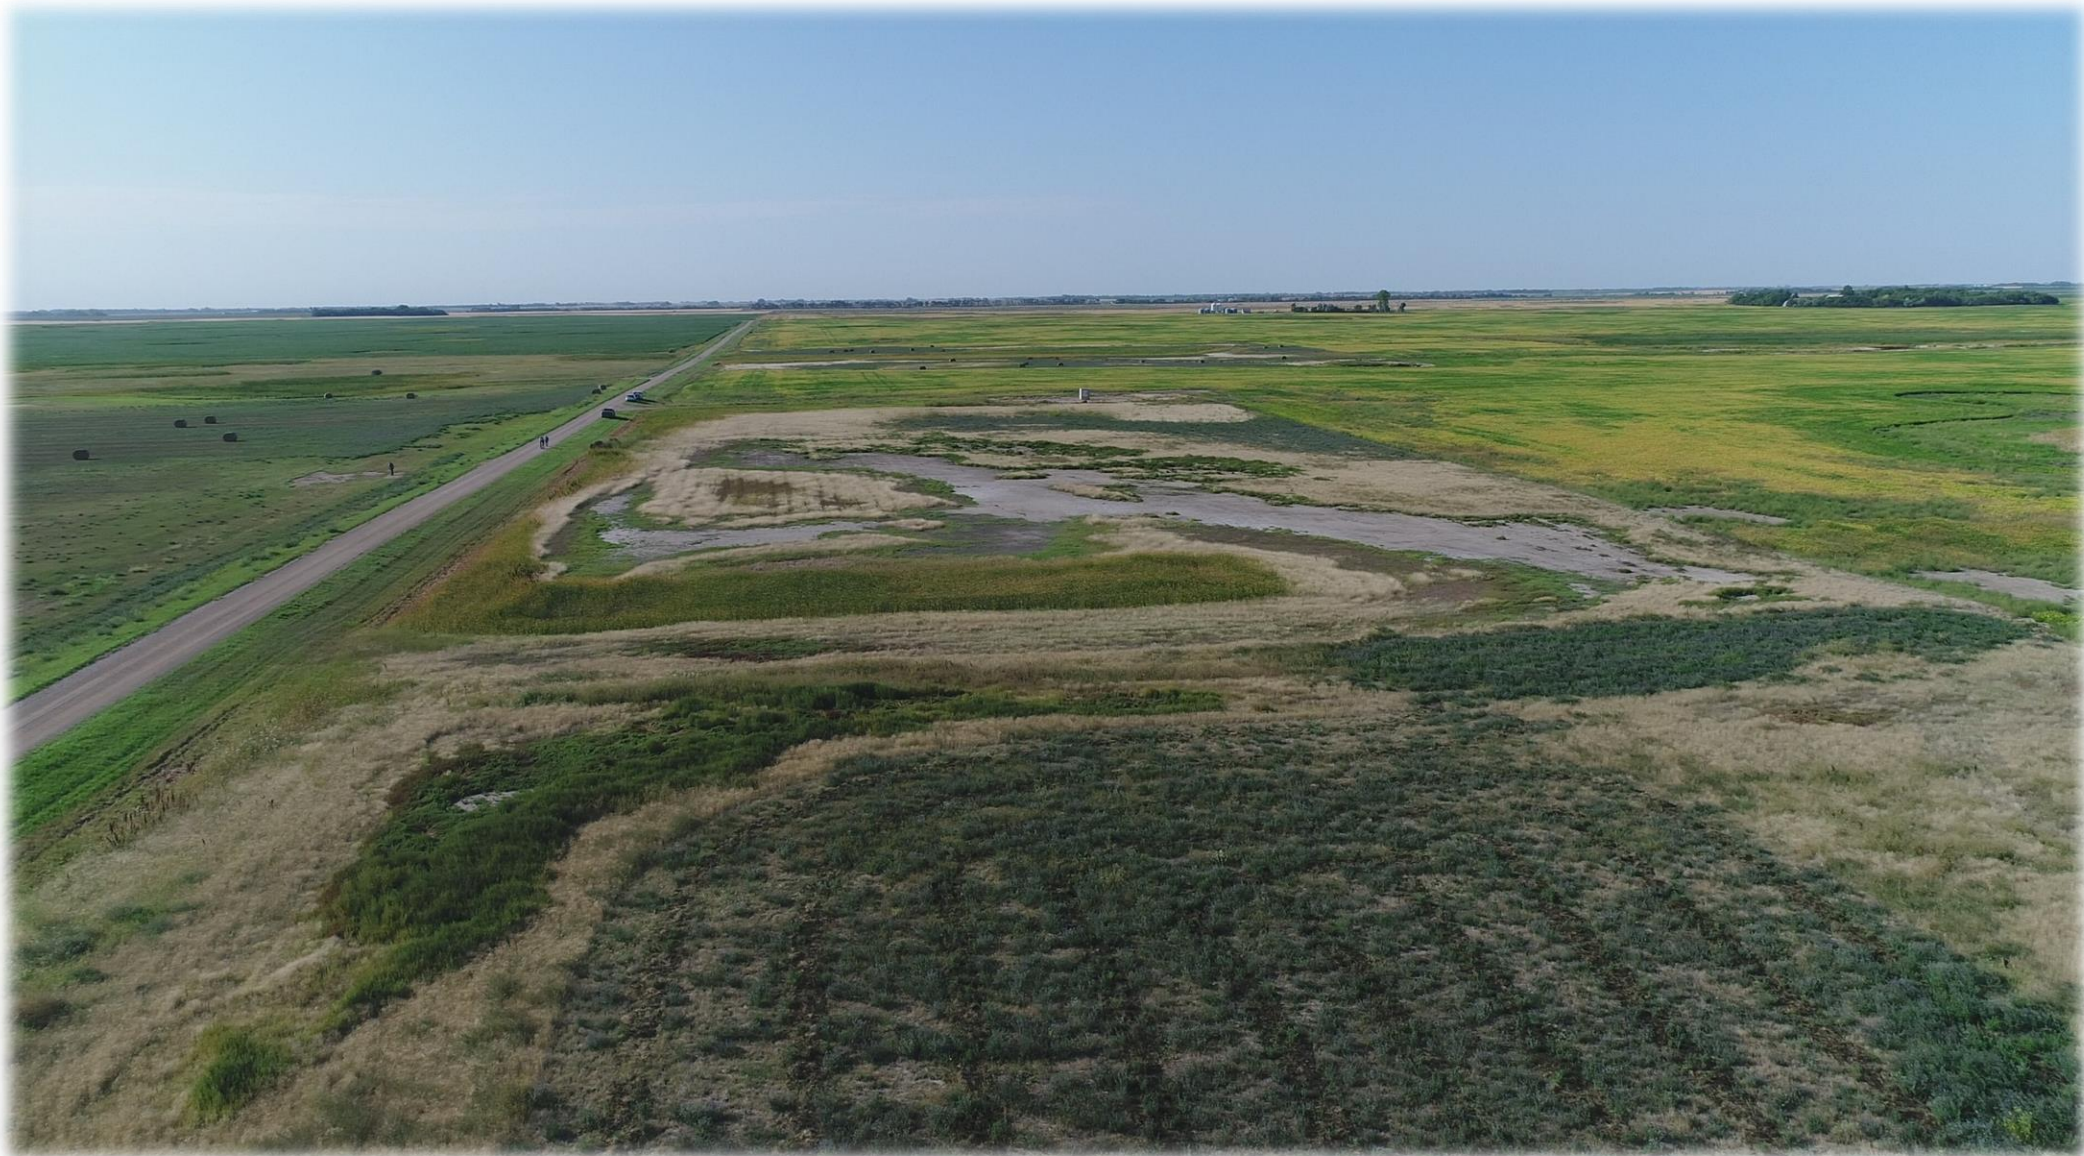
North of Site Looking South Prior to Field Work

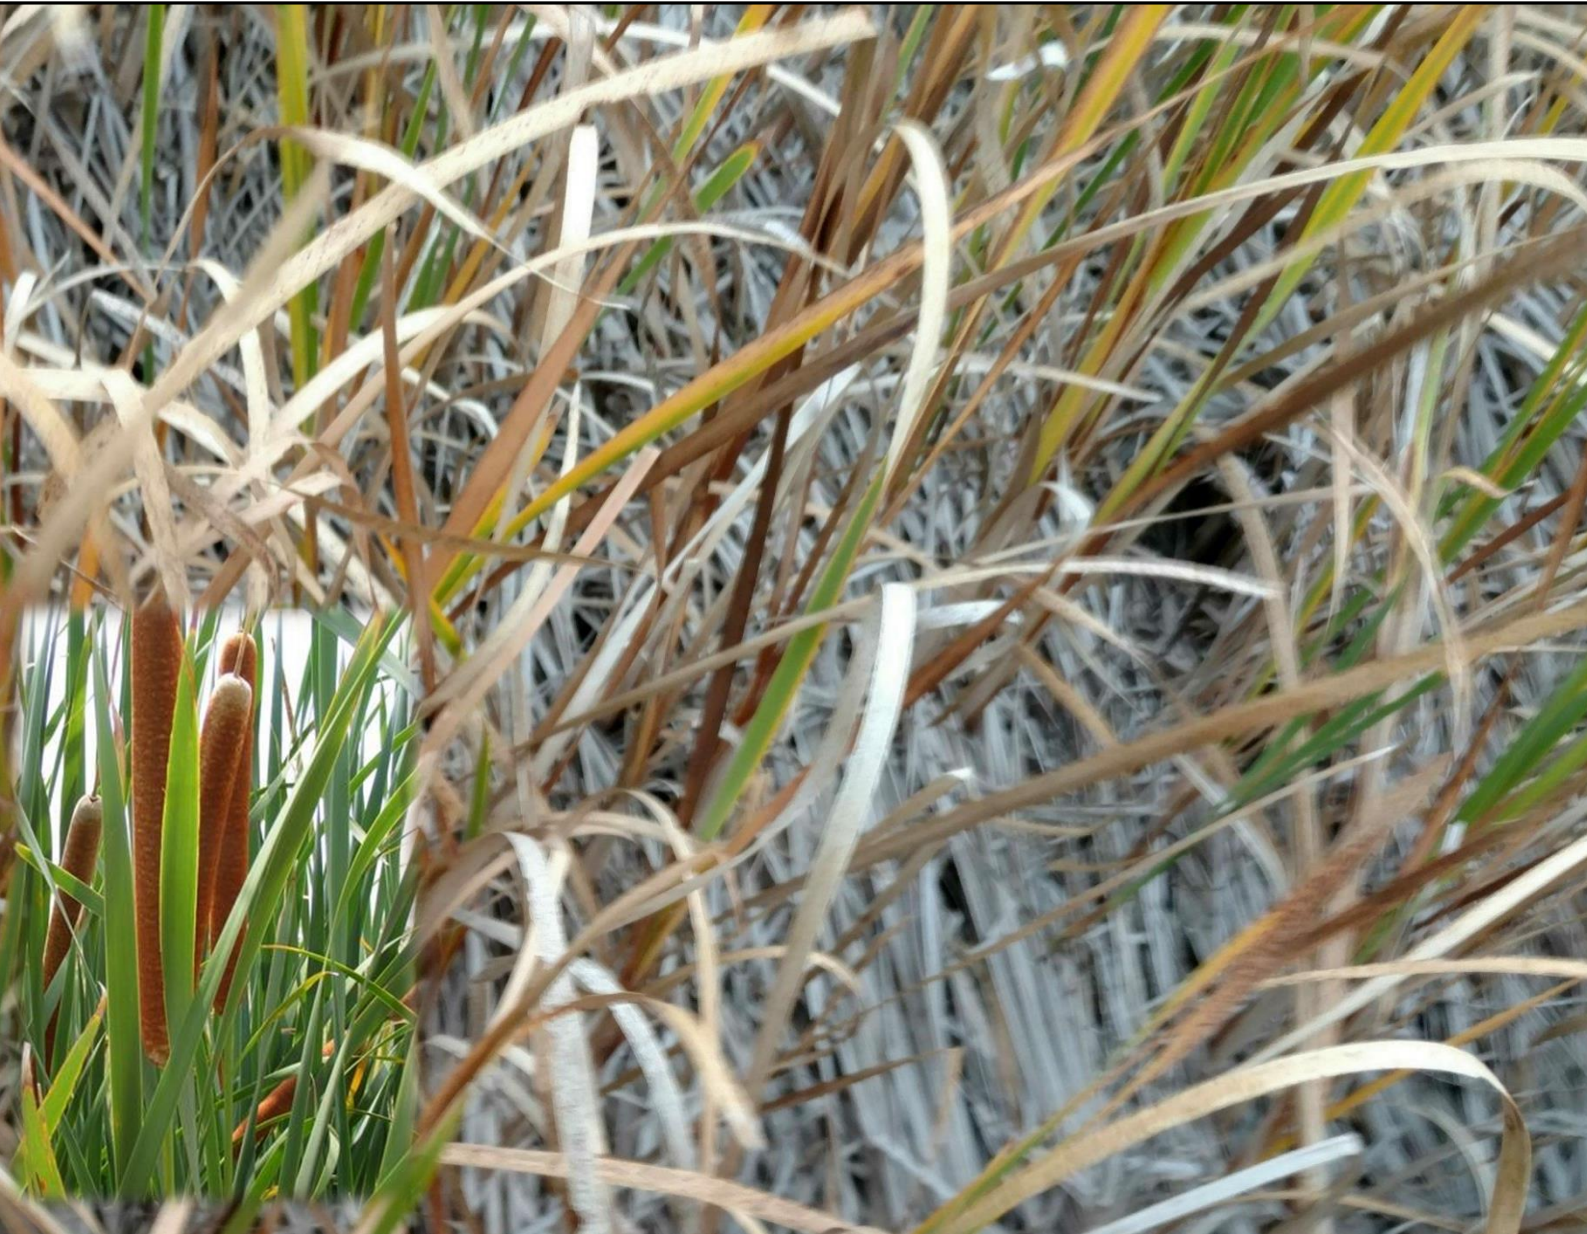
# Narrow-leaf Cattail (*Typha angustifolia*)

Surface = 2,200  $\mu\text{S}/\text{cm}$

Surface - 12" = 2,300  $\mu\text{S}/\text{cm}$

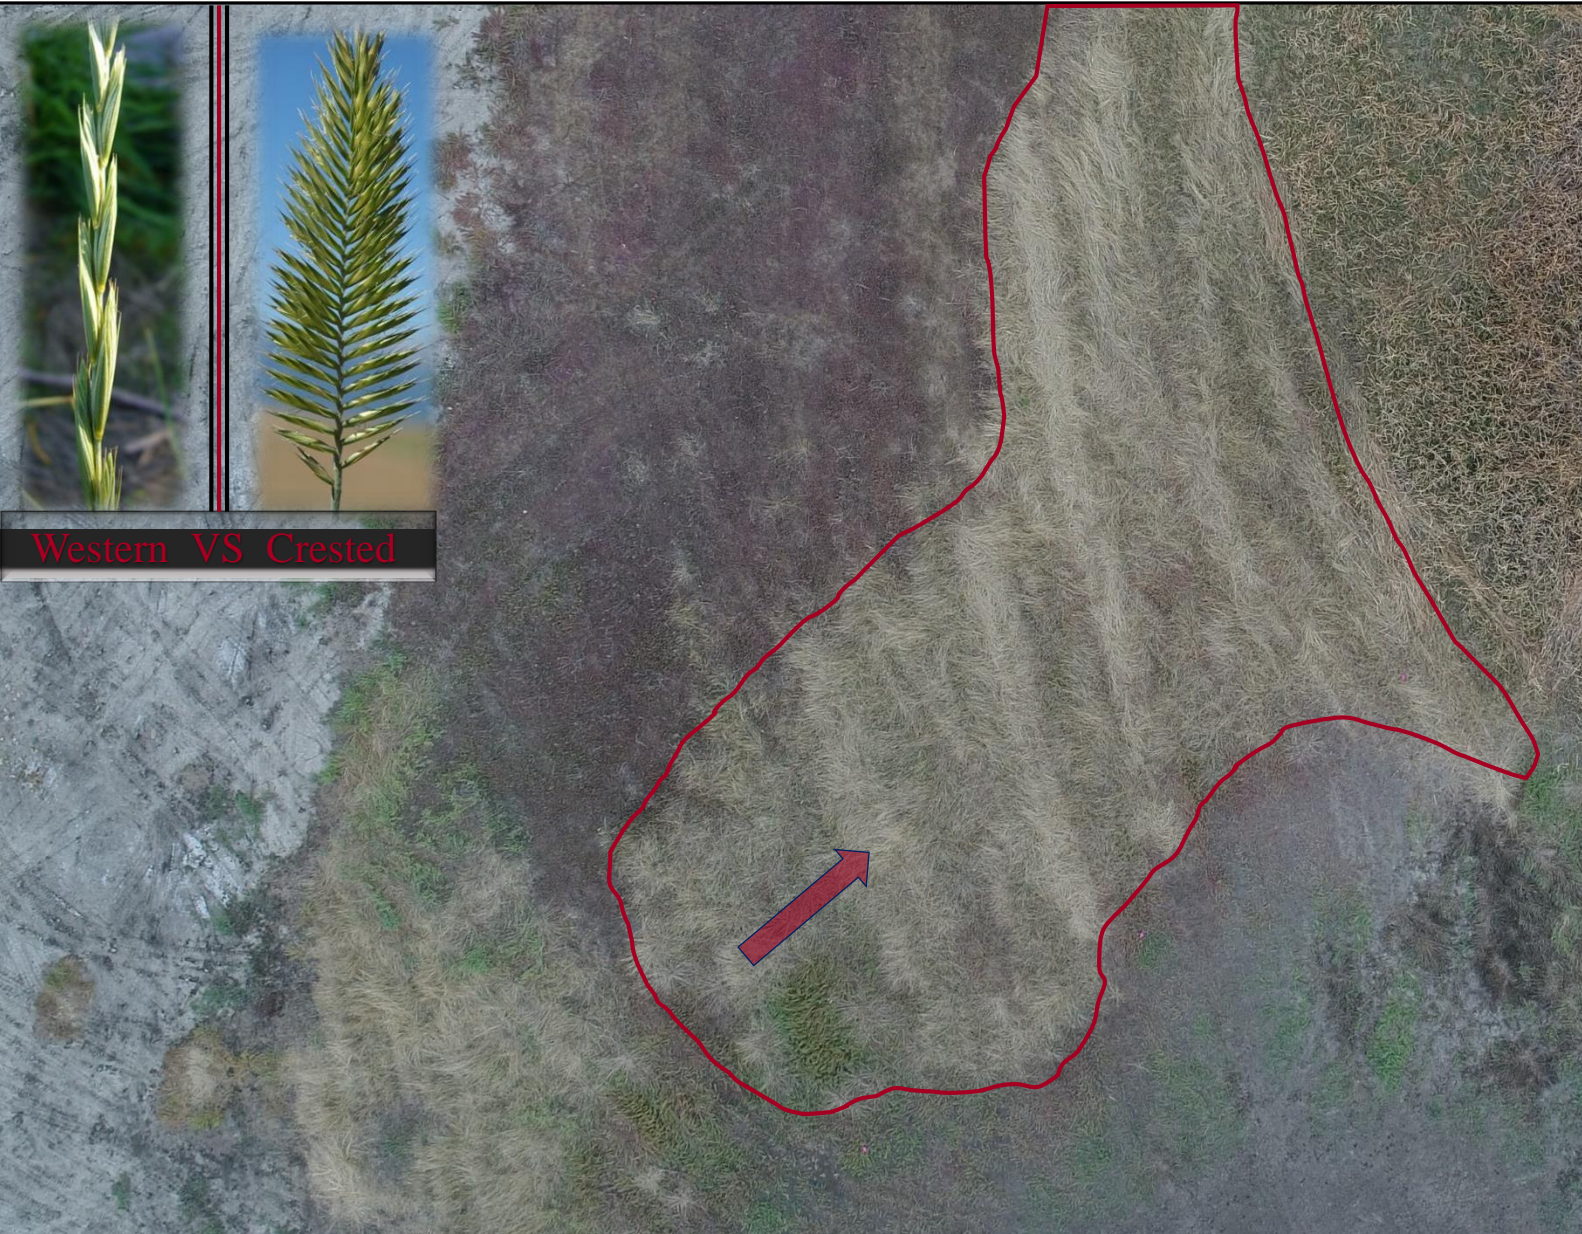
# Western Wheatgrass (*Pascopyrum smithii*)

Surface = 2,400  $\mu\text{S}/\text{cm}$

Surface - 12" = 3,500  $\mu\text{S}/\text{cm}$

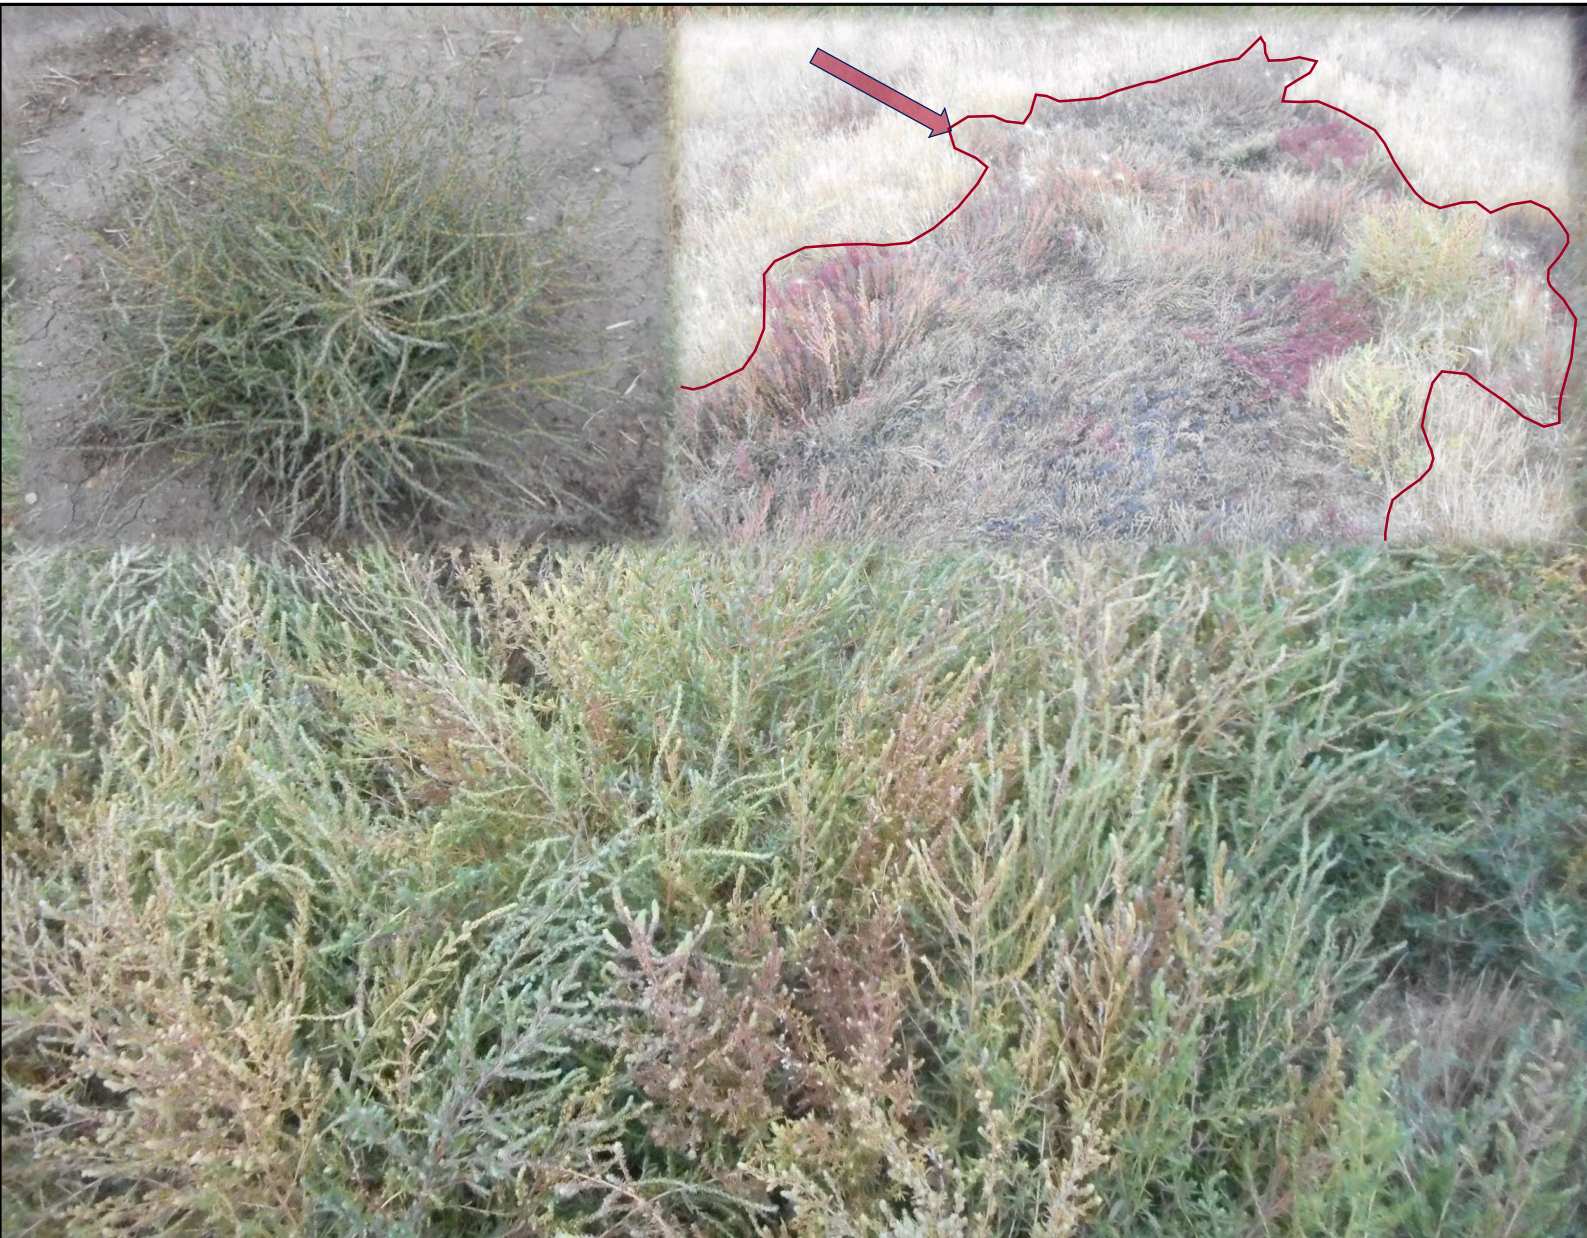
# Russian Thistle/Tumbleweed (*Salsola* sp.)

Surface = 6,800  $\mu\text{S}/\text{cm}$

Surface - 12" = 9,800  $\mu\text{S}/\text{cm}$

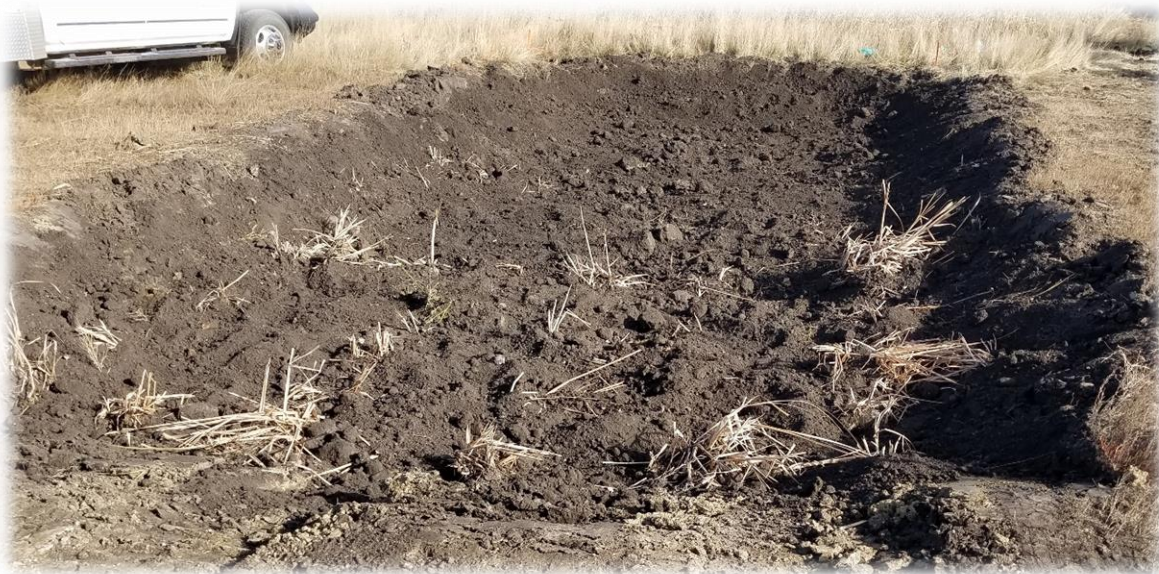
**After Backfilling to Cover Seeds/Cattail Bulbs**

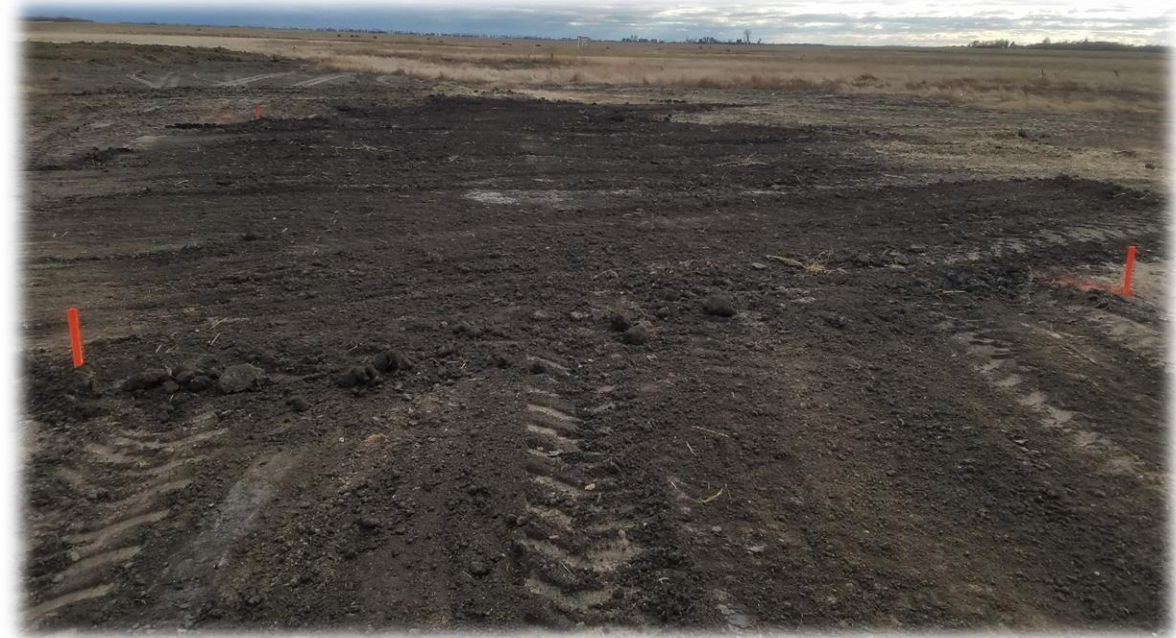
Test Plot 1A After Backfilling

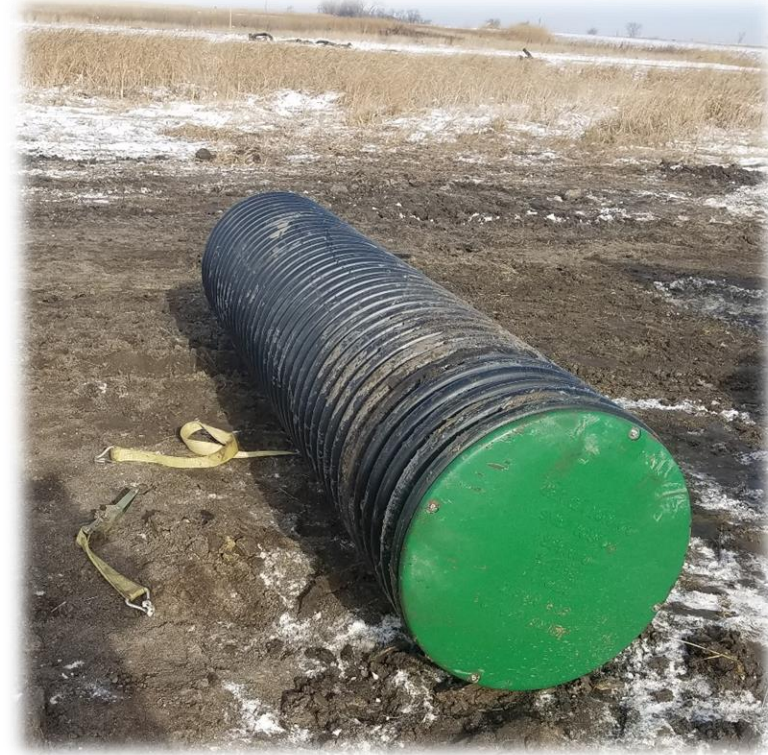
**Sump Pit with Leak-Proof Caps**

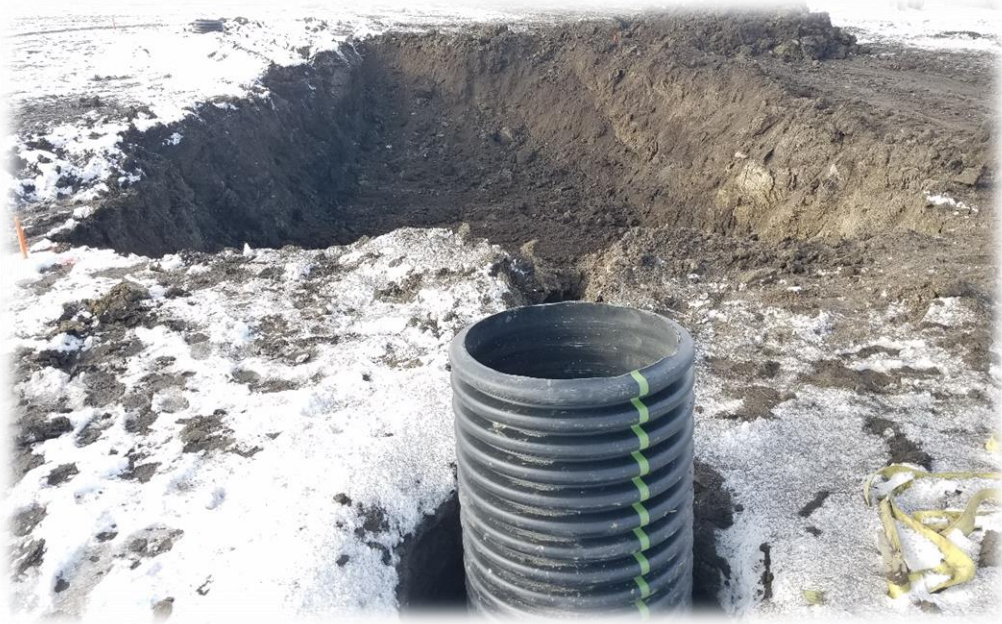
**PRC-3 During Excavation**

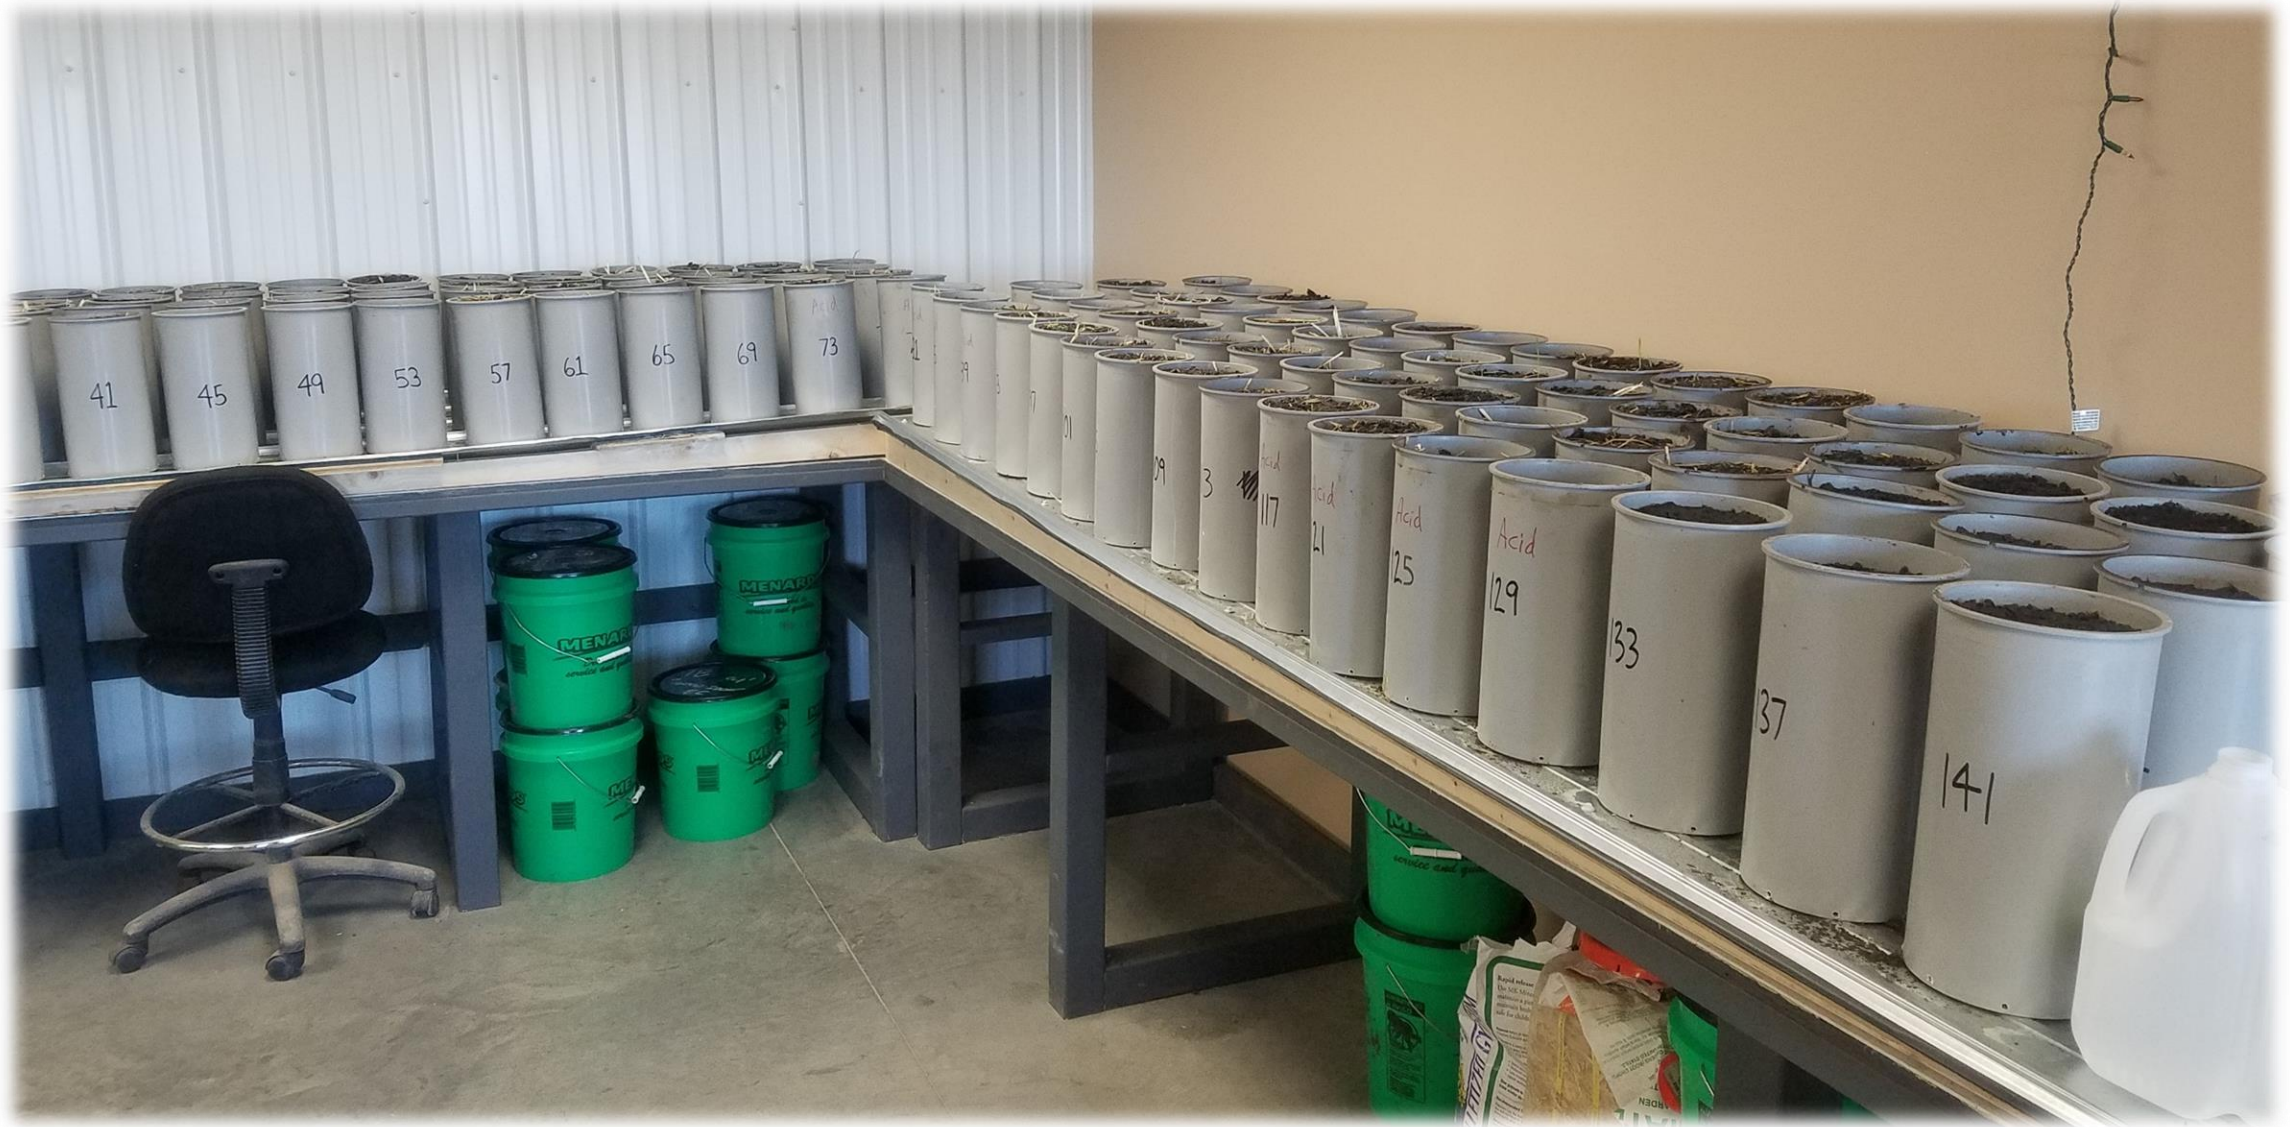
Test Cells with Drainage for Water Collection

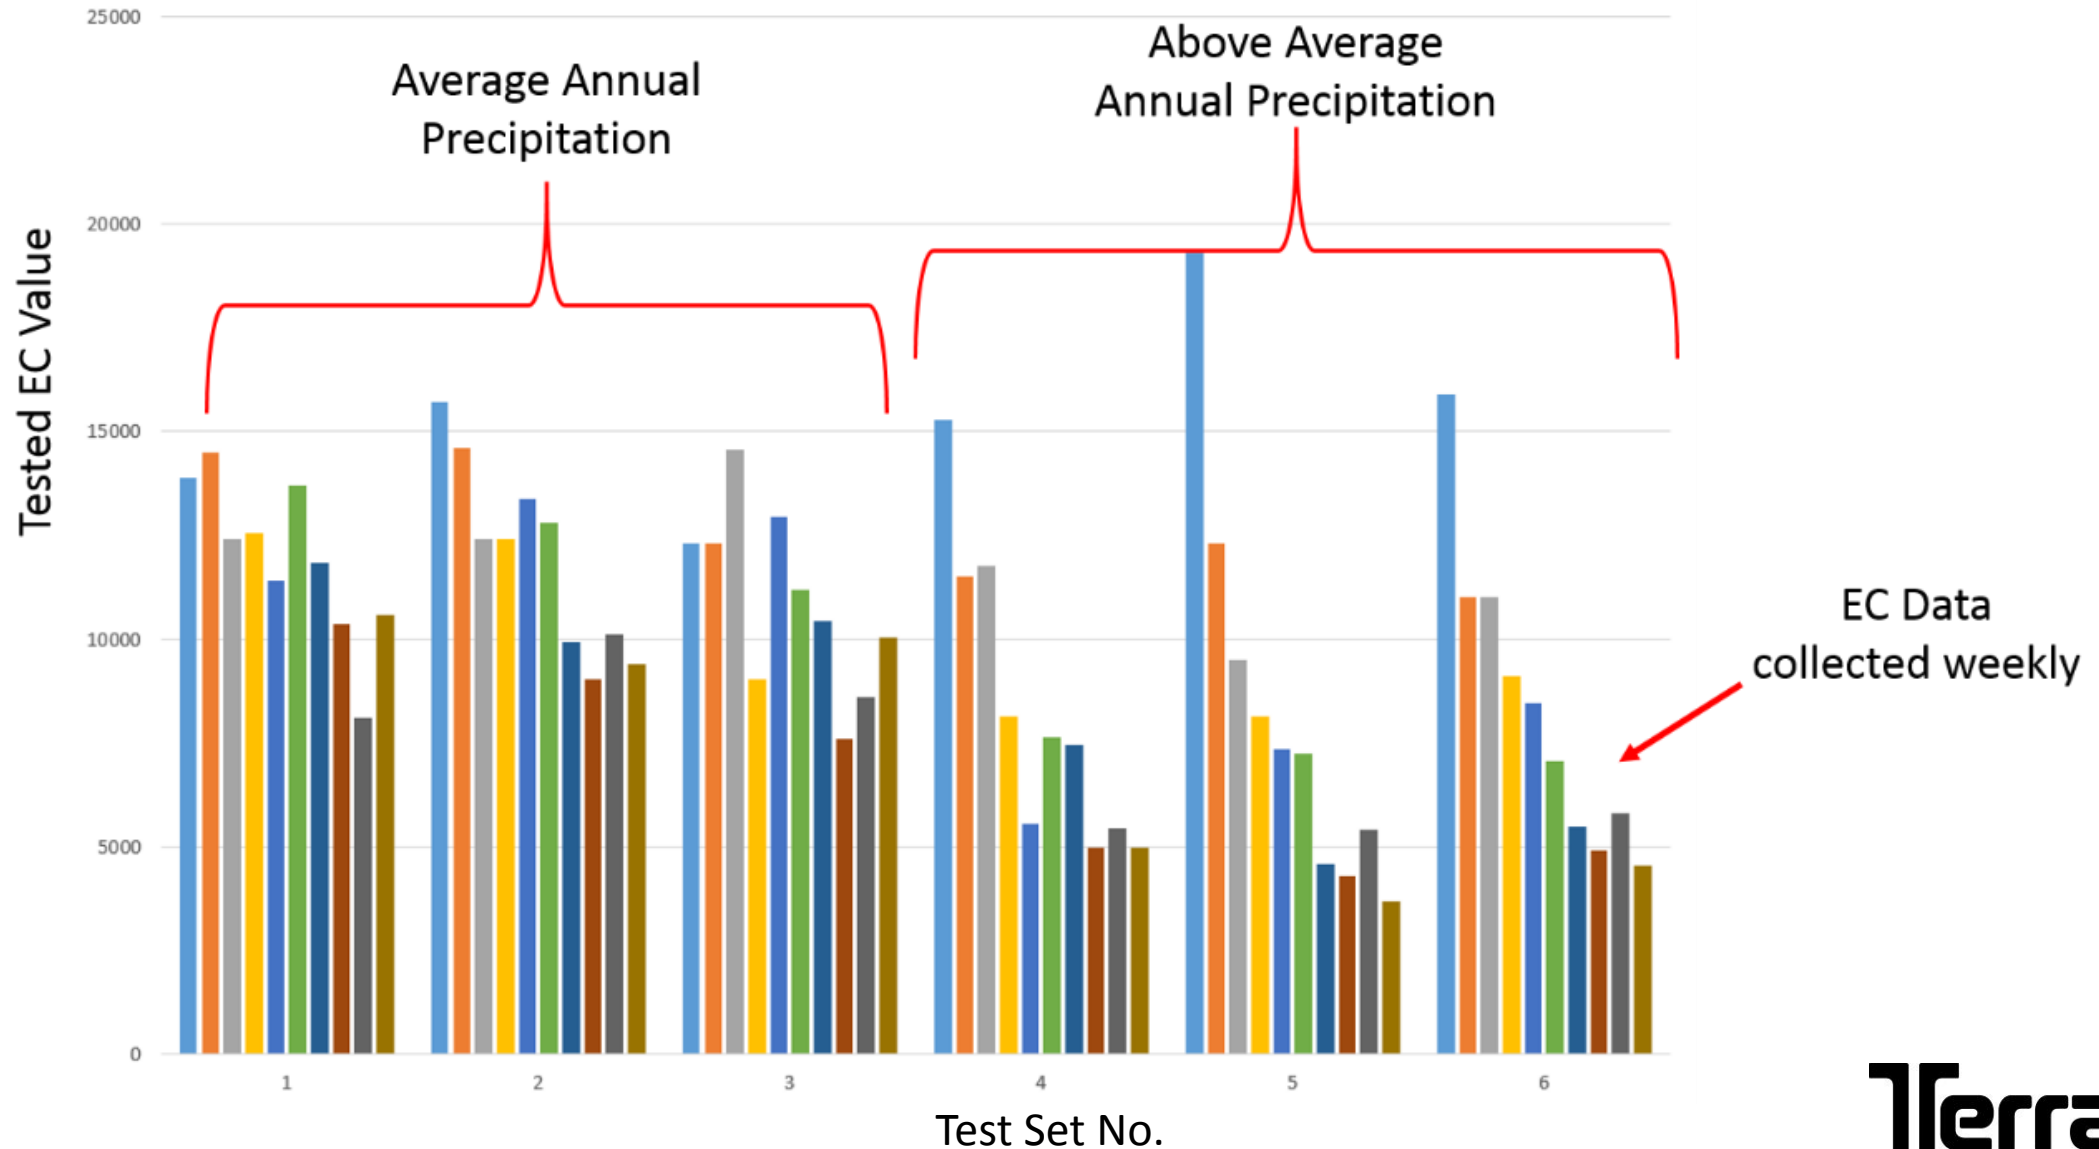
Example of Data Set Organization for Weekly EC Data

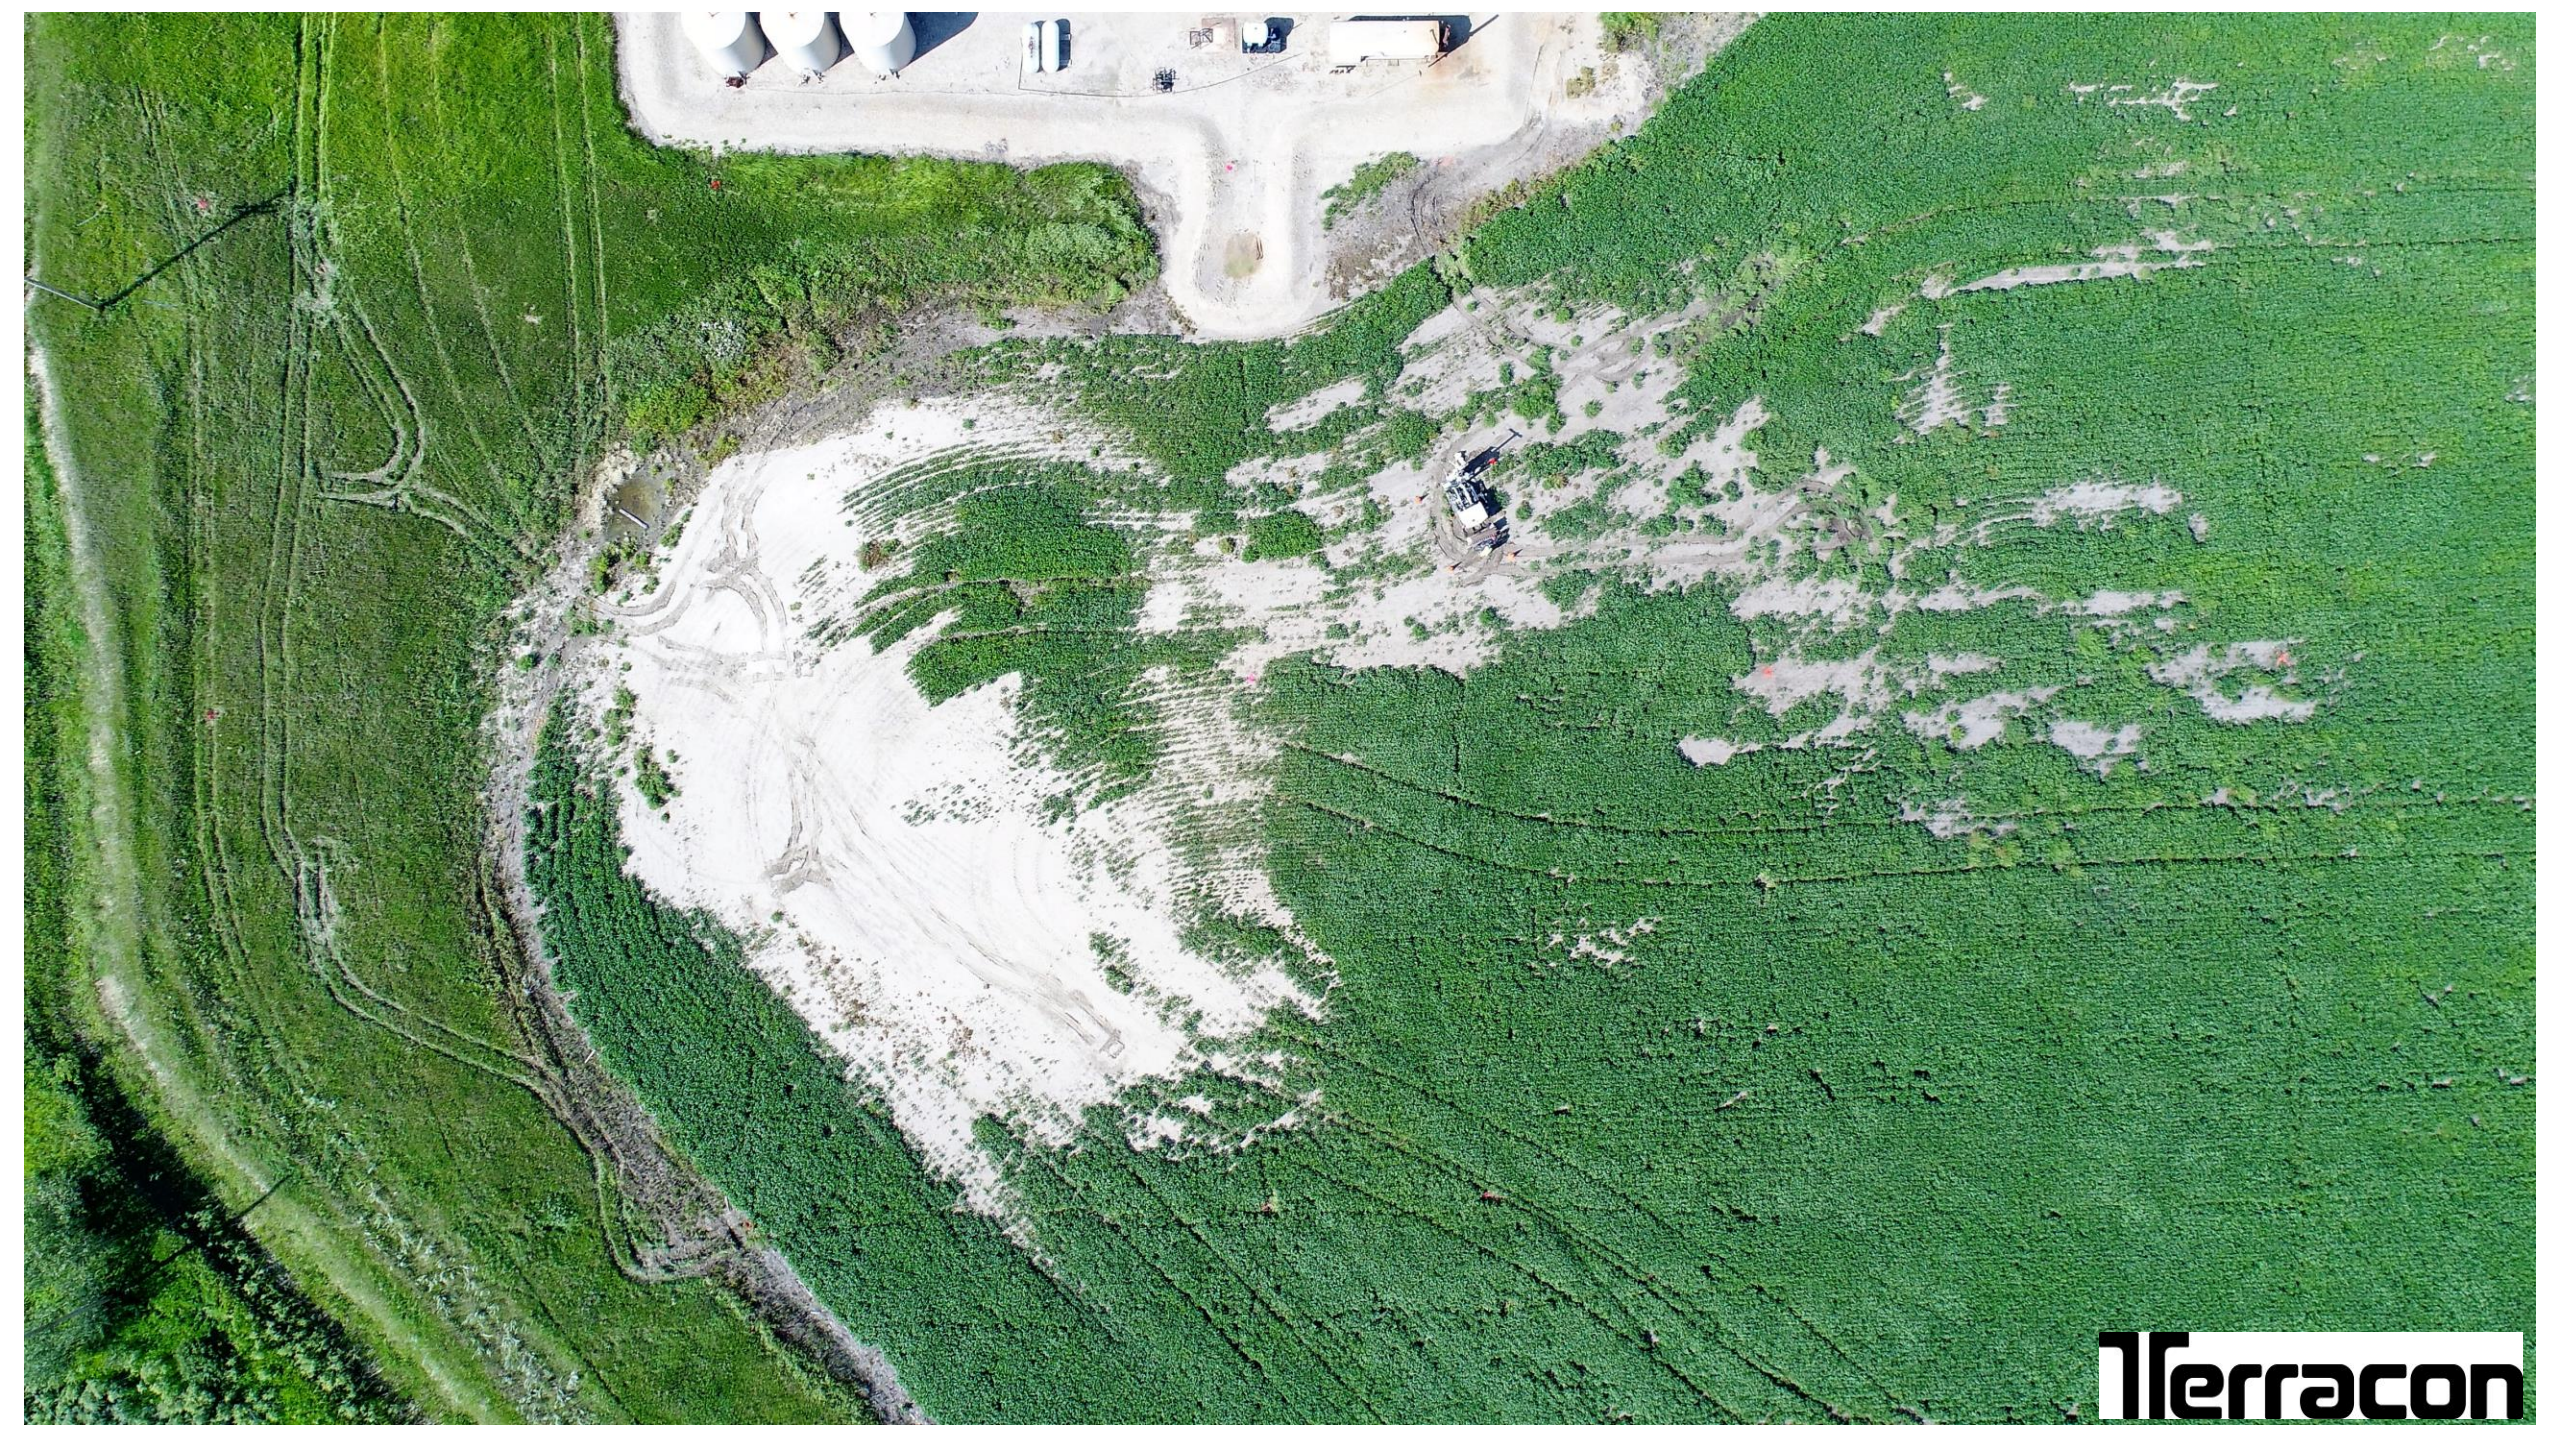
Aerial photograph taken 08/06/2019 by CO  
Height: 400 feet above ground

Phytoremediation Cell

Bentonite Trench

Clay Berm

Surface Contamination

Gravel Capillary Break

<b>Terracon</b> Consulting Engineers & Scientists 1401 1st Avenue NW PO Box 200 Fargo, ND 58102	Project No.: MT 10720 Drawn By: SGT Checked By: JGP Date: 8/23/2019	Exhibit <b>9</b>	<b>Proposed Remediation Plan</b> SW 14 of S11 T108N-R20W Renville County North Dakota
---	--	---------------------	---
